Case Report

Nontraumatic Fracture of the Femoral Condylar Prosthesis in a Total Knee Arthroplasty Leading to Mechanical Failure

Girish N. Swamy, Conal Quah, Elmunzar Bagouri, and Nitin P. Badhe

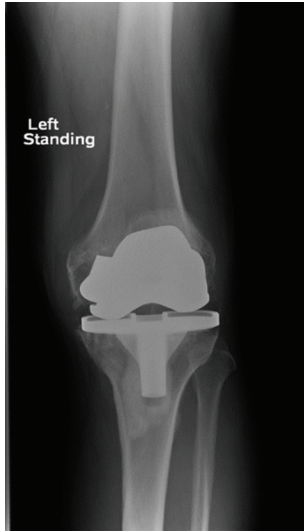
FIGURE 1: An anteroposterior radiograph of the knee showing evidence of the fracture of the medial femoral condylar prosthesis.

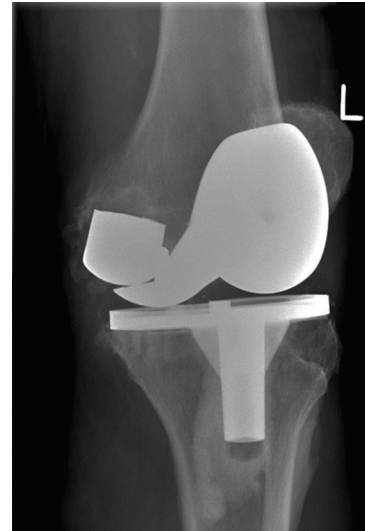
FIGURE 3: An oblique radiograph of the knee demonstrating the broken prosthesis.

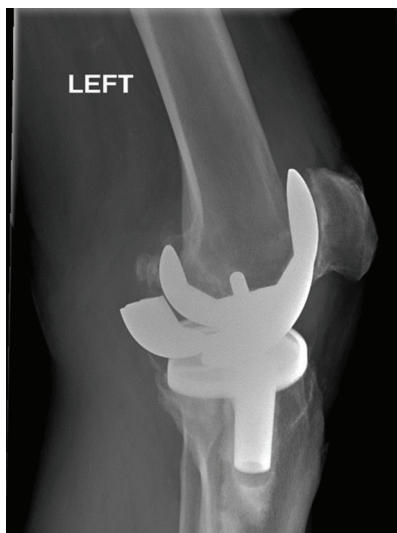
FIGURE 2: A lateral radiograph of the knee showing the broken prosthesis.

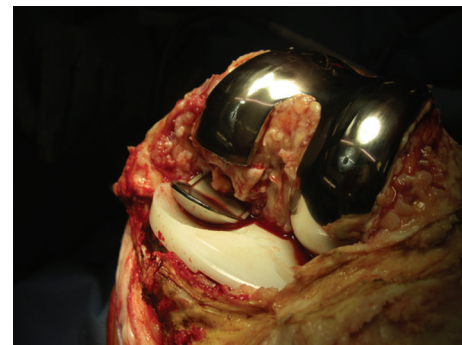
Revision surgery was performed as an elective procedure in August 2009 revealing the broken prosthesis (Figures 4 and 5). A TC3 RP PFC revision prosthesis was used with a medial parapatellar approach. A size 4 tibial prosthesis with a 53 mm sleeve and 12 * 75 mm stem and a size 4 femur with 31 mm sleeve and 14 * 75 mm stem along with femoral metallic augments and a 12.5 mm RP insert were used. Intraoperative range of motion was from 0 to 120 degrees and the procedure

FIGURE 4: Intraoperative evidence of the fracture through the medial femoral condylar implant.

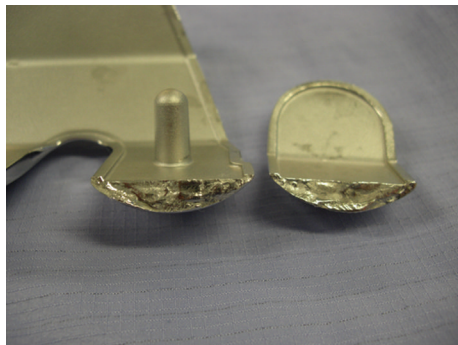
A metallurgical analysis of the failed prosthesis revealed no weakness in its strength.

FIGURE 5: Broken femoral component was cleaned and sent for metallurgical analysis.
