# Image quality and artifacts in automated breast ultrasonography

Sung Hun Kim

## PICTORIAL ESSAY

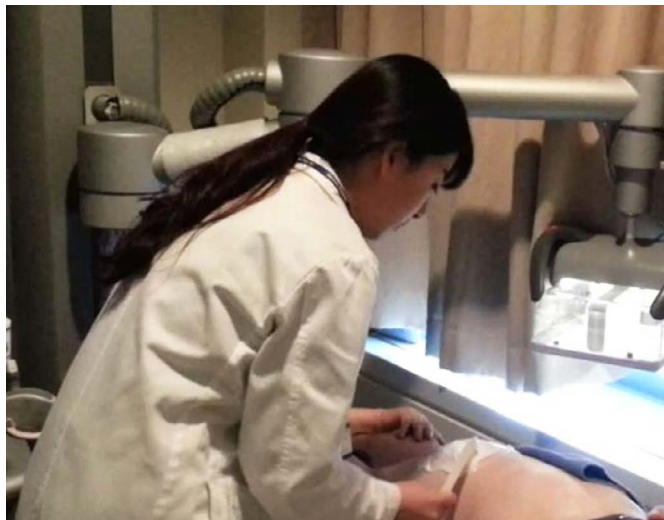
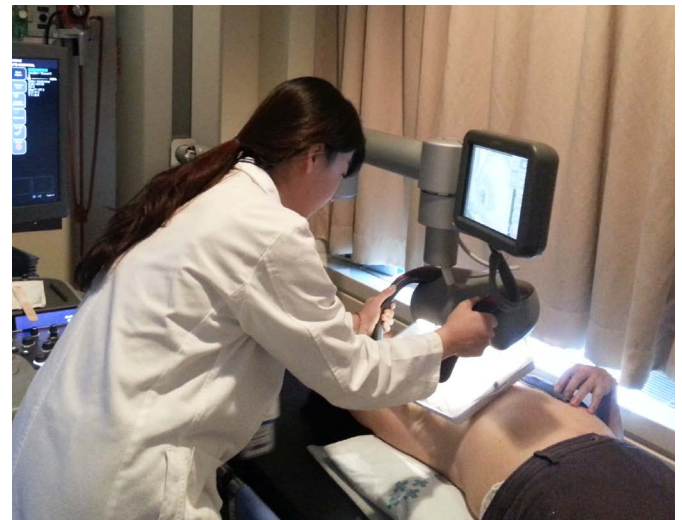
**A** **Fig. 1.** Image acquisition for automated breast ultrasonography. **A.** The patient was placed in the supine position. A special lotion was applied to the skin. **B.** The transducer was positioned on the breast with slight pressure and locked prior to scanning.

In ABUS, the patient assumes the same position as in HHUS. An ABUS-exclusive lotion that serves as a coupling agent is applied to the skin instead of the usual gel (Fig. 1A). The transducer is positioned on the breast with slight pressure and locked prior to scanning (Fig. 1B).

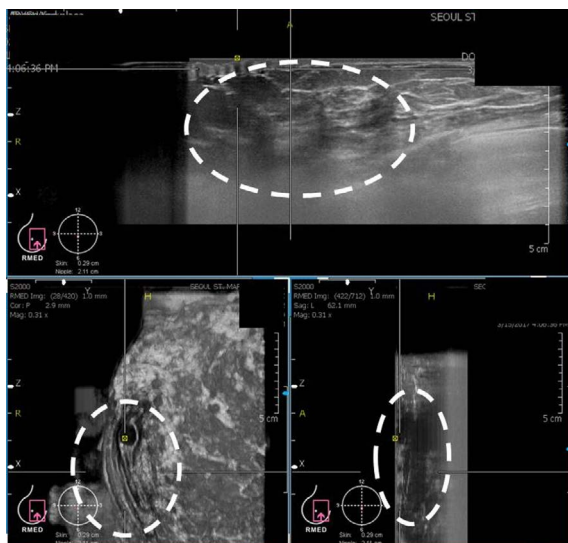
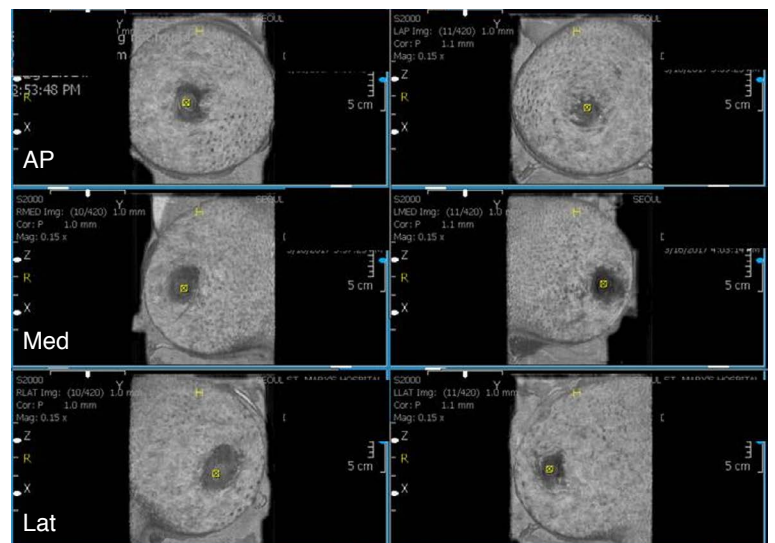
**A** **Fig. 2.** Representative cases showing image quality affected by the acquisition process. **A.** A poor-quality image is shown. Compared with the upper breast region, the lower breast is deeply wrinkled, resulting in dirty shadowing in the echo texture (white circles). **B.** An optimal image is shown. In the anteroposterior view (AP), the nipple is positioned in the center, and in the medial and lateral views (Med, Lat), the nipple is located in the periphery of the image.

The breast tissues should be fully covered. Poor contact between the transducer and skin could prevent the complete coverage of the breast and adversely affect image acquisition (Fig. 2A). Therefore, gentle compression and skillful manipulation of the probe to cover the whole breast is important.

In the anteroposterior view, the nipple should be positioned at the center of the image. In the medial and lateral views, the nipple should be positioned at the periphery of the image (Fig. 2B). It is easier to acquire images in women with large breasts than in those with small breasts. The depth of the scan should be evaluated to ensure that the deep and peripheral breast tissues are included in the image fields. In women with large breasts (a bra cup size larger than an E), the upper and deep central breast tissues are frequently not covered. Therefore, additional views should be acquired after correcting for the error in depth (Fig. 3A–C).

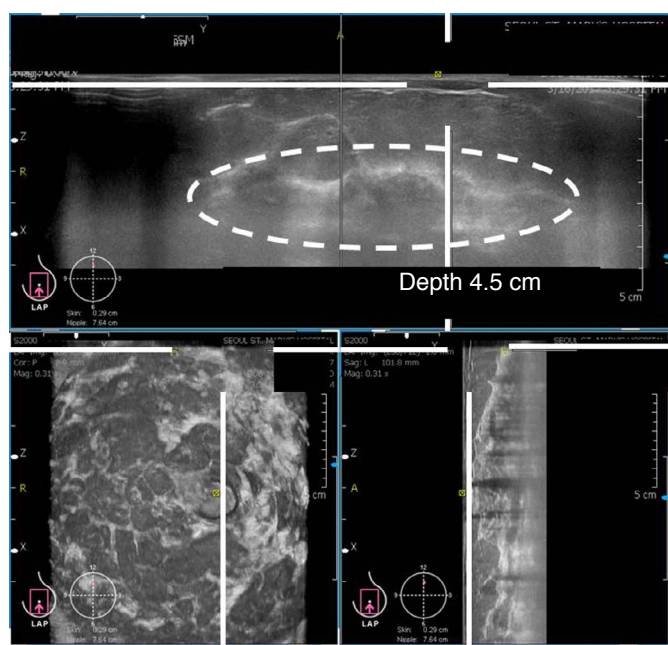
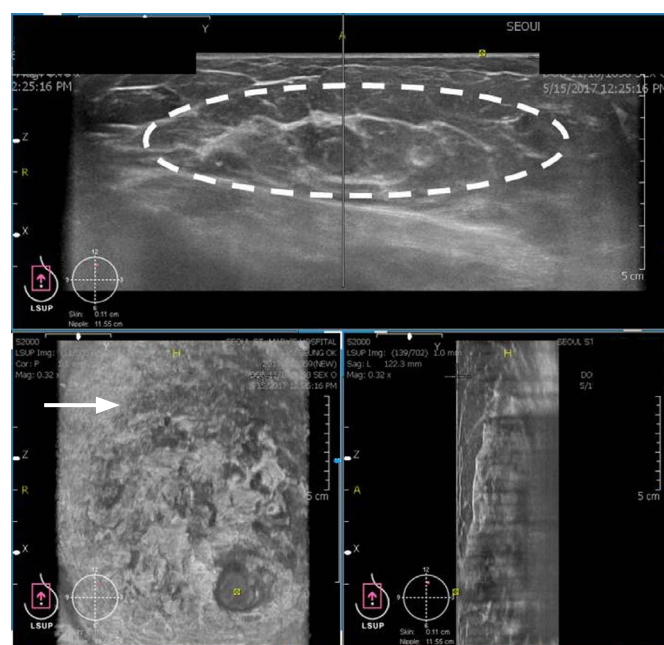
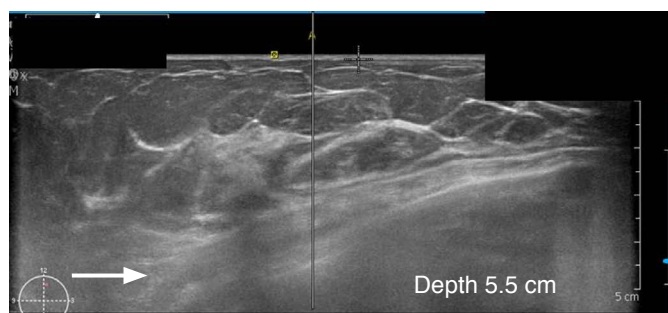
**Fig. 3.** Image depicting depth and coverage in a 44-year-old woman with a bra cup size of E.

**A.** The coronal view shows proper nipple position and coverage, and the axial view still reveals breast tissue (white circle) at the end of the upper breast region. The retromammary fat layer and chest wall are not shown. **B.** A superior view was additionally obtained. The fat layer without parenchyma (white circle) is shown in the upper breast (arrow). **C.** Rescanned image with a widened depth of 5.5 cm includes the chest wall boundary (arrow).

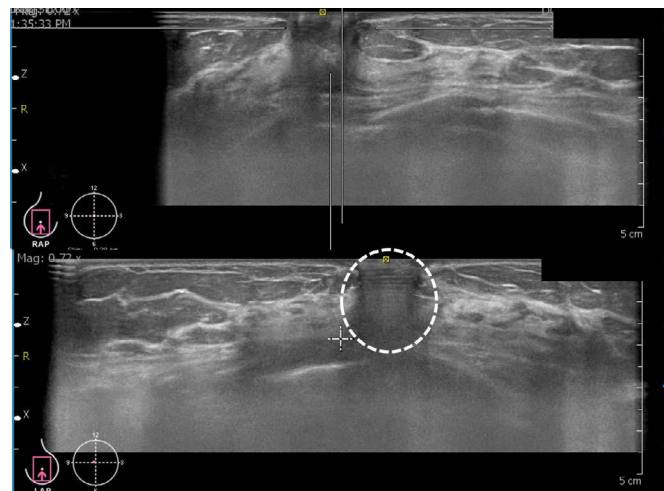
**Fig. 5.** Nipple shadow and reverberation artifact in a 41-year-old woman. A hypoechoic lesion is shown at the left subareolar region (white circle), in comparison with the right breast (upper image). The patient was recalled for hand-held ultrasonography and no abnormality was seen (not shown). The hypoechoic area was a reverberation artifact showing multiple parallel lines.

Nipple shadow and reverberation artifacts are problematic in ABUS (Fig. 5).

A reverberation artifact has the typical feature of multiple parallel lines that decrease in intensity and are equidistant from each other [12]. In addition, in the area around the nipple, the contact between the transducer and the skin is often imperfect, resulting in an acoustic shadow behind the nipple.

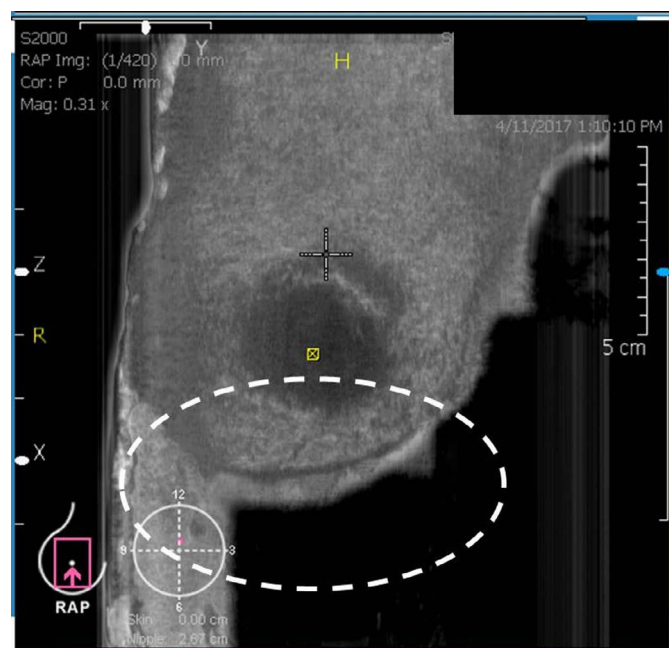
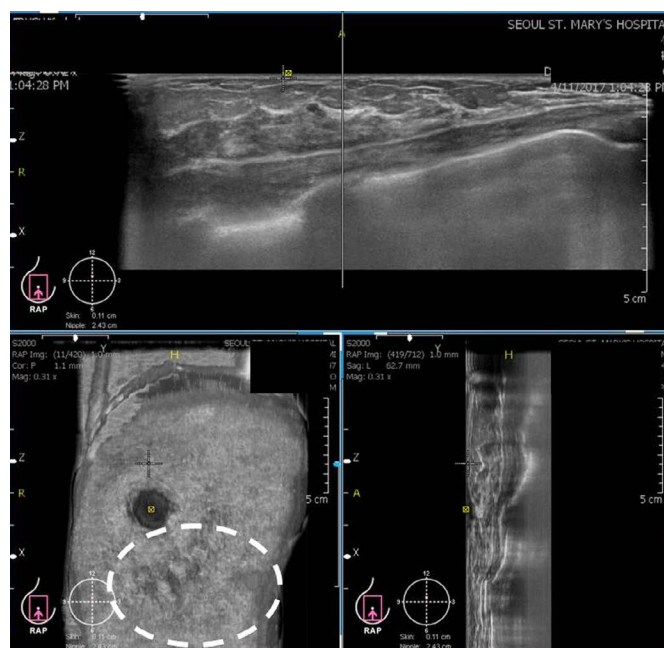
**Fig. 4.** Technologist’s assessment of image quality in a 47-year-old woman.

**A.** After scanning the patient, the coronal plane of the acquired volume was displayed at the skin level. The technologist detected incomplete coverage of the lower and medial breast regions (white circle). **B.** The probe was repositioned and rescanned. The lower and medial breast was covered adequately (white circle).

coverage, and gross contact artifacts (Fig. 4A, B).

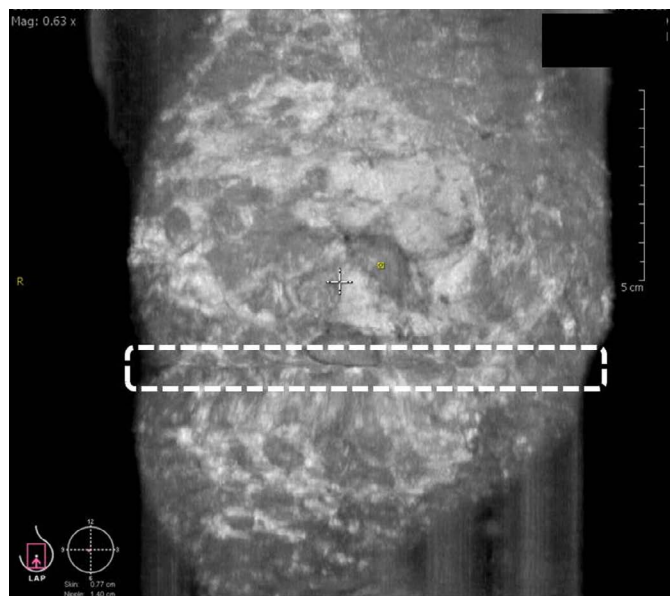
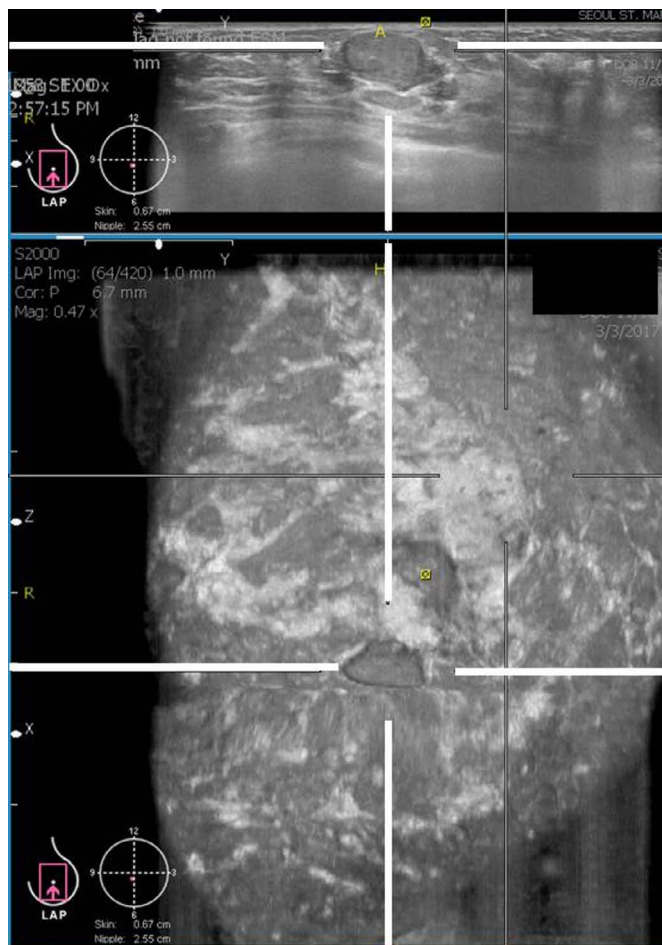
**Fig. 6.** Skip artifact in a 42-year-old woman. **A.** Coronal image shows the transverse line (white box). **B.** On the 3-display view, a true mass is present above this line.

A skip artifact is seen as a transverse anechoic line (Fig. 6A). It is common where there is a change in tissue stiffness, either due to a mass or simply due to moving from fat to dense tissue (Fig. 6B).

Although artifacts generally interfere with image quality, this type of artifact can, however, help to characterize a lesion or other findings [13]. When a transverse anechoic line is shown, the radiologist

must try to identify the cause of the change in tissue stiffness. Skip artifacts can be useful for detecting isoechoic masses, which are difficult to distinguish from the surrounding fat.

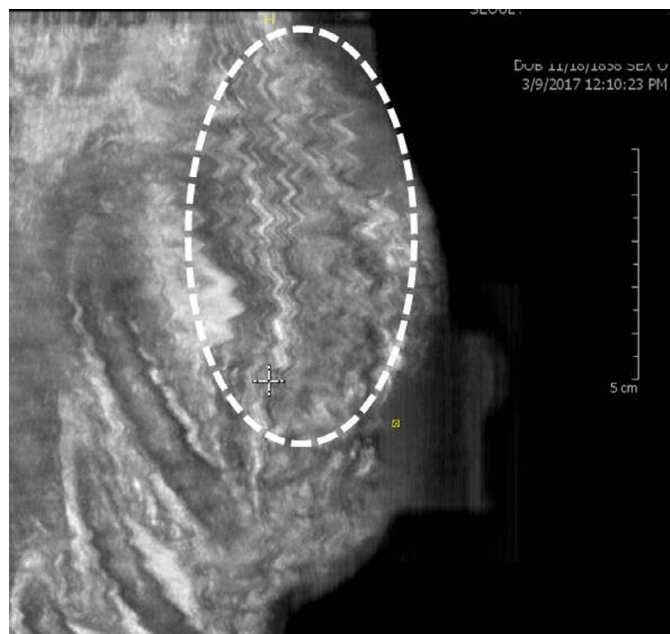
**Fig. 7.** Motion artifact in a 45-year-old woman. Coronal image shows multiple zigzag lines (white circle).

Motion artifacts are seen as multiple zigzag lines. The probe is designed to move smoothly over the area of interest. However, when the probe is placed just above the rib cage and vigorous compression or patient motion occurs, the probe can move discontinuously and create these curly lines (Fig. 7) [13,14].

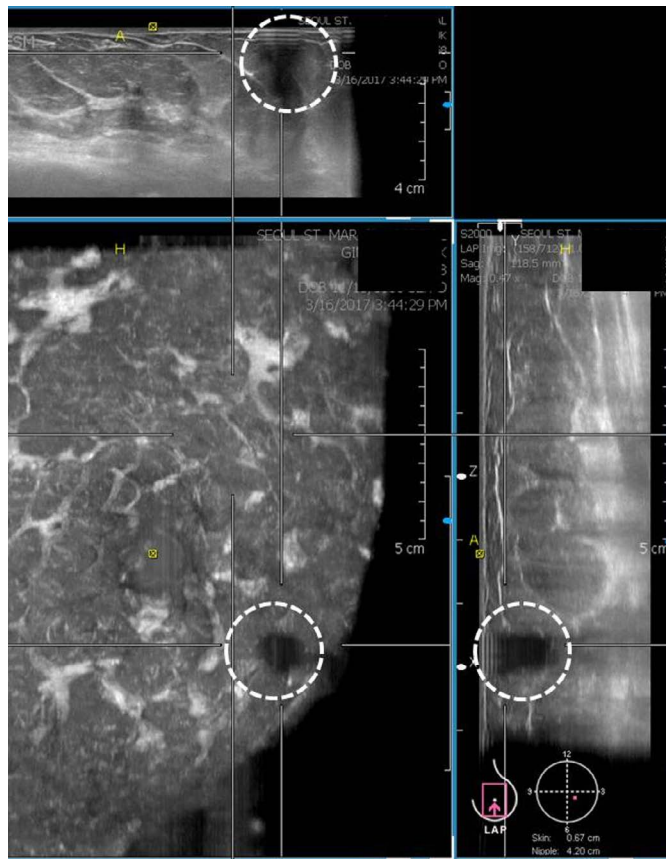
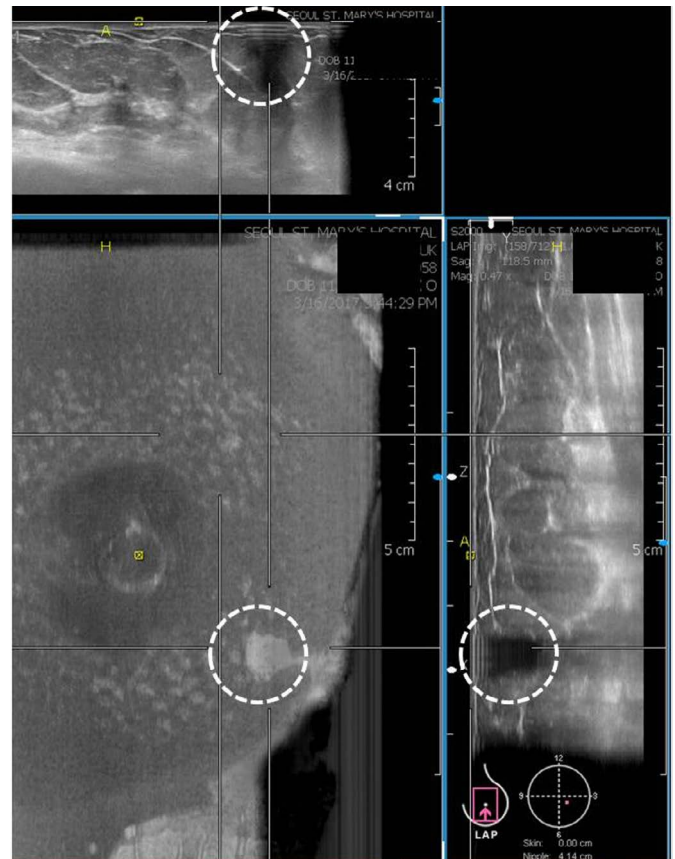
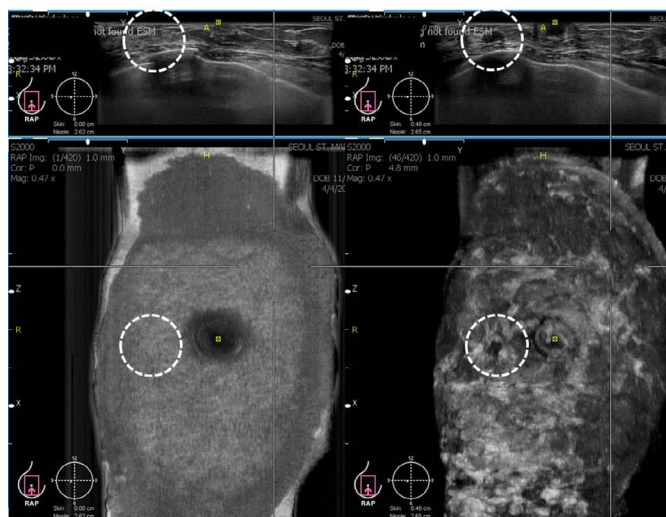
**Fig. 8.** Two representative cases showing a contact artifact and true mass in a 44-year-old woman.

**A.** An irregular, speculated, hypoechoic lesion (white circles) suspected to be a mass is shown. **B.** This hypoechoic lesion changed to a white area (white circles) at the skin layer due to poor contact between the transducer and skin. This contact artifact is mainly seen on the superficial breast tissues. **C.** A true mass (white circles) is located at the layer of the breast parenchyma, at a different point from that of the contact artifact.

A contact artifact appears as an irregular hypoechoic to anechoic lesion depending on the area of poor contact between the transducer and skin (Fig. 8A). It can mimic a breast mass.

The difference between a true lesion and this artifact is that the hypoechoic area of this artifact changes to an echogenic area at the skin layer (Fig. 8B). Contact artifacts occur in the superficial portion of the breast, from the skin layer to the subcutaneous fat layer (Fig.

8A). However, true lesions are located at the layer of the breast parenchyma (Fig. 8C).

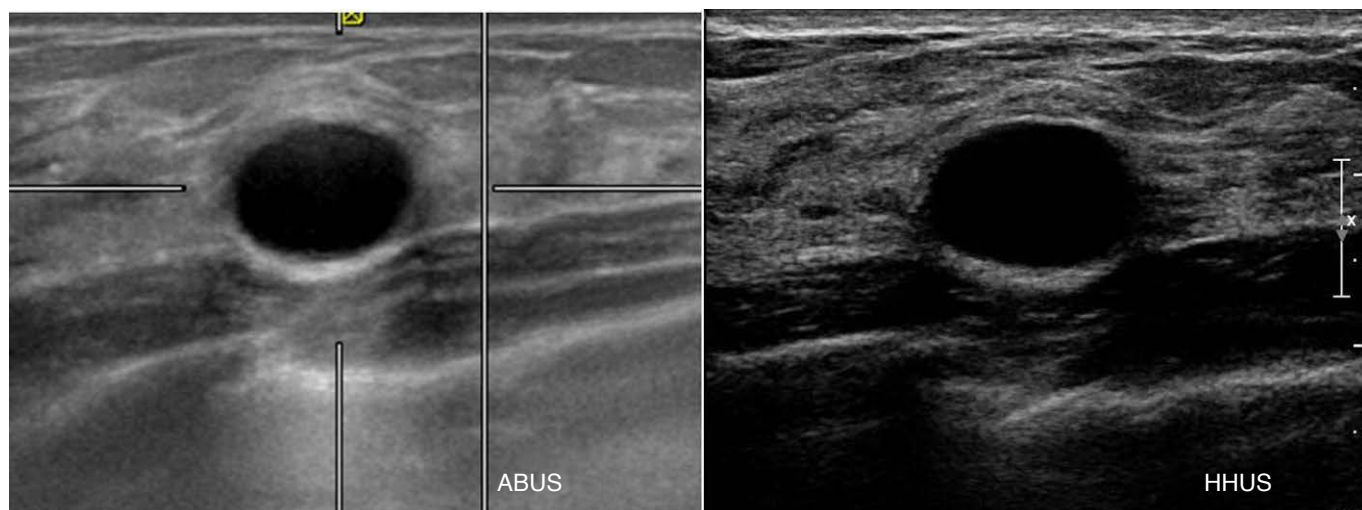
**Fig. 9.** Section thickness artifact in a 49-year-old woman. Axial image of automated breast ultrasonography (ABUS) demonstrates an anechoic cyst with anterior echogenicity. However, this lesion is shown as a simple cyst on hand-held ultrasonography (HHUS).

A section thickness artifact is associated with echo-signal averaging

within the section thickness. It is shown as a false area of sludge or debris with an anechoic cystic structure, and is commonly seen in cysts and the bladder (Fig. 9) [12]. Since a wide fixed focal zone is applied in ABUS, these artifacts occur frequently.

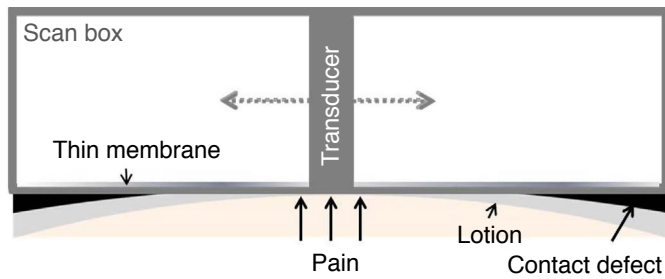
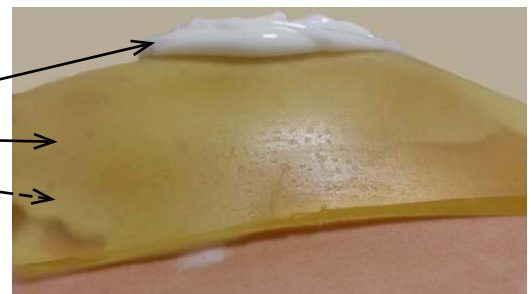
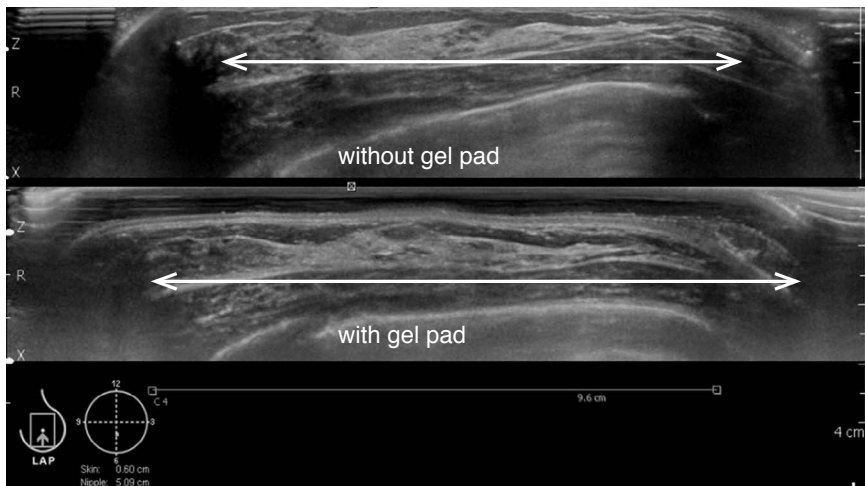
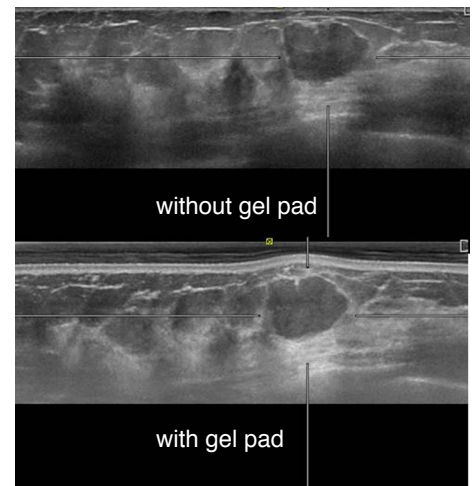
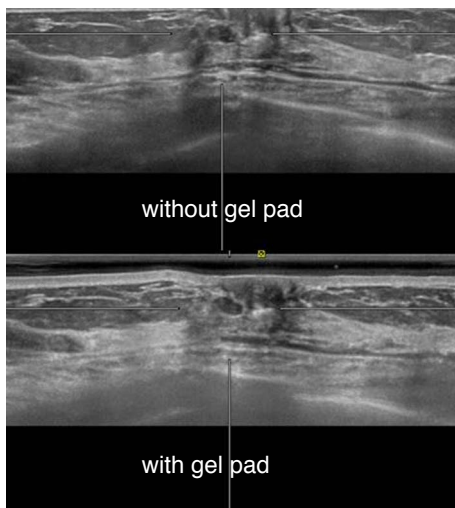
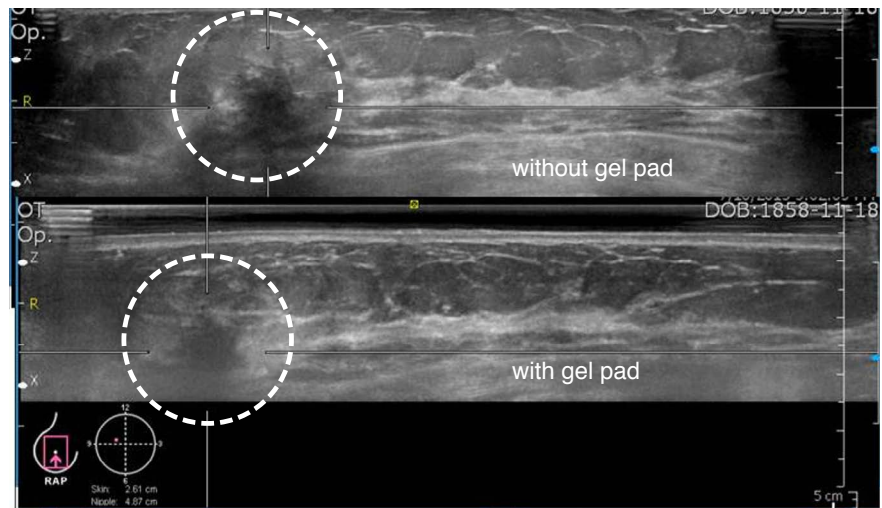
**Fig. 11. Gel pad application and image quality.**

A. Schematic diagram shows a peripheral contact defect. B. A commercial gel pad was applied as a specialized coupling agent. C. The width of the properly scanned area was increased by using a gel pad. D, E. Images with and without a gel pad show no difference in image quality in breast cancer (D) and fibroadenoma (E). F. The deep portion (white circles) was not fully included in the scan field due to the thickness of the gel pad.

[17]. As the probe moves on the dome-shaped breast horizontally, pressure imbalance and contact defects occur (Fig. 11A). Therefore, image quality can be degraded at the periphery.

A commercial gel pad was used as a specialized coupling agent to improve contact defects (Fig. 11B). As the gel pad was placed on

the breast, the breast became more flattened, with fewer contact defects at the periphery. With regard to the coverage of the breast, the area of the breast properly scanned was increased by using a gel pad (Fig. 11C).

In terms of image quality, no significant differences were found between images acquired with or without gel pad application in terms of conspicuity, contrast, degree of retroareolar shadowing, and retroareolar lesion visibility (Fig. 11D, E). When a gel pad is placed on the breast, the deep portion may not be included in the scanning field because of the thickness of the gel pad. Therefore, it is necessary to consider the gel pad thickness when making tissue depth adjustments (Fig. 11F).
