Knee Arthrodesis Using Dual-Plate Construct is Following Failed Distal Femur Megaprosthesis-A Case Report

Sujit Kumar Tripathy¹, Paulson Varghese¹, Shahnawaz Khan¹, Narayan Prasad Mishra¹, Mantu Jain¹

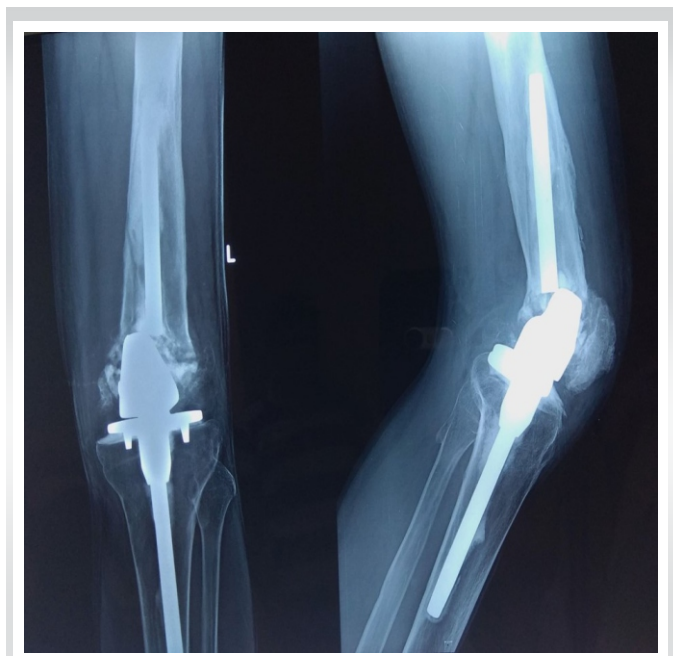
Figure 1: Radiograph showing broken distal femur megaprosthesis.

Anterior-posterior and lateral radiographs of the knee revealed a broken distal femur megaprosthesis (Fig. 1). The prosthesis was broken at the junction of the stem and shaft. Blood investigations revealed normal complete blood counts (TLC 8400/mm³), erythrocyte sedimentation rate (19 mm/h), and C-reactive protein (3 mg/dL). As there were no clinical signs of infection and the laboratory markers were normal, infection risk was excluded.

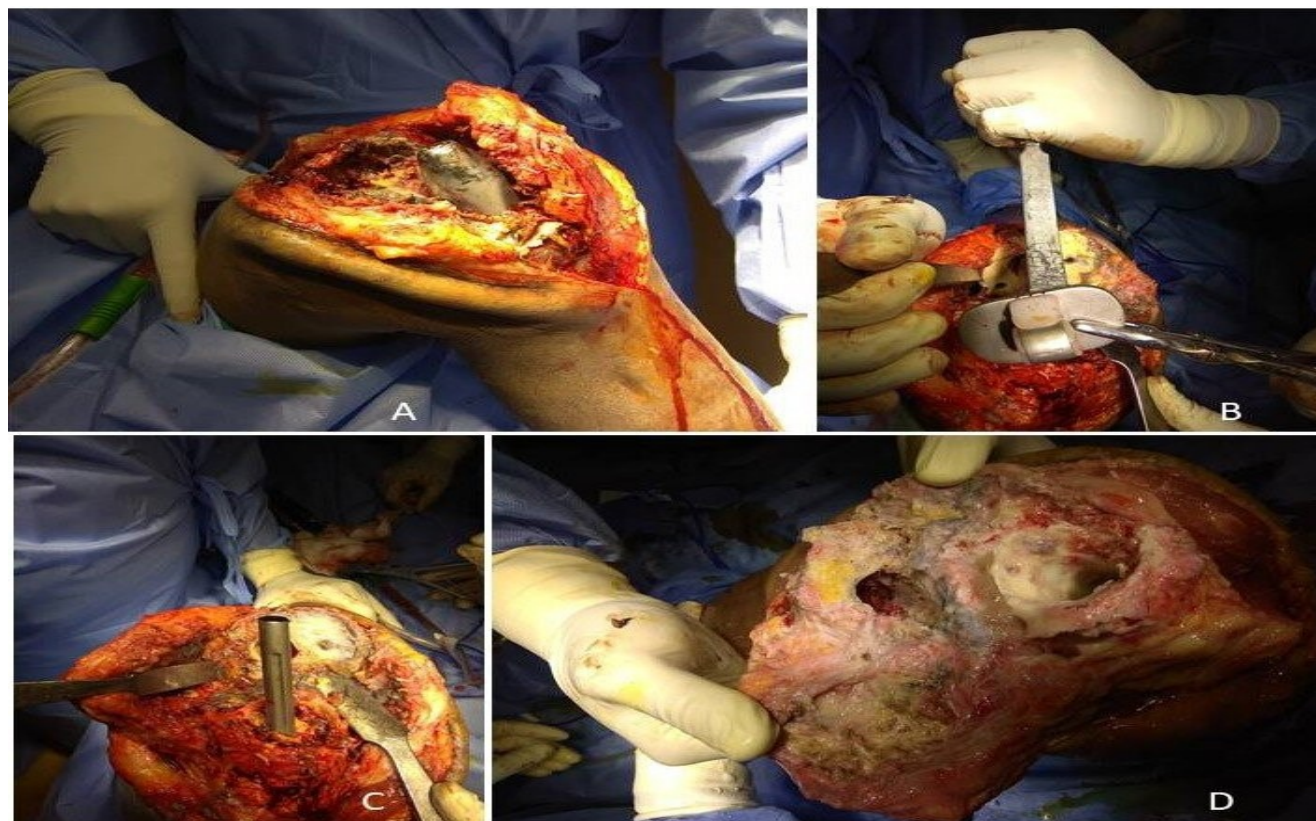
Figure 2: Intraoperative picture shows (A) broken distal femur megaprosthesis at stem-shaft junction, (B) Tibial component removal using osteotome, (C) The retained femoral stem was extracted after removal of cement mantle using osteotome and chisel, and (D) The tibial surface was prepared after freshening of the sclerotic margin, the bony surface was sclerotic on the femoral side because of cement effects.

As per his demand and financial condition, knee arthrodesis was planned. After due consent from the patient and a pre-anesthetic evaluation, we proceeded with the removal of the broken implant, followed by knee fusion. The previous midline scar was used as the line of incision, and a medial knee joint arthrotomy was performed. On flexing the knee joint, the broken distal end of the prosthesis was delivered. The cement mantle was removed with an osteotome. The proximal part of the prosthesis had to be pulled out using an extractor. We used 1.5 mm K-wire to drill around the component and break the prosthesis-cement bonding, and later, using multiple curettes and a fine osteotome, we removed the cement mantle. The tibial component was then removed using multiple stack osteotomes (Fig. 2), and similarly, the cement was removed. As a backup, we were prepared to place a screw in the stem and use a slap hammer to extract. The patient was explained about creating a cortical window or corticotomy below or above the prosthesis, breaking the cement mantle, and pushing the component toward the joint in case the need arises. Accordingly, all-size implants were kept ready. The surrounding devitalized soft tissues were debrided. The bone surfaces were freshened up and approximated in near-anatomical positions. The apposed bony surfaces were provisionally fixed with K-

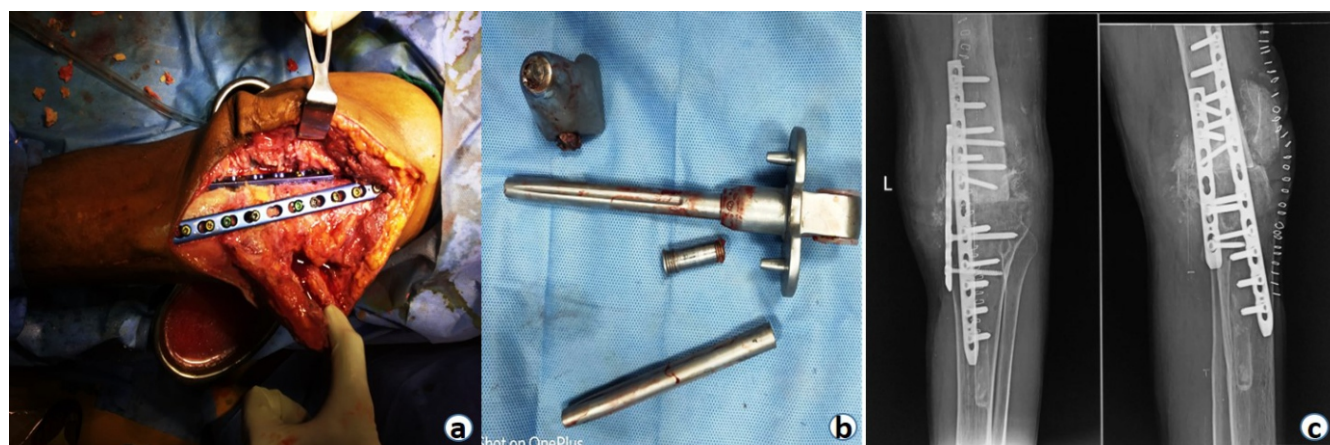
Figure 3: (a) Two plates (at 90°) were fixed to the medial and anterior surface for fusion, (b) the extracted prosthesis components, (c) Postoperative radiograph showing well apposed bony surfaces of tibia and femur.

wires in the desired position (neutral coronal and sagittal alignments with 15° external rotation), followed by definite fixation with two orthogonal limited contact dynamic compression plates contoured to the surface: one on the medial aspect (6-hole combi-hole locking plate) and the other on the anterior aspect (11-hole combi-hole locking plate) (Fig. 3). The construct was found to be stable. A cancellous bone graft harvested from the iliac crest was applied at the fusion site to augment the process of healing. The tissue samples from the knee joint were sent for culture and a frozen section. A negative suction drain was placed, and the wound was closed in layers. The histopathology and culture reports did not reveal any signs of infection.

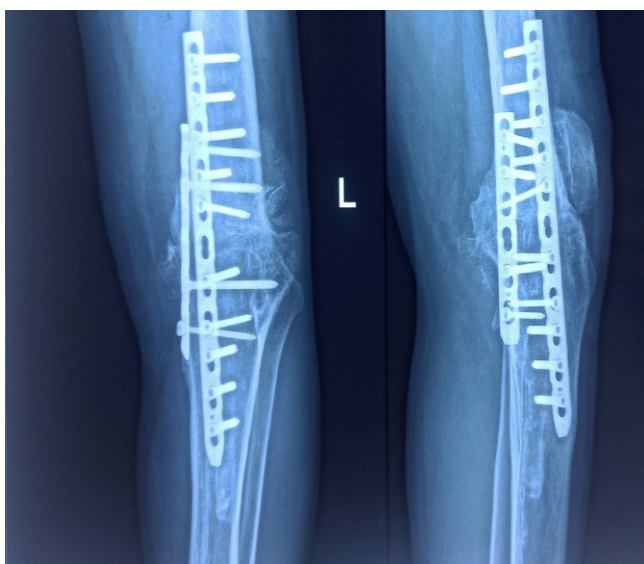
Figure 4: Four years follow up radiograph shows complete osseous fusion at the knee joint.

The patient was followed up biweekly for the 1st month and once a month thereafter. At the end of 3 months, the patient started walking independently without complaining of pain. However, he had a short-limb gait, and it improved after the shoe raise. The patient was advised on limb lengthening, but he denied it. He was very happy to resume his daily work. At the end of 4 years, the X-ray showed solid union at the knee arthrodesis site without complaint of back pain or any other joint pain (Fig. 4). He does not want a removal surgery at present.
