# Clinically insignificant trunnionosis in large-diameter metal-on-polyethylene total hip arthroplasty

**H. S. Hothi,  
D. Kendoff,  
C. Lausmann,  
J. Henckel,  
T. Gehrke,  
J. Skinner,  
A. Hart**

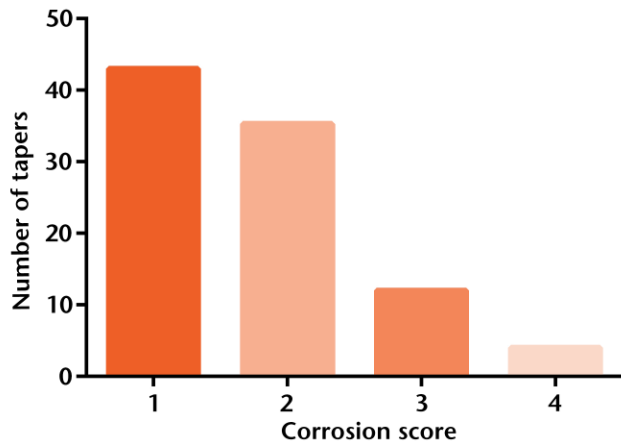
Fig. 1

Taper corrosion scores for the metal-on-polyethylene hips.

**Corrosion assessment.** We found that approximately 45% of the MOP head tapers had no evidence of corrosion (score 1), 38% were mildly corroded (score 2), 13% were moderately corroded (score 3) and 4% were severely corroded (score 4) (Fig. 1). The four tapers with signs of severe corrosion all had evidence of black surface

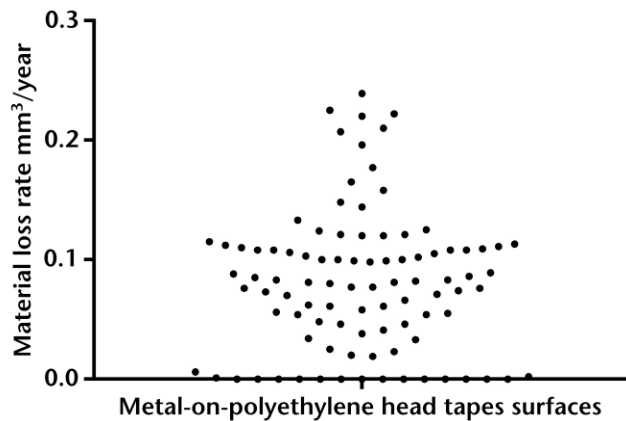
Fig. 2

Dot plot of the annual rate of material loss for the metal-on-polyethylene hips from each head taper in this study.

**Material loss measurement.** The median volume of total material loss measured at the MOP head taper surfaces was 1.45 mm<sup>3</sup> (0 to 4.53). The median rate of material loss annually was 0.084 mm<sup>3</sup>/year (0 to 0.239) (Fig. 2).

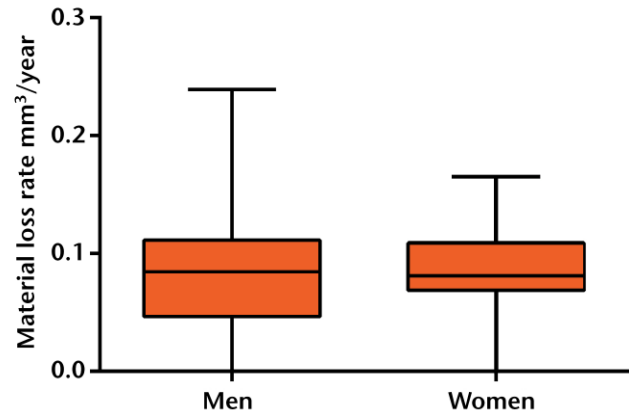
Fig. 3

Box plot presenting the annual rate of material loss for male and female patients. The plots present the median values, upper and lower quartiles and the maximum and minimum values of material loss rate.

**Statistical analysis of influencing MOP variables.** The median rate of material loss at the MOP head taper was 0.081 mm<sup>3</sup>/year (0 to 0.239) in men and 0.0845 mm<sup>3</sup>/year (0 to 0.165) in women. This difference was not statistically significant ( $p = 0.89$ ) (Fig. 3).

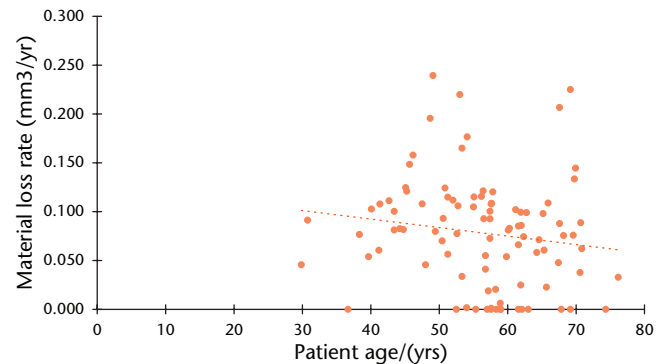
Fig. 4

Plot showing the association between patient age (years) and the annual rate of material loss (mm<sup>3</sup>/year). A line of correlation is fitted with  $r = 0$ .

We found a weak negative correlation between patient age at the time of the original arthroplasty procedure and rate of taper material loss ( $r = -0.2307$ ;  $p = 0.033$ ) (Fig. 4). There was no correlation between the time to revision
