**Case Report**

# **Prosthodontic Rehabilitation of a Bruxer Patient with Severely Worn Dentition: A Clinical Case Report**

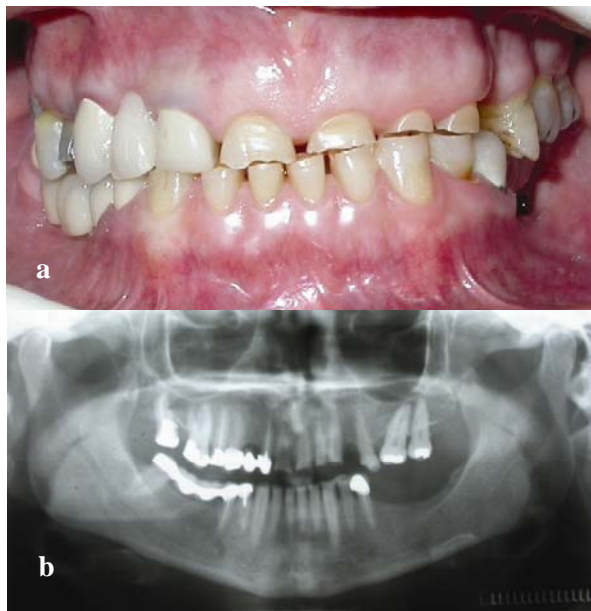
A 54-year-old woman was referred to the Department of Prosthodontics in the Faculty of Dentistry at Tehran University of Medical Sciences, Iran, for prosthodontic treatment. The patient's chief complaint was the restoration of the worn teeth, in addition to the replacement of unacceptable restorations and missing teeth. An initial evaluation of the patient indicated a history of depression, and also, parafunctional habits of bruxism and clenching. Oral hygiene was fair and there was no periodontal problem. Clinical and radiographic examinations and diagnostic casts revealed severe attrition and abfraction, especially on anterior teeth and an uneven occlusal plane (Figure 1a,b). The causes of the severe wear were parafunctional habits, unsuitable restorations, and a lack of left posterior occlusion due to missing left mandibular posterior teeth.

Figure 1. Frontal view of teeth in occlusion (a), and panoramic radiograph (b) before treatment.

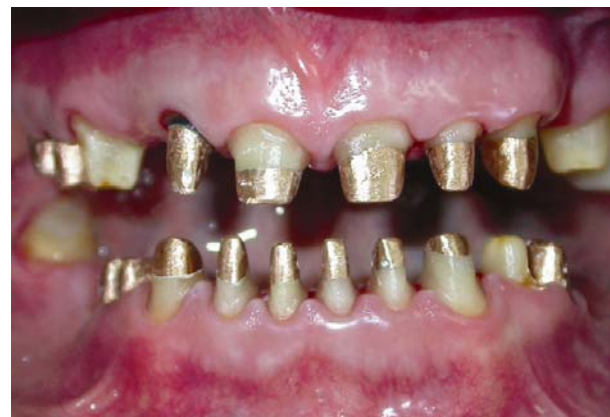
Figure 3. Cast gold posts and cores.

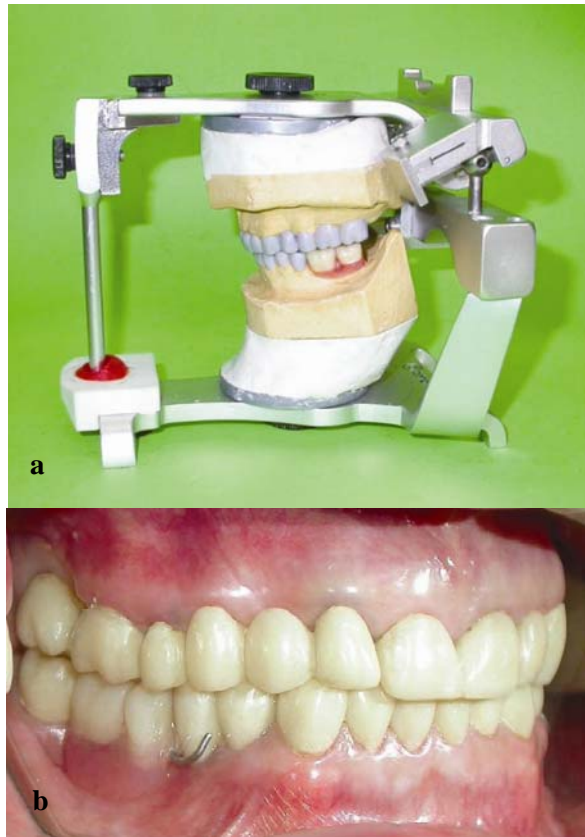
**Figure 4.** Diagnostic wax up (a) and fixed provisional restorations in place (b).

were fabricated according to the diagnostic wax-up (Figure 4), for which the Broadrick flag analyzer was used to determine the curve of occlusal plane. Impressions were made from provisional restorations, and casts were transferred to the Denar Mark II articulator (Teledyne Water pik, Fort Collins, CO, USA) using the Denar Slidematic facebow (Teledyne Water pik, Fort Collins, CO, USA) and mandibular record base. Then, an anterior guide table was customized by pattern resin (Duralay, Reliance Dental MFG Co, Worth, CO, USA).

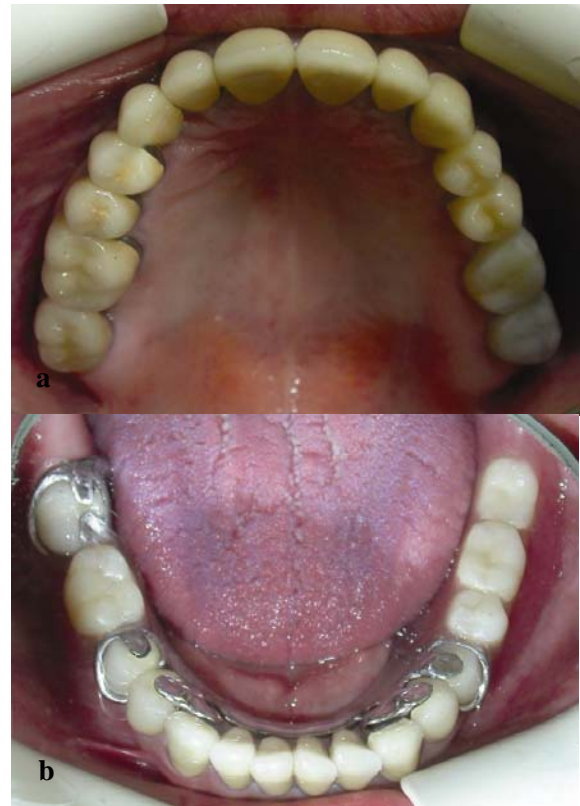
**Figure 5.** Occlusal view of the maxillary (a) and mandibular (b) arch after treatment.

After completion of teeth preparations, the final impressions were made with silicon impression material (Speedex, Coltene AG, Alstatten, Switzerland) and metal-ceramic restorations were fabricated. In mandibular restorations, rest seats, guide planes and retentive undercuts were formed in the RPD abutments. Kennedy class II mode 1 mandibular RPD was fabricated using altered cast technique and delivered (Figure 5). Finally, the occlusion of restorations was adjusted so that equal-intensity centric contacts were established on all teeth (Figure 6; a) and anterior guidance discluded all posterior teeth in eccentric jaw movements. A maxillary occlusal splint was fabricated for protecting the restorations from patient's parafunction. The smile view of patient after treatment is shown in Figure 6. One year follow-up showed no problem in teeth, restorations and temporomandibular joints.

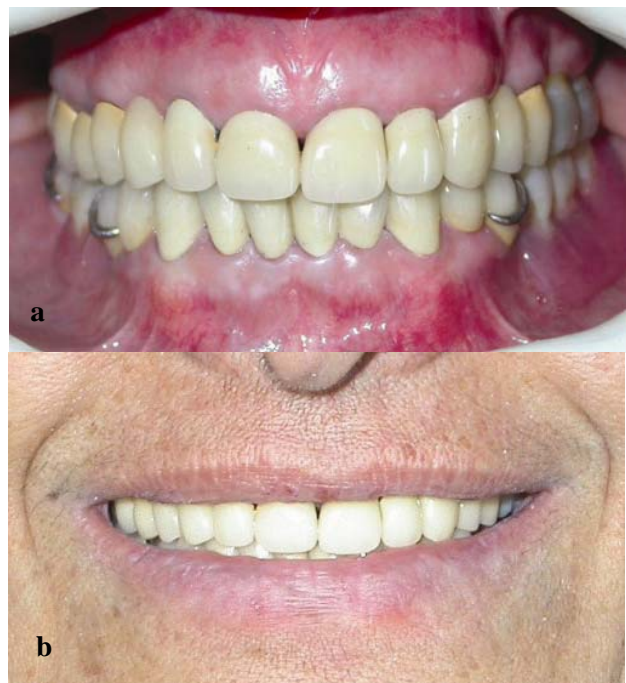
**Figure 6.** Frontal view of teeth in occlusion after treatment (a); smile view after treatment (b).
