International Journal of Surgery Case Reports

Tibial baseplate fracture associated with polyethylene wear and osteolysis after total knee arthroplasty[☆]

INTRODUCTION: Fracture of the tibial baseplate following total knee arthroplasty is very rare given the developments in modern prosthesis design. Tibial baseplate fracture secondary to polyethylene wear, osteolysis and component malalignment in an elderly obese patient is reported in the present article.

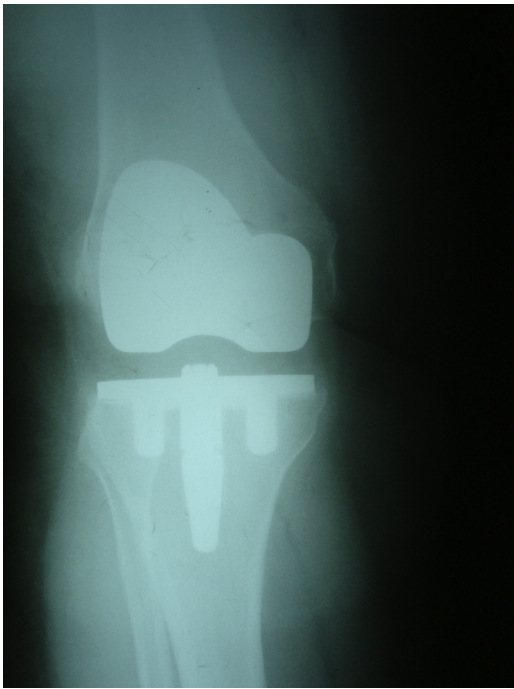
Fig. 1. Follow-up radiograph revealed varus malalignment of the tibia three years after the total knee arthroplasty.

In the present case, as observed on the early pre-operative X-ray, the cemented tibial stem was relatively well-fixed, but there was varus malalignment due to inadequate ligament balance, which resulted in continuous overloading of the medial compartment of the knee. Osteolysis and bone loss occurred in the medial region of the tibia in the present case, and this was the site of the tibial fracture; this clinical situation is consistent with those in previous articles.^{4,5,8} The current patient was obese when the initial procedure was performed and had no follow-up for six years. Although these multifactorial predisposing factors of osteolysis leading to the possible failure of the knee arthroplasty existed, the patient had not been informed about the possible complications and the need for regular follow-up even years after the initial procedure. Furthermore, when she was admitted to the local hospital after her pain worsened, an analgesic drug was prescribed without a meticulous investigation of her knee; the chance of an early revision was therefore missed.

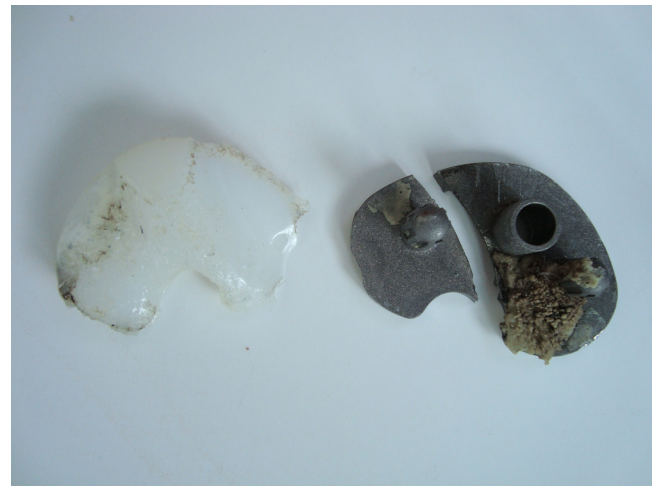
The patient underwent a revision knee arthroplasty, and the previous incision site was used. There was a medial tibial baseplate fracture in the sagittal and coronal planes and a heavily worn polyethylene insert (Fig. 3A and B). There was no loosening in the lateral part of the tibial baseplate and no evidence of infection.

Fig. 3. Intraoperative view of the fractured tibial component (A) and the fractured tibial component showing bone ingrowth in the lateral part of the knee with severe polyethylene wear (B).

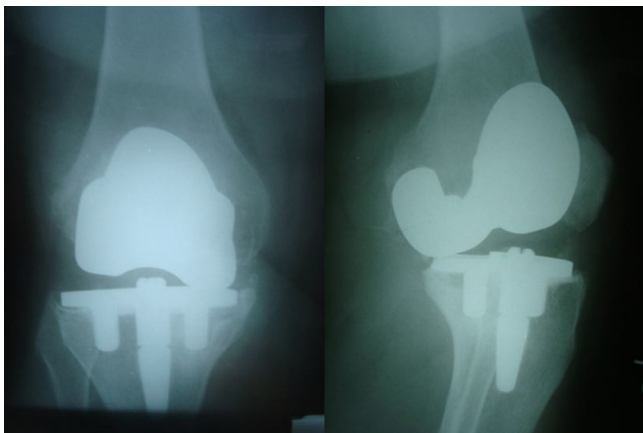
As her pain continued to increase over time, she presented to our central hospital; radiographs taken at that time revealed significant osteolysis in the medial condyle of the tibia (Fig. 2). Physical examination revealed a healthy-appearing obese woman in no acute distress and normal examination of the lower extremities. There was a well-healed anterior incision over the left knee without any evidence of skin infection. Active and passive motion of the knee caused pain in the medial part of knee. C-reactive protein, erythrocyte sedimentation rate, thyroid function tests and all other laboratory values were in the normal range. Loosening of the tibial component without any infection was reported on the bone scintigraphy.

Fig. 2. Preoperative AP and lateral radiographs.

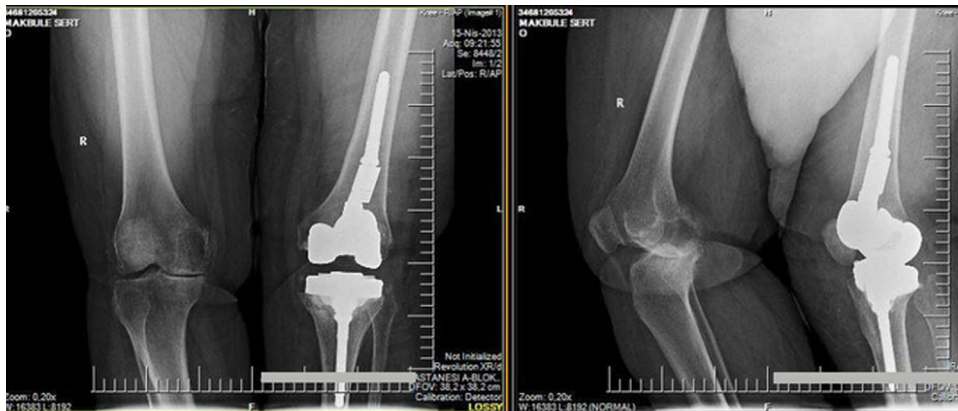
Fig. 4. Postoperative AP and lateral radiographs after the revision knee arthroplasty.

Revision knee arthroplasty was performed after removal of the implants (Fig. 4). There were no post-operative complications, and the patient was ambulating with partial weight-bearing on the second day after the surgery. Significant pain relief and functional improvement was achieved based on early follow-ups.
