The role of vascular echography in the management of complications associated with central venous access for hemodialysis in cancer patients: two case reports and literature review

Abstract

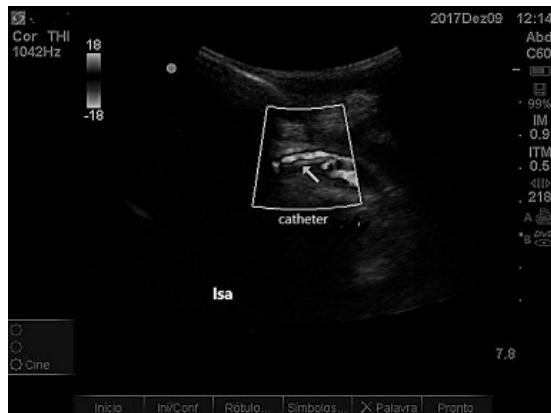
Figure 1. Catheter in the left subclavian artery (Lsa).

The patient was a 66-year-old male with advanced malignant prostate cancer, bone metastases, and kidney failure requiring dialysis. While an inpatient at a cancer hospital, he was transported to the intensive care unit (ICU) for catheter placement and a hemodialysis session. The professional on duty chose a left subclavian vein access, using anatomic landmarks. The blood aspirate at puncture appeared to be venous and the guidewire was advanced without difficulties, but after dilation of the tract and insertion of the catheter, retrograde pulsating flow was observed. Inadvertent positioning in the left subclavian artery (LSA) was confirmed by blood gas analysis and Doppler ultrasound (Figure 1). The examination ruled out the possibility of injuries to the carotid or vertebral vessels, which had normal morphology and blood flow. Physical examination found 4+ brachial and radial pulses. The device was left in place and the patient was transferred to a hospital with vascular and endovascular surgery services. Inherent problems within the Brazilian National Health Service (SUS - Sistema Único de Saúde) delayed the transfer by 18 days. Since there was a risk of fatal complications, the catheter was not removed from the LSA and the patient was not given anticoagulation because of a recent history of melena. After transfer, the catheter was removed, but endovascular repair was not possible because a thrombus was seen in the arterial lumen. There was no bleeding or formation of hematoma, and left upper limb perfusion was maintained, although the brachial pulse was rated 2+ and the distal pulses were absent at that time. The patient was transferred back to the

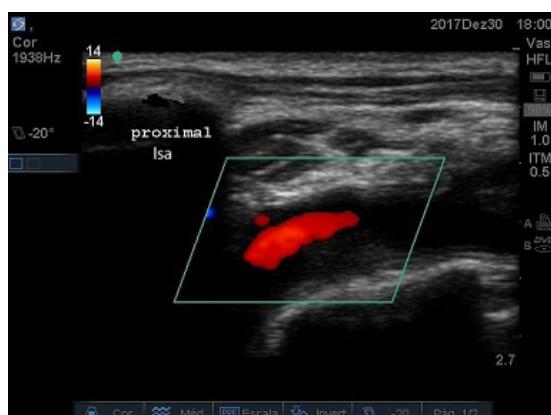
Figure 2. Left subclavian artery (Lsa) after removal of the catheter: subacute luminal thrombus.

cancer hospital. Doppler vascular echography was conducted again, showing a subacute thrombus in the LSA, where flow was monophasic (Figures 2 and 3), constituting subocclusion. The arterial thrombosis was in topography distal of the emergence of the vertebral

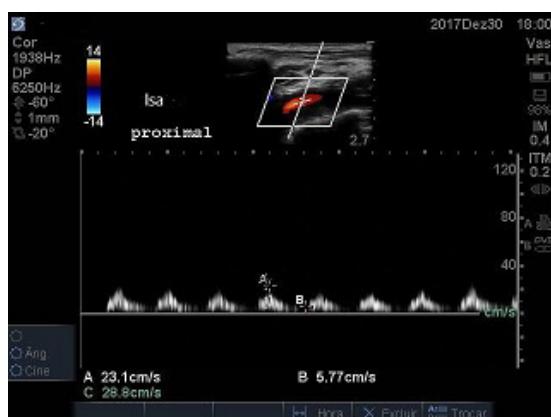
Figure 3. Left subclavian artery (Lsa) after removal of the catheter: monophasic flow.

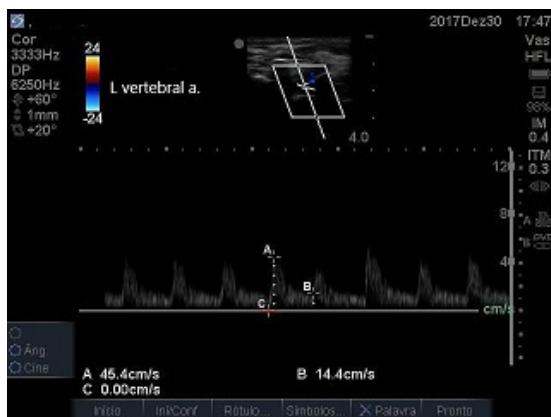
Figure 4. Left vertebral artery: normal flow.

artery, in which flow was laminar, anterograde and with velocities within the limits of normality (Figure 4). At the subclavian-axillary transition, an arterial branch was observed with reversed flow that, based on topography, may have been the dorsal scapular artery (Figure 5). The axillary (Figure 6) and brachial

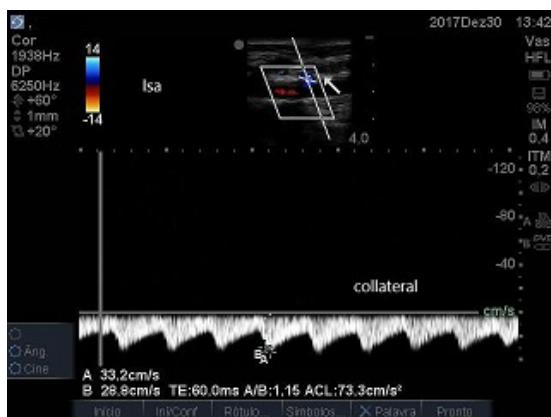
Figure 5. Reverse flow in branch of the left subclavian artery: dorsal subscapular artery.

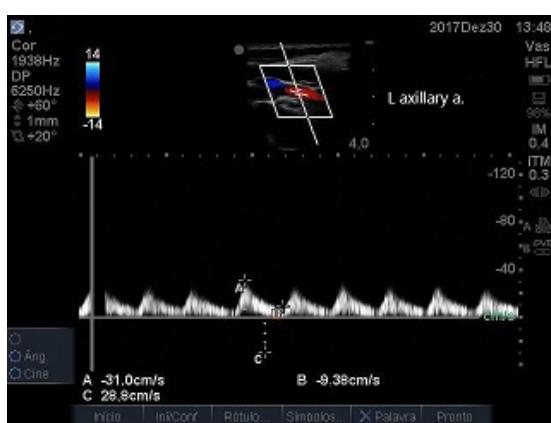
Figure 6. Axillary artery: slow, low-resistance flow.

arteries were patent and exhibited slow, low resistance flow, as did the radial and ulnar arteries. The conduct adopted in this case was watching and waiting since, in addition to the contraindication to anticoagulation already mentioned, the patient's level of morbidity was elevated for an attempt at open revascularization and predictive indicators of the success of a possible bypass were unfavorable: the time elapsed since thrombus formation (22 days), the poor prognosis of the patient's cancer, and the presence of kidney failure. The patient was observed for a further 2 weeks and did not show any sign of cyanosis, pain at rest, or trophic lesions. He was discharged from hospital for palliative home care.

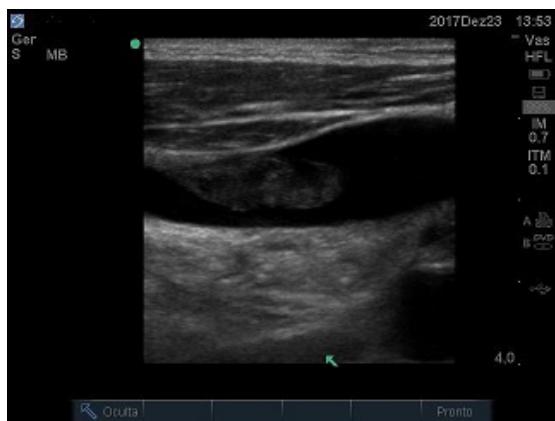
Figure 7. Free-floating thrombus in the right internal jugular vein.

The patient was a 56-year male who had been admitted to a cancer hospital because of malignant bladder cancer, with a history of radical surgical cystectomy and nephrostomies. He suffered kidney failure requiring dialysis and underwent CVC placement via the right internal jugular vein (RIJV) with no intercurrent conditions. While in hospital, treatment for pyelonephritis was initiated. Concurrently, the CVC became detached and vascular access was lost. Since nitrogen compounds were stabilized and there was urine production via the left nephrostomy, he did not need hemodialysis for 9 days, when his renal function deteriorated and he exhibited hyperkalemia. At this point he was transferred to the ICU for another CVC fitting. During the mapping process with vascular ultrasonography conducted to define the best puncture site, a heterogeneous thrombus with a free-floating tail was observed in the RIVJ (Figure 7), where the previous catheter had dwelt for 1 week. The contralateral internal jugular vein was patent and was chosen for the second vascular access, in view of the urgency of dialysis. Since he had no history of recent bleeding, the patient was treated according to the CHEST 2016 recommendations,⁵ with full anticoagulation using unfractionated heparin and warfarin, withdrawing the heparin once his international normalized ratio (INR) reached the therapeutic range. He exhibited shivering after hemodialysis had been started via the catheter. Blood samples were taken for cultures and a wide spectrum antimicrobial regimen was initiated, since it was considered that cutaneous colonization by staphylococcus could have occurred, with a possibility of hematogenous dissemination of the urinary bacteria. One week later, the patient was no longer exhibiting fever or shivering. Another Doppler ultrasound examination was conducted, showing that the thrombosis was still present, but the images suggested that it had receded (Figure 8)

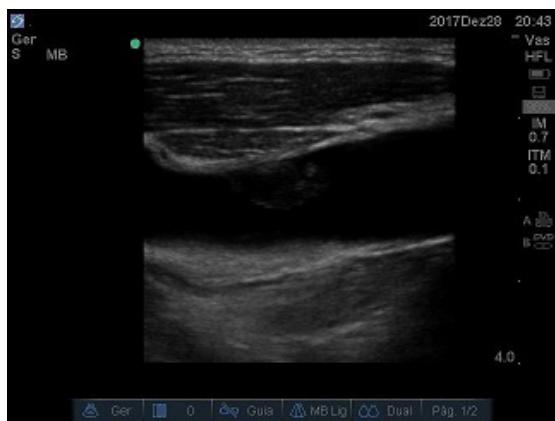
Figure 8. Progress of thrombus in the right internal jugular vein.

and were compatible with the organization phase of a thrombus. The patient remained under investigation for a suspected relapsed tumor in the right kidney and the recommendation was to maintain anticoagulation for 3 months.

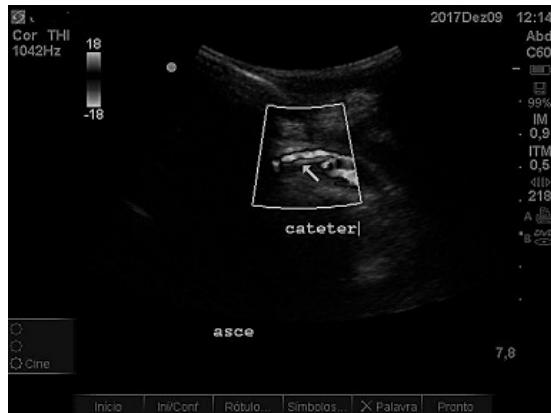
Figura 1. Cateter em artéria subclávia esquerda (asce).

Paciente masculino, 66 anos, tinha neoplasia maligna avançada da próstata, com metástases ósseas e insuficiência renal dialítica. Internado em um hospital oncológico, foi encaminhado à unidade de terapia intensiva (UTI) para implante de cateter e sessão de hemodiálise. O plantonista optou pelo acesso em veia subclávia esquerda, utilizando marcadores anatômicos como guias. O sangue aspirado na punção parecia de natureza venosa e a passagem do fio-guia ocorreu sem dificuldades, mas, após a dilatação do pertuito e o implante do cateter, houve retorno de fluxo pulsátil. O posicionamento inadvertido na artéria subclávia esquerda (ASCE) foi confirmado por gasometria e Doppler (Figura 1). O exame afastou a possibilidade de lesão em carótidas e vertebrais, cuja morfologia e fluxo eram normais. O exame físico demonstrou pulsos braquial e radial 4+. O dispositivo foi mantido *in situ*, e o doente foi encaminhado para um hospital com serviço de cirurgia vascular e endovascular. Dificuldades inerentes ao Sistema Único de Saúde brasileiro levaram à demora de 18 dias na transferência. Havendo risco de complicações fatais, o cateter não foi removido da ASCE e o paciente não foi anticoagulado devido à história recente de melena. Após a transferência, o cateter foi removido, mas o reparo endovascular não foi possível devido à visualização de trombo no lúmen arterial. Não houve sangramento ou formação de hematoma, e o membro superior esquerdo manteve-se perfundido, embora o pulso braquial fosse 2+ e os pulsos distais estivessem ausentes naquele momento. O paciente retornou ao hospital oncológico de origem. A ecografia vascular

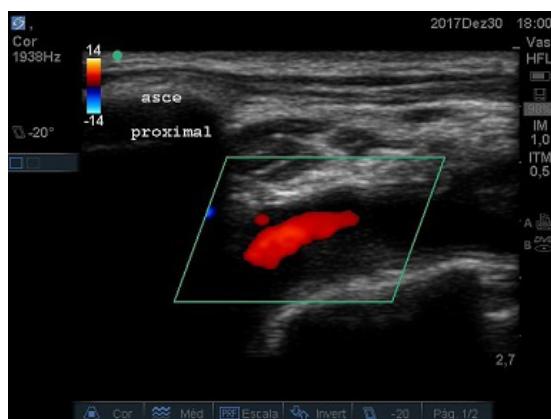
Figura 2. Artéria subclávia esquerda (asce) após a remoção do cateter: trombo luminal subagudo.

com Doppler foi realizada novamente e revelou presença de trombo subagudo em ASCE, onde o fluxo era monofásico (Figuras 2 e 3), configurando padrão de suboclusão. A topografia da trombose arterial foi distal à emergência da artéria vertebral.

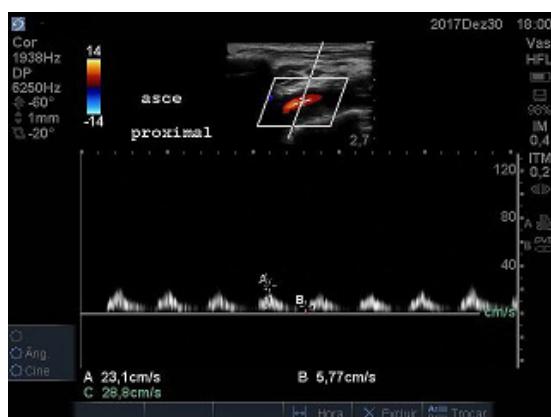
Figura 3. Artéria subclávia esquerda após a remoção do cateter: fluxo monofásico.

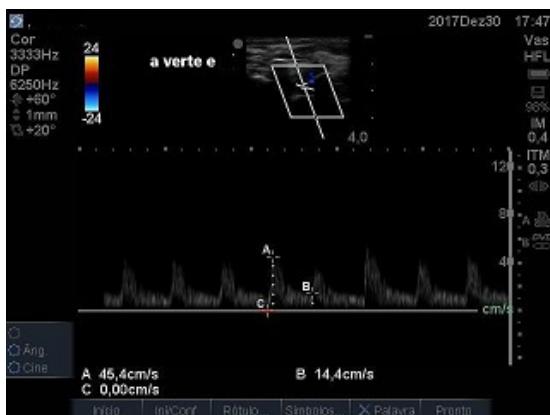
Figura 4. Artéria vertebral esquerda: fluxo normal.

Nesta última, o fluxo era laminar, anterógrado e com velocidades dentro do limite da normalidade (Figura 4). Observou-se, na transição subclávia-axilar, a presença de ramo arterial com fluxo invertido, o qual, pela topografia, poderia corresponder à artéria escapular dorsal (Figura 5). As artérias axilar (Figura 6)

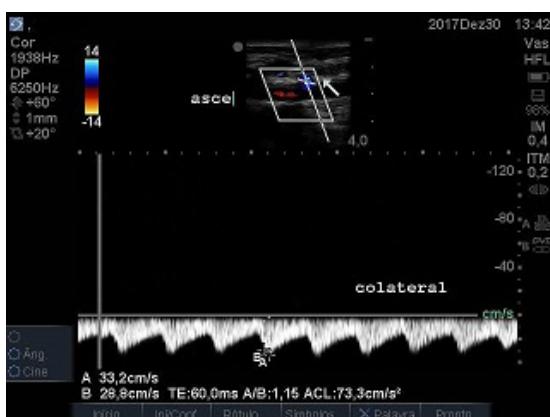
Figura 5. Fluxo invertido em ramo da artéria subclávia esquerda: artéria subescapular dorsal.

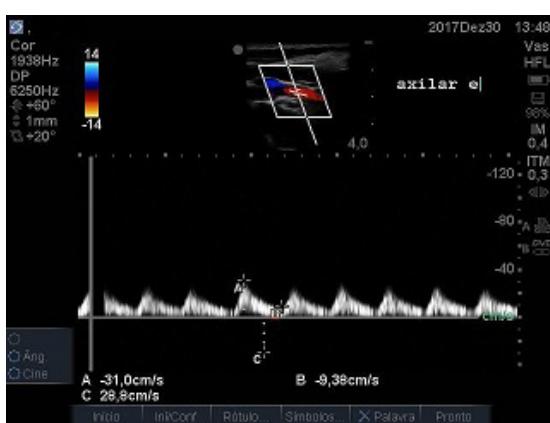
Figura 6. Artéria axilar: fluxo desacelerado de baixa resistência.

e braquiais encontravam-se pétias e tinham fluxo desacelerado de baixa resistência, assim como as artérias radial e ulnar. A conduta para o caso foi expectante, considerando-se, além da mencionada contra-indicação para anticoagulação, a elevada morbidade para a revascularização aberta no doente em questão e os preditores desfavoráveis à patência de um possível *bypass*: tempo de evolução do trombo (22 dias), mau prognóstico da neoplasia e presença de insuficiência renal. O paciente foi observado por mais 2 semanas, não apresentando cianose, dor de repouso ou lesão trófica. Recebeu alta hospitalar para cuidados paliativos domiciliares.

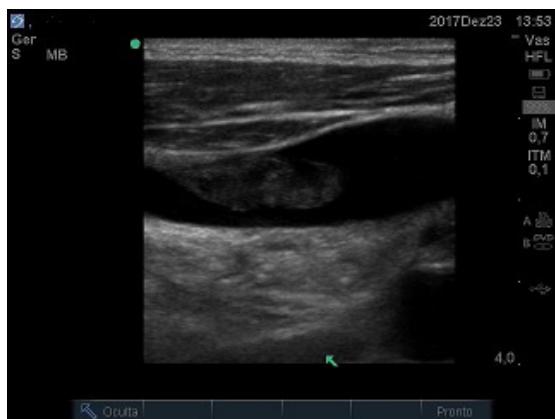
Figura 7. Trombo flutuante em veia jugular interna direita.

Paciente masculino, 56 anos, estava sendo acompanhado em hospital oncológico por neoplasia maligna da bexiga, antecedentes cirúrgicos de cistectomia radical e nefrostomias. Evoluiu com insuficiência renal dialítica e recebeu implante de CVC na veia jugular interna direita (VJID), sem intercorrências. Durante o internamento, iniciou tratamento para pielonefrite. Paralelamente, evoluiu com exteriorização e perda do acesso vascular. Tendo em vista a estabilização das escórias nitrogenadas e produção de urina pela nefrostomia esquerda, permaneceu sem necessidade de hemodiálise por 9 dias, quando apresentou piora da função renal e hipercalemia. Na ocasião, foi encaminhado à UTI para novo implante de CVC. Ao mapeamento com ultrassonografia vascular para definir o melhor sítio de punção, observou-se a presença de trombo heterogêneo com cauda flutuante em VJID (Figura 7), sítio onde o cateter prévio permaneceu por 1 semana. A veia jugular interna contralateral encontrava-se pétia, sendo eleita para o acesso vascular em questão, considerando-se a urgência dialítica. Não havendo história de sangramento recente, o paciente foi tratado conforme as recomendações do CHEST 2016⁵, com anticoagulação plena com heparina não fracionada, concomitante à varfarina, suspendendo-se a heparina após a razão normalizada internacional (RNI) atingir a faixa terapêutica. O paciente apresentou calafrios após iniciar a hemodiálise pelo novo cateter. Coletadas as hemoculturas, iniciou-se esquema antimicrobiano amplo, ponderando-se a colonização cutânea por estafilococos e a possibilidade de disseminação hematogênica do germe urinário. Decorrida uma semana, o paciente não apresentava mais febre ou calafrios. Um novo Doppler foi realizado, evidenciando ainda a presença da trombose, porém a imagem sugeriu retração (Figura 8), compatível com a fase de organização do trombo. O paciente prosseguiu em investigação para suspeita de recidiva tumoral em rim direito, com recomendação de manter a anticoagulação por 3 meses.

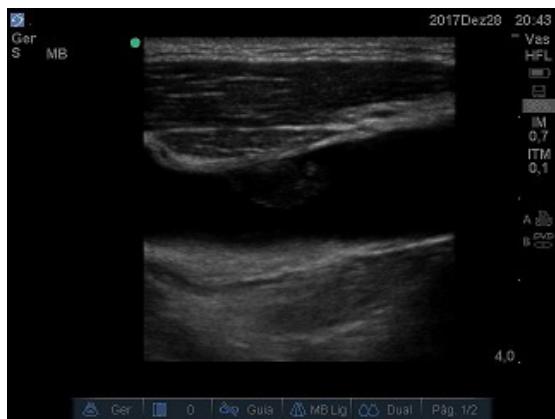
Figura 8. Evolução do trombo em veia jugular interna direita.
