## International Journal of Surgery Case Reports

# Spontaneous dissociation of bipolar hip hemiarthroplasty in a patient with nerve palsy: A case report and review of the literature

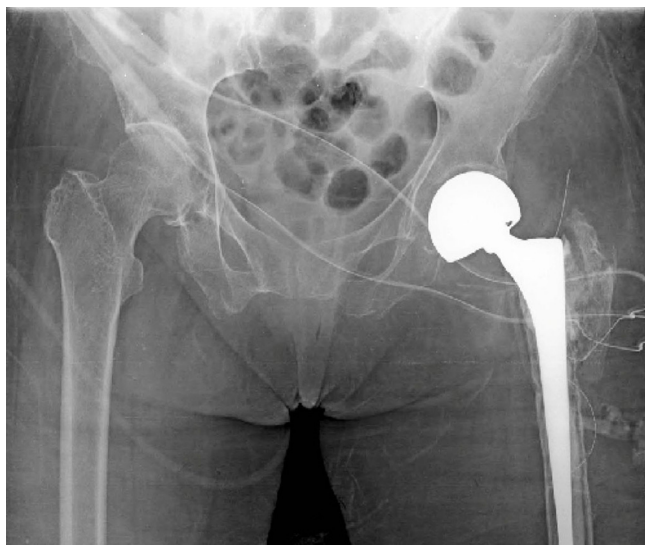
Fig. 5. Immediate postrevision operative plain radiograph.

Open reduction was performed through the old surgical scar using the posterior approach. The femoral head component was found intraoperatively in the acetabulum and was covered with a well healed capsule. The tapered part at the inner head and stem neck didn't show any scratch marks or defects. A new femoral head with a longer offset was assembled to the old femoral stem (Fig. 5).

Postoperatively, the patient received an orthopedic shoe lift to correct the limb length discrepancy and she was encouraged to apply full weight during ambulation. At one-year follow-up, there were no complications. She was able to ambulate with a walker and the Harris hip score was 69.
