Fracture resistance of endodontically treated canines restored with different sizes of fiber post and all-ceramic crowns

PURPOSE. The aim of this study was to determine the fracture resistance and the mode of fracture of endodontically treated teeth restored with different fiber posts and all-ceramic crowns. **MATERIALS AND METHODS.** Two glass fiber reinforced post systems in two different sizes and polyethylene fiber ribbon in two different thicknesses (n=10) were used. The specimens, restored with all-ceramic crowns, were subjected to a compressive load (in N) delivered at a 130-degree angle to the long axis until a fracture could be noted. The results were analyzed statistically with a One-Way ANOVA test ($P<.05$). **RESULTS.** Statistically significant differences were observed between the mean fracture resistance values of Postec, Snowlight, and Kerr Connect thin specimens ($P<.0095$). The Postec results (395.70 N) were found to be significantly higher than the others. No statistical difference was observed among the thick specimens ($P<.2657$). The mean fracture resistance values of the Snowlight thick samples were found to be higher than those of the Snowlight thin samples

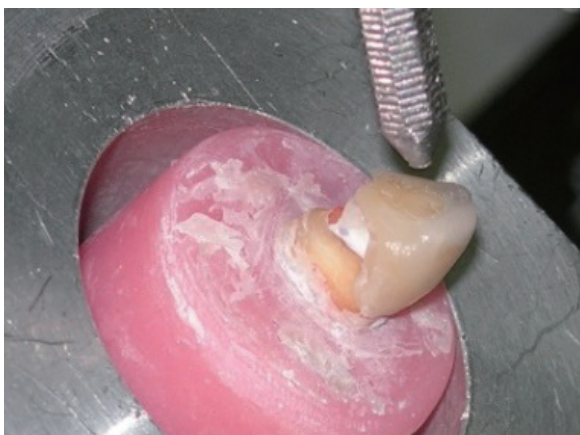
Fig. 2. Fracture of the all-ceramic crown.

The all-ceramic crown fracture failure results indicated that the percentage ratio of the thin and thick specimens of Postec and Kerr Connect materials were the same, 30% and 0% respectively. No all-ceramic crown fractures were seen in the Kerr Connect specimens, whereas 30% of the fractures were seen in the Postec specimens. 10% of the thin and 30% of the thick specimens of the Snowlight all-ceramic specimens were fractured. The fractures always occurred around the cemento-enamel junction at the palatal side (Fig. 2 and Fig. 3, Table 4).

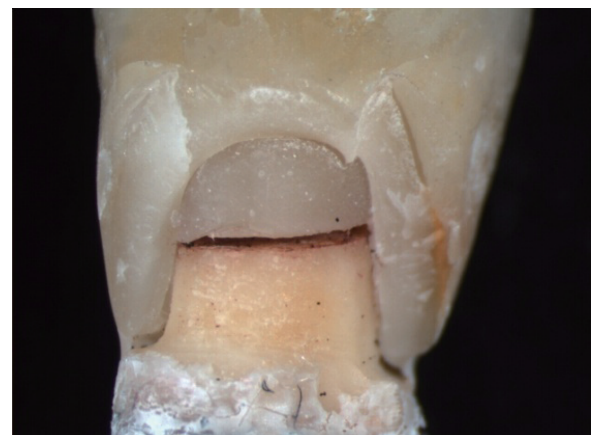
Fig. 3. Failure of all-ceramic crown fracture.

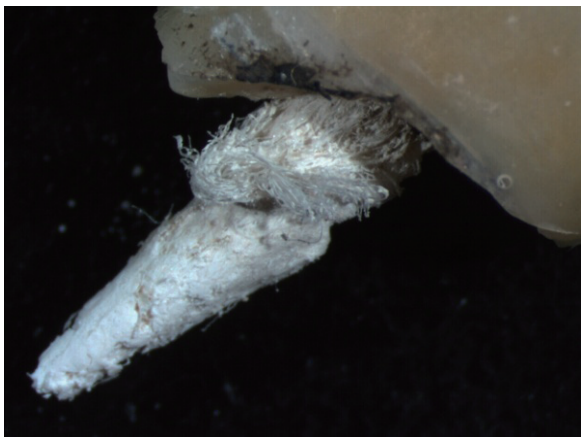
Fig. 4. Failure of post fracture.

No post fractures were observed in the thin Snowlight and Kerr Connect specimens or in the thick Postec and Kerr Connect specimens. The percentage ratios of the thin Postec and thick Snowlight specimens were 10% (Fig. 4, Table 5).

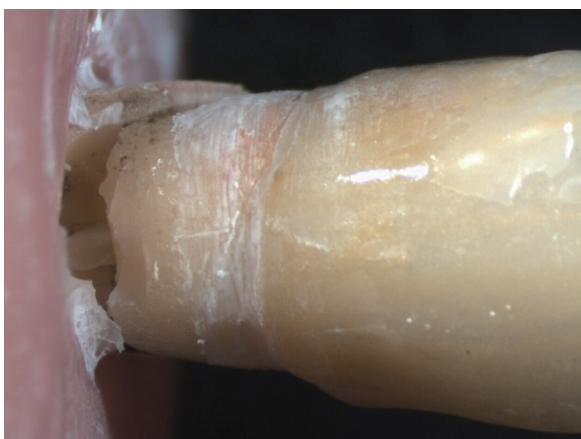
Fig. 5. Failure of root fracture.

Among the common failure types of the specimens, the worst was observed to be the root fracture failure. The percentage ratios of the thin Postec, Snowlight, and Kerr Connect were high, and the ratios were 60%, 70%, and 100%, respectively. The thick specimen percentage ratios were 60%, 60%, and 100%, respectively (Fig. 5, Table 6).

Root fractures occurred at the cervical portion of the root for all the tested materials. Eskitascioglu *et al.*³⁶ evaluated fiber composite laminate (FLC) post core restoration by using a finite elemental stress-analysis method and concluded that using FLC post cores distributed stress to the cervical 1/3 region of the tooth and the supporting bone structure, which agrees with the result of this study.³⁶ In another study, Sirimai *et al.*²⁷ added polyethylene woven fiber ribbon to the post and core restoration and reported that, with this procedure, there was a significant reduction in the incidence of vertical root fractures. In the present study, no vertical root fracture was observed in the groups using polyethylene fiber ribbon as post material. Giovani *et al.*³⁷ and de Oliveria *et al.*³⁸ reported fractures at the cervical region of longer glass-fiber posts (8 and 10 mm) and also fractures of the restorative material or the coronal structure of the prefabricated carbon fiber post. The results of the present study are therefore supported by those of Sirimai,²⁷ Giovani,³⁷ and de Oliveria *et al.*³⁸.

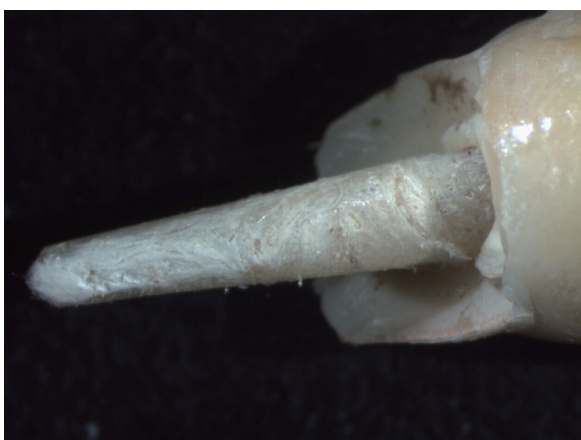
Fig. 6. Failure of post dislodgement.

The highest post dislodgement failure result (80%) was obtained from the thin Kerr Connect specimens. A statistically significant difference was found between the thin specimens of all 3 post systems tested ($P = .001$). No post dislodgement was observed for the thin Snowlight specimens. No statistically significant difference was observed for the thick specimens of each material tested ($P = .069$). The percentage ratios of the thick Postec, Snowlight, and Kerr Connect specimens according to the post dislodgement factor were 0%, 20%, and 60%, respectively (Fig. 6, Table 7).
