## C A S E R E P O R T

# Two-stage management of a spontaneous fracture of the greater trochanter through osteolytic lesions induced by polyethylene wear of a total hip arthroplasty. A case report

*Dario Regis, Andrea Sandri, Elena Samaila, Bruno Magnan*

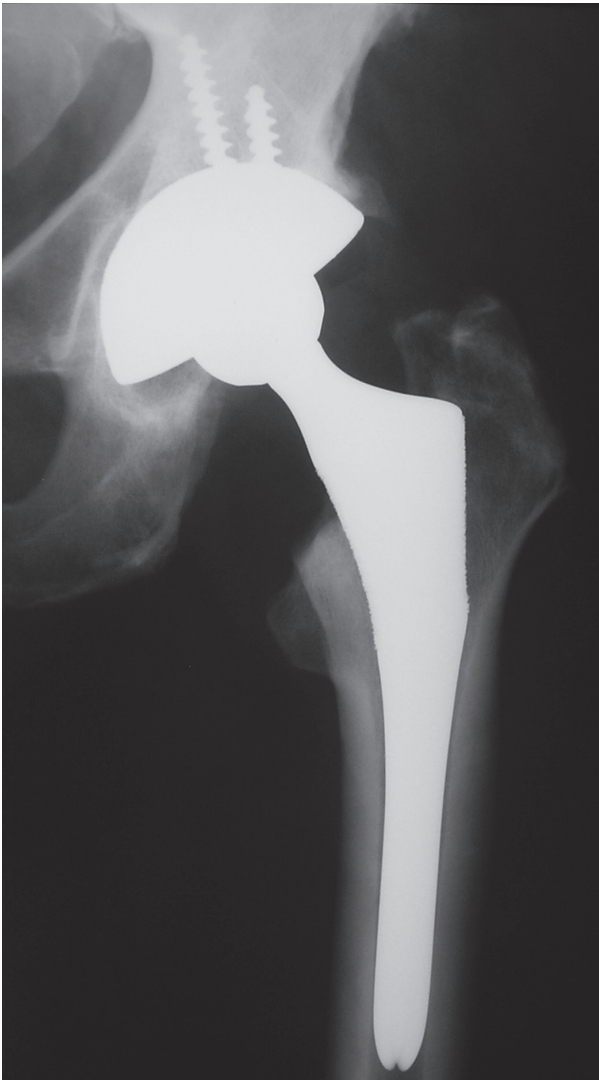
**Figure 1.** Immediate postoperative x-ray shows the correct positioning of a left cementless total hip arthroplasty

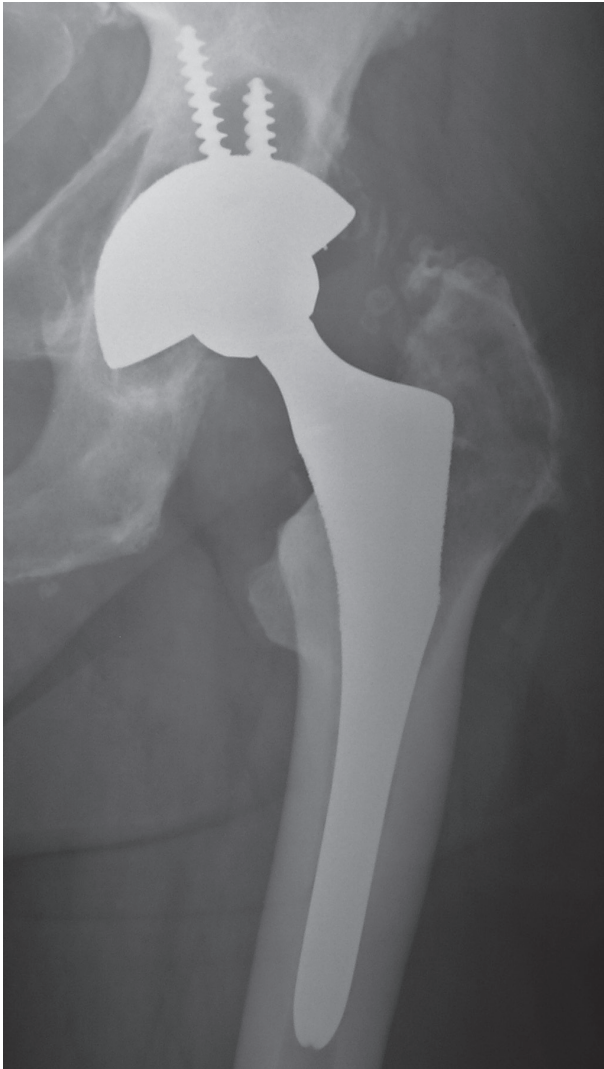
**Figure 3.** Six-week x-ray check demonstrates significant signs of fracture healing

fracture healing were present (Figure 3). Subsequent computed tomography scan confirmed that fracture of the GT had healed, revealing extended areas of acetabular bone deficiency (Figure 4).

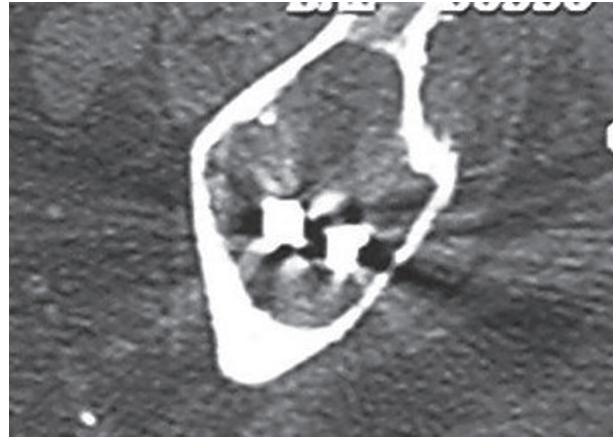
**Figure 4.** Computed Tomography taken two months after the fracture. Reveals extended areas of acetabular osteolysis

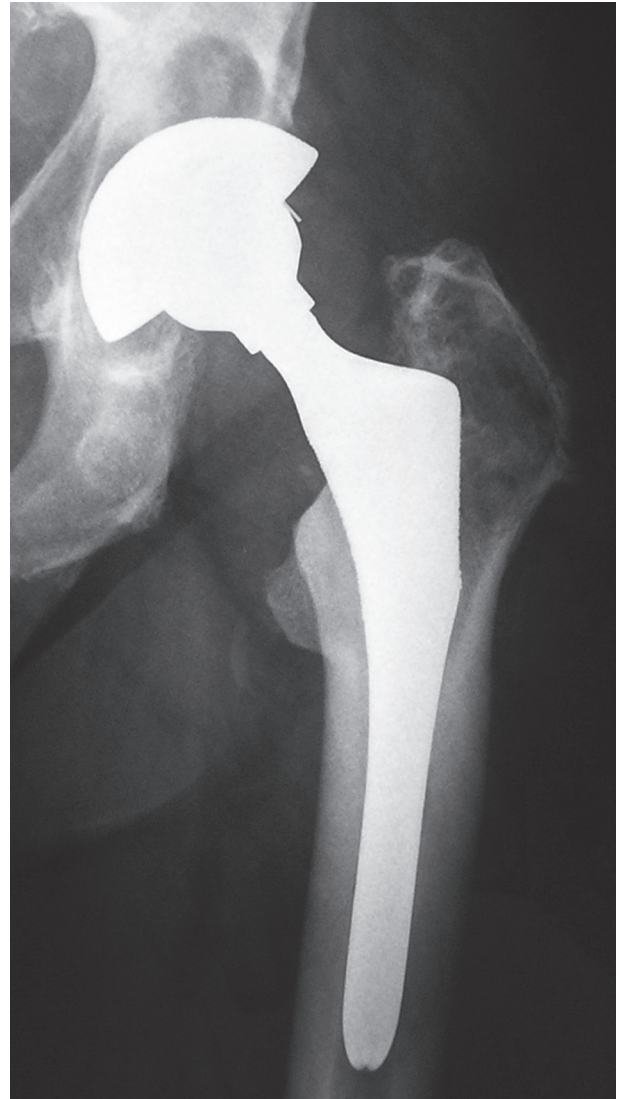
**Figure 6.** Postoperative radiograph. Iliac screws were removed and acetabular bone defect was partially filled with morselized allograft; both prosthetic bearing surfaces were replaced

from the tip of the GT and the histological study showed the presence of a vigorous remodelling bone tissue consistent with a normal fracture healing process (Figures 5a and 5b). Revision included removal of both screws, which were completely loose, and filling pelvic defects with morselized bone allograft through the screw holes of the metal-back cup. Finally, brand new coupling surfaces (PE liner and CrCo prosthetic head) were implanted (Figure 6).

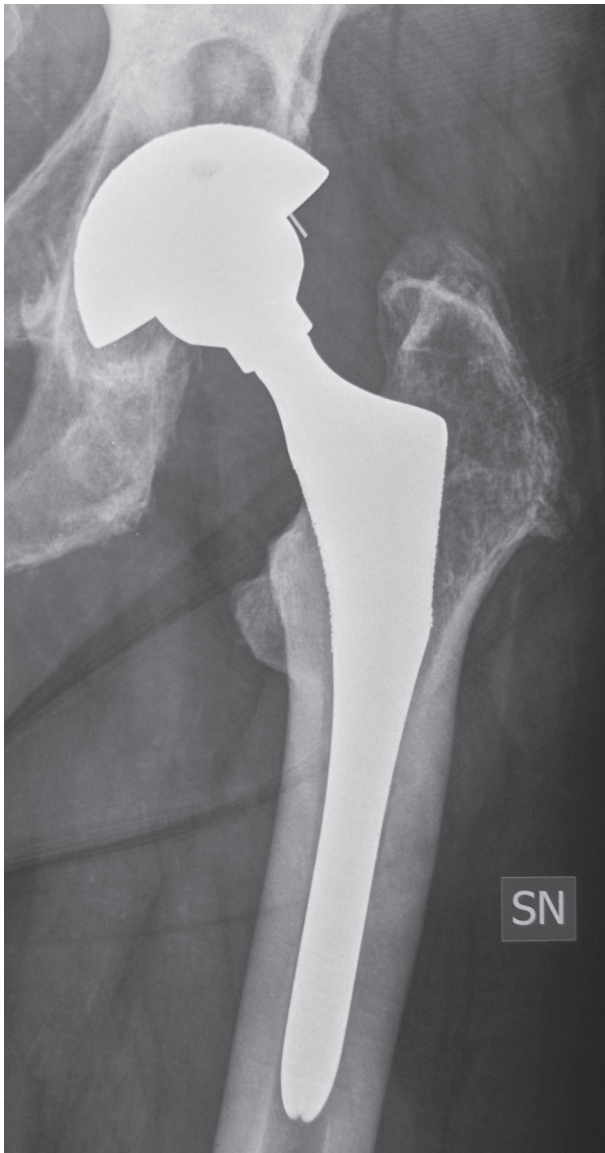
**Figure 7.** Conventional x-ray performed five years following revision surgery shows complete healing of the trochanteric fracture with periprosthetic bone stock restoration

At the most recent follow up examination, five years after revision surgery, the patient has resumed all his activities of daily living with no hip pain and successful radiological outcome (Figure 7).
