Removal of a Past Varnish Treatment from a 19th-Century Belgian Wall Painting by Means of a Solvent-Loaded Double Network Hydrogel

The wall painting is located in the Sint-Jan Berchmanscollege, Antwerp, Belgium. The school was named after the saint Jan Berchmans (Diest, Belgium, 1599–Rome, Italy 1632), a scholastic of the Society of Jesus [27,28].

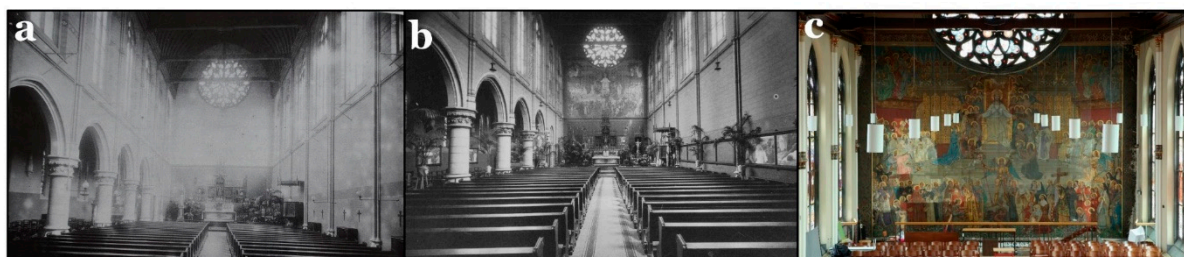
Figure 1. (a) A black and white photograph of the chapel in 1897 in the Sint-Jan Berchmanscollege, when the wall painting was not yet executed. (b) The chapel in the 1930s, after Ernst Wante created the wall painting. The chapel was not yet divided into two floors at that time [33]. (c) A photograph of the wall painting in 2017 showing its state before conservation. The wall painting is now found on the top floor of the chapel.

Originally, the wall painting occupied the top part of the eastern chapel wall, as can be seen in Figure 1a,b. Later, the chapel was divided into two levels. The lower level is now a gymnastics hall, while the upper one, where the wall painting is located, is used for celebrations, lectures, and music lessons (Figure 1c). Consistent with the surrounding architecture, Wante executed the wall painting in a neo-Gothic style.

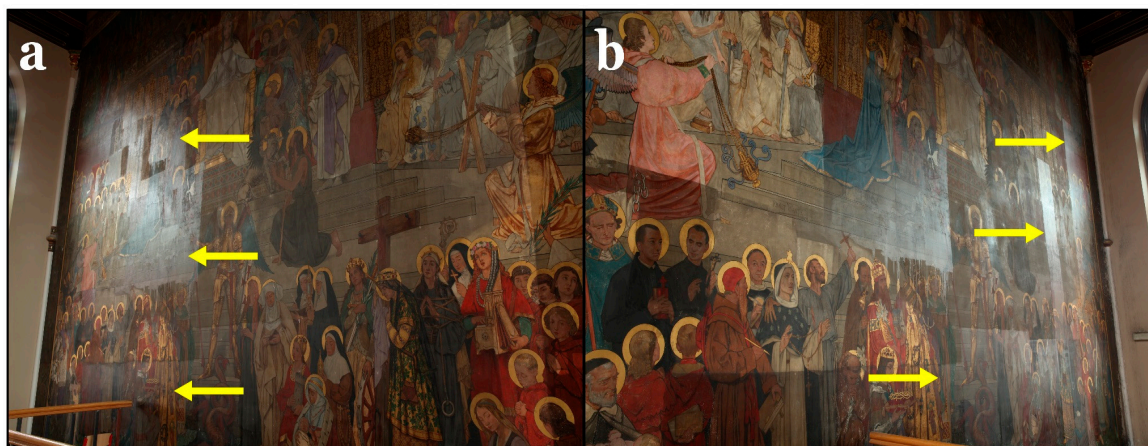
In a previous undocumented conservation campaign, the wall painting was partially coated with a varnish layer, while some areas were left uncoated. Examination of the collected samples under the microscope revealed that the thickness of this layer was in the range of 20–45 μm (Figure 2c). The varnish was probably applied to protect the paint layers and facilitate routine cleaning. Nonetheless, the varnish has degraded, leading to significant changes in its appearance. The most noticeable change is the severe darkening, obscuring the clarity of the painting's figures and colors. Additionally, the varnish altered the original matt appearance of the wall painting, giving it a glossy surface (Figure 4a,b). Along with the deteriorated varnish layer, the wall painting also showed a number of other manifestations of degradation, such as paint losses, detached paint layers, hollow areas in the plaster layers, surface soiling, and lacunae.

Figure 4. Photographs showing the glossy varnish that was not applied to the entire wall painting, as indicated by the yellow arrows. (a) Left side and (b) right side of the wall painting.

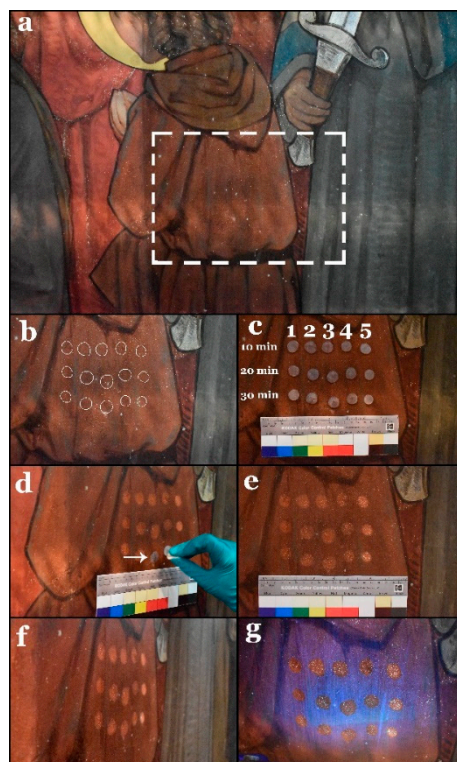
Figure 5. (a) General view of the selected area for the first stage tests. (b) Selected spots before the treatment indicated by white circles. (c) The five hydrogel composites applied to the surface during three different contact times: 10, 20, and 30 min. The numbers 1 to 5 represent the hydrogels loaded with 10% EA, 10% PC, 5%/5% EA/PC, 10% MEK, and 5%/5% MEK/1-PeOH, respectively. (d) Treatment of the surface with a dry cotton ball after peeling off the hydrogel pellets. The arrow refers to the swelling of the varnish resulting in a whitish haze. (e) View of the selected area after gel cleaning treatments. (f) View of the same area under raking light. (g) The same view under UV light showing the disappearance of the varnish fluorescence and the severe damage that occurred at the treated spots with the 5%/5% MEK/1-PeOH hydrogel composite (right-most column of test spots).

To achieve this, the five hydrogel composites were applied in small hydrogel pellets (with a diameter of *c.* 1.5 cm and a *c.* 0.3 cm thickness) on the wall painting for 10, 20, and 30 min (see Figure 5a–c). After the hydrogel composites were peeled off, the varnish layer was noticeably whitish because of the swelling effect; the pretreated varnish could be rapidly and gently rubbed away by means of a dry cotton ball (see Figure 5d). Visually, the hydrogel composite, loaded with 5/5% MEK/1-PeOH, induced severe damage to the paint layer (see Figure 5e,f). The results of 10% EA, 10% PC, and 5/5% EA/PC hydrogel composites were more or less similar. On the other hand, the 10% MEK hydrogel composite yielded unsatisfactory results: varnish removal was difficult, possibly leaving varnish residues. Regarding the contact times, there were no significant differences among them; thus, during the following test activities, only the shortest exposure time was employed.

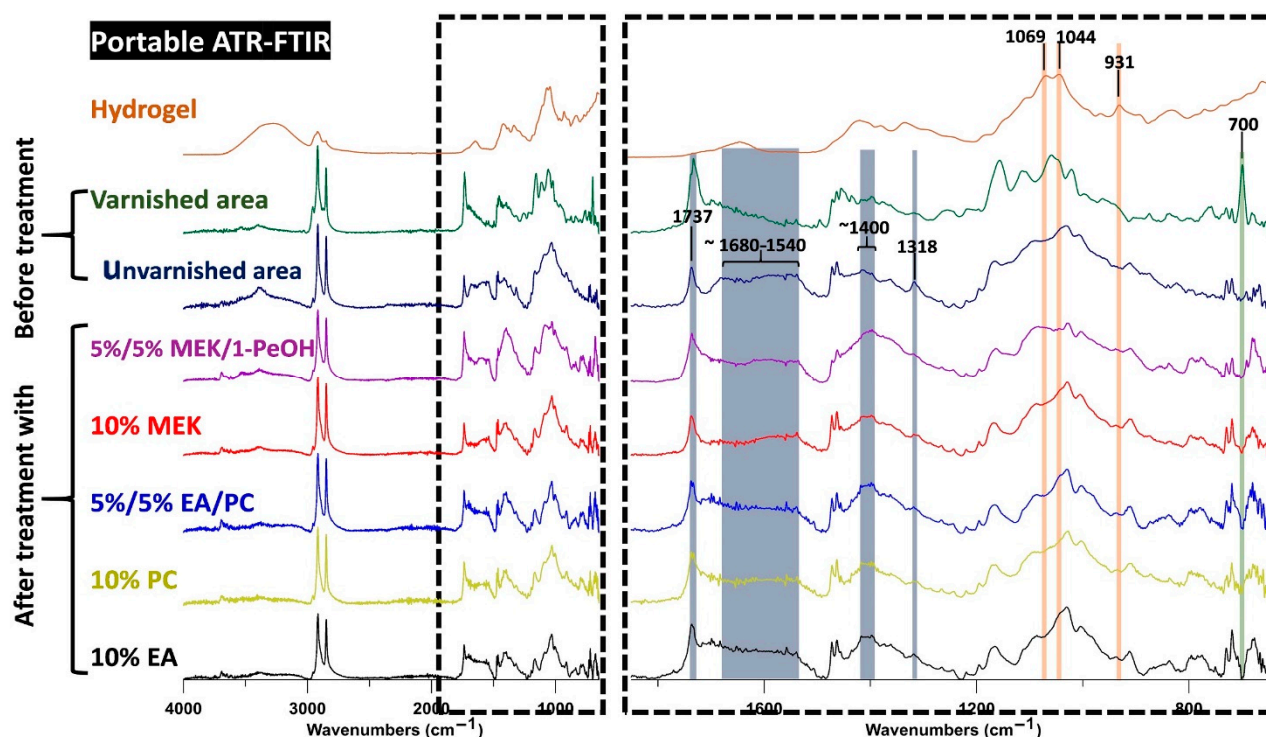
The original painting had bands in the range of 1540 to 1680 cm^{-1} , which were probably linked to the presence of carboxylates (see Figure 6). The intensity of these bands was comparable to the intensity of the band at 1737 cm^{-1} linked to the use of drying oil as a binding medium. In the spectra of the spot cleaned with MEK, this proportion was different (the band at 1737 cm^{-1} is higher), probably because of the presence of varnish remains, which have a band at 1726 cm^{-1} contributing to the enhanced intensity of the band at 1737 cm^{-1} . Additionally, the painting layer showed a band at 1318 cm^{-1} , which most likely corresponds to oxalates resulting from the degradation of the organic compounds and thus was a band that originated from the painting layer. This band was much less intense in the spectra of the region cleaned with MEK, which can be explained by the presence of varnish remains on the surface that partially covered the painting layer. This result is in agreement with the visual examinations.

Figure 6. ATR-FTIR spectra of hydrogel, unvarnished and varnished paint layers, and spots treated with the five tested hydrogels in the first-stage tests.

In the spot treated with 5%/5% MEK/1-PeOH hydrogel composite, some changes were observed around 1400 cm^{-1} . In this spectral range, the unvarnished and the varnished painting had several bands that were probably linked to CH_3 and CH_2 bending. However, in the spectra of the region cleaned with 5%/5% MEK/1-PeOH hydrogel composite, this region showed an intense band corresponding to lead carbonate (1416 cm^{-1}), which was also found in the priming coat. This suggests a partial removal of the painting layer, thereby exposing the preparation so that the associated compounds showed more intense bands. Furthermore, the bands related to carboxylates (bands between 1680 and 1540 cm^{-1}) were lower in intensity, which is consistent with the partial removal of the paint layer.

Finally, the spectra of the spots cleaned with 10% EA, 10% PC, and 5%/5% EA/PC hydrogel composites showed no clear differences compared with those of the unvarnished areas. To confirm these conclusions and select the most suitable hydrogel composites, more tests were performed.

The collected spectra of the treated spots also provided information about the potential presence of hydrogel residues. It is relevant to note that the characteristic intense bands of the hydrogel (at 1069 , 1044 , and 931 cm^{-1}) were absent in all of the spectra of the treated spots; this indicates that the hydrogel left no (ATR-FTIR-detectable) residues on the surface.

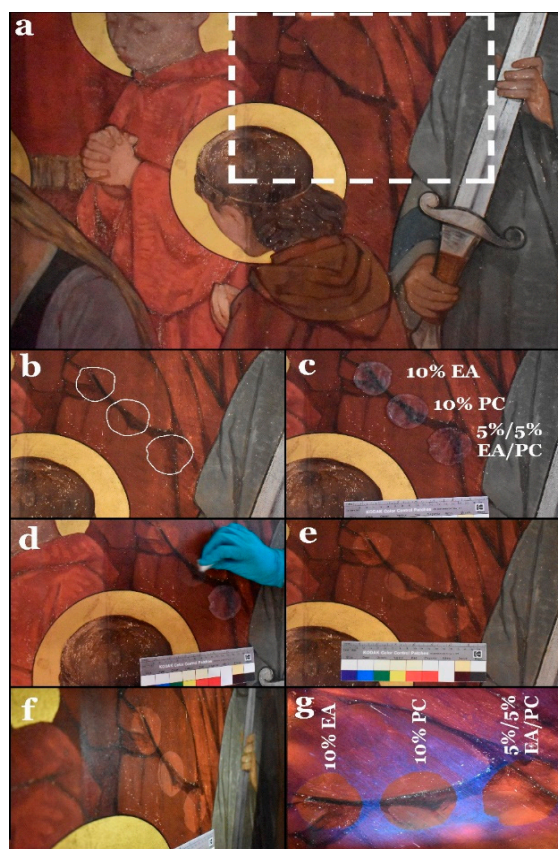
Figure 7. (a) General view of the selected area for the second-stage tests. (b) Selected areas before gel treatments. (c) The selected three hydrogel composites during application. (d) Removal of the swelled varnish after peeling off the hydrogel using a dry cotton ball. (e) View of the surface after the treatment. (f) The same view under raking light. (g) The same view under UV light.

Given the good performance demonstrated by the hydrogels loaded with 10% EA, 10% PC, and 5%/5% EA/PC, these gels were applied to larger areas (with a diameter of *c.* 5 cm and *c.* 0.3 cm thickness) of the same color/paint layer in order to verify the results obtained in the first test (see Figure 7a–d). The gel application time was 10 min.

The effects of the three hydrogel composites were verified by examination of the treated areas under visible and UV light. As in the first stage, there were no differences between the results of the three hydrogel composites (Figure 7e–g); therefore, it was decided to test them on an area of the wall painting featuring a more sensitive paint layer in order to obtain measurable differences in the response.

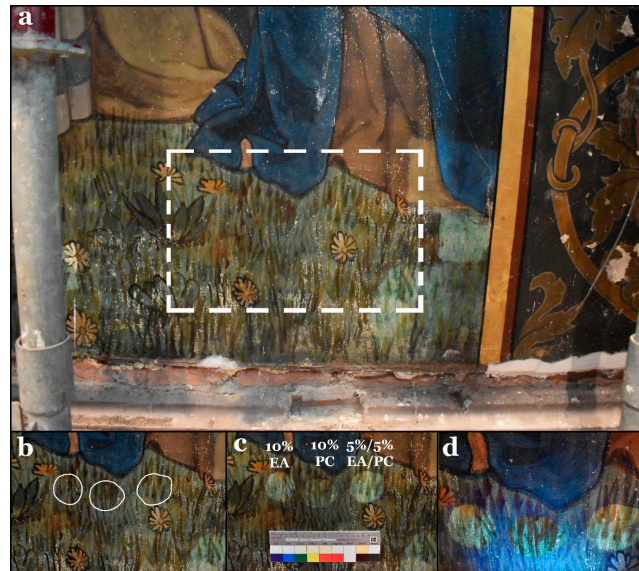
The green/brown areas of the wall painting (representing grass) are composed of superimposed paint layers (see Figure 8a). As can be seen in Supplementary Figure S3b (results of previous varnish removal tests using traditional methods), these areas proved to be very sensitive to any mechanical action. In this regard, the 10% EA, 10% PC, and 5%/5% EA/PC hydrogel composites were tested following the same cleaning criteria adopted in the second-stage test. According to the visual examinations, the 10% PC hydrogel composite showed better results than the other two. Both 10% EA and 5%/5% EA/PC hydrogel composites gave rise to a slight overcleaning of the paint layer, which can be explained as a partial removal of the paint layer and the appearance of the white priming coat underneath (Figure 8b–d).

Figure 8. (a) General view of the selected area for the third-stage tests. (b) Selected areas before treatment. (c) The surface after treatment with the three hydrogel composites. Spots treated with the 10% EA and 5%/5% EA/PC hydrogel composites were overcleaned. (d) The same view under UV light showing the same observation regarding the overcleaning effect.

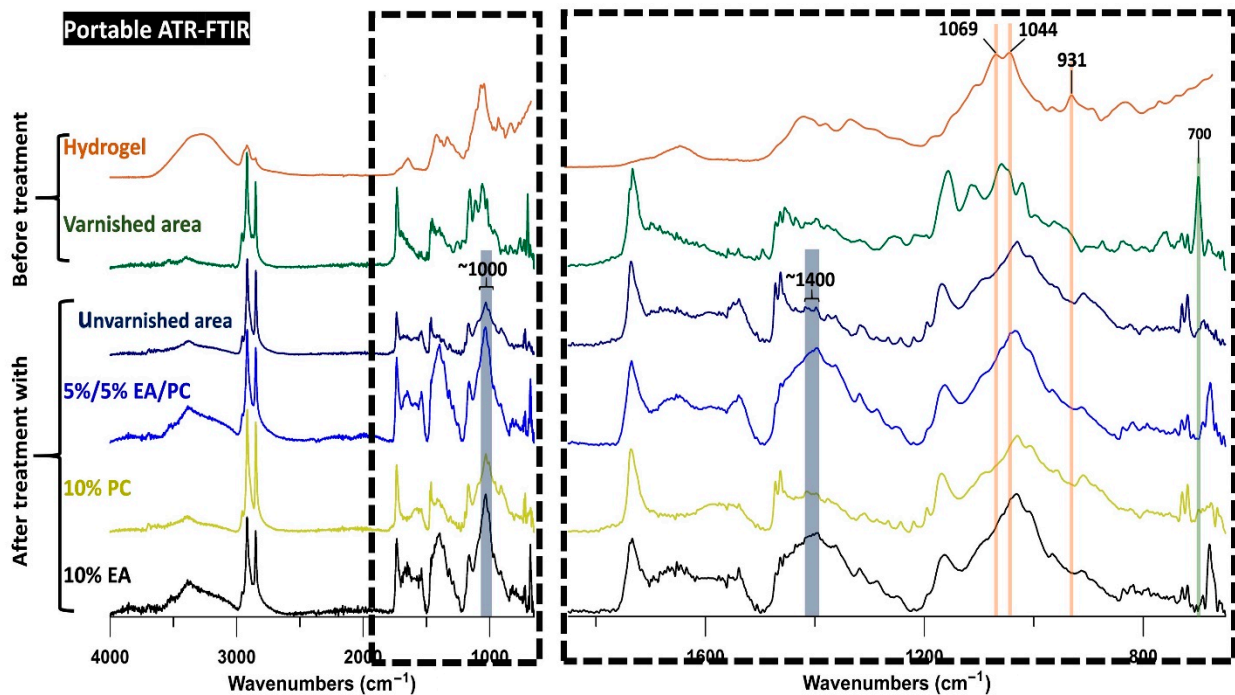
The ATR–FTIR measurements agree with the conclusions obtained from visual examination (see Figure 9). Indeed, spots cleaned with 10% EA and 5%/5% EA/PC showed a more intense band at $\sim 1400\text{ cm}^{-1}$ related to the lead white present in the priming coat. This suggests that the paint layer was partially removed during cleaning. Additionally, the spot treated with the 10% PC hydrogel composite exhibited more intense bands around 2900 cm^{-1} that were more intense than the ones assigned to the pigments (around 1000 cm^{-1}); this was likely related to a higher proportion of the binding medium (long CH_2 chains). In the spots cleaned with 10% EA and 5%/5% EA/PC hydrogel composites, the same bands were less intense, indicating that the cleaning process partially removed the binding medium. In general, the spectra of the unvarnished area were very similar to the spectra of the areas cleaned with the 10% PC hydrogel composite, consistent with a small alteration of the painting layer after cleaning.

Figure 9. ATR-FTIR spectra of hydrogel, unvarnished and varnished areas, and the spots treated with three hydrogel composites (5%/5% EA/PC, 10% PC, and 10% EA) in the third-stage tests.

From all the results mentioned above, it can be concluded that the hydrogel loaded with 10% PC provided the best cleaning results overall, especially when treating areas with sensitive paint layers.

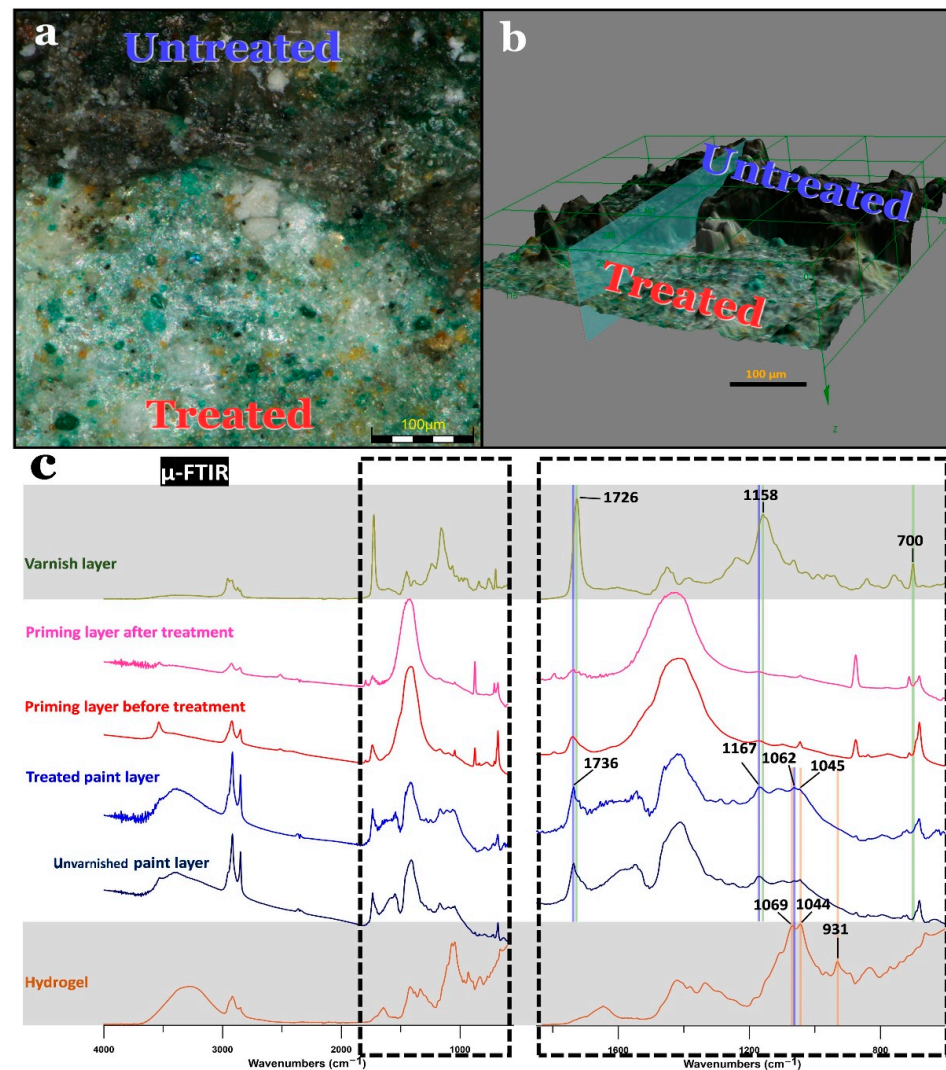
To study the removal of the varnish, a paint sample at the boundary between a gel-treated and an untreated green area was collected and subjected to a number of measurements (Figure 10). Examination of the sample under the three-dimensional microscope showed the darkened varnish layer obscuring the green paint layer in the untreated area. On the other hand, the treated area of the sample showed that the varnish was completely removed and revealed the original appearance of the paint layer, with no hydrogel residues visible (Figure 10a,b).

Figure 10. (a) Photomicrograph showing the boundary between a treated and an untreated area of a green area of the wall painting. The untreated area shows the darkened varnish layer, while the treated area illustrates the total removal of the varnish layer, revealing the original color of the surface. (b) 3D photomicrograph of the same view revealing the presence of a thick, darkened varnish layer. (c) μ -FTIR spectra of the varnish, priming coat before and after the treatment, treated and nontreated paint layers, and hydrogel.

In order to assess the effects of the gel treatment on the binding medium, fragments from treated and untreated paint areas were collected and analyzed by μ -FTIR spectroscopy. It was noticeable that the spectra of the unvarnished and treated paint layers were very similar (Figure 10c). This indicates that the solvent used for varnish removal caused no changes detected by FTIR. With respect to varnish removal efficiency, the most intense bands of the varnish at 1726 and 1158 cm^{-1} were in a similar position to the bands at 1736 and 1167 cm^{-1} of the drying oil (Figure 10c). An increase in these bands after the cleaning could be attributed to the infiltration of the varnish. There was an additional less intense peak of the styrene component of the varnish at 700 cm^{-1} that did not overlap with any bands from the paint, allowing it to be used as corroboration. As can be seen, after the cleaning there was no increase in the bands related to the varnish. This means that the varnish was successfully removed from the paint layer; if any varnish remained, it was in an amount low enough not to be detected by μ -FTIR. Furthermore, fragments from the priming coat were measured to investigate the infiltration of the varnish into the substrate after gel cleaning. Similar to the paint layer, there was no increase in the bands related to the varnish itself; this confirms that the varnish did not diffuse into the bulk of the paint strata during or after the treatment.

Regarding hydrogel residues investigations, the band at 931 cm^{-1} was only present in the hydrogel and can be used to corroborate the results. Both the paint layer and hydrogel contain a double band around 1050 cm^{-1} (Figure 10c). Specifically, the gel showed two peaks at 1044 and 1069 cm^{-1} , while in the paint layer they appeared at 1045 and 1062 cm^{-1} . These peaks were more intense in the hydrogel, so an increase in these bands after the cleaning would be linked to the remains of hydrogel on the surface. However, the band at 931 cm^{-1} was not present in the painting after the cleaning. In addition, no increase could be seen in the bands at 1069 and 1044 cm^{-1} after the cleaning. The slight shift of the band at 1062 cm^{-1} from the painting compared with the band at 1069 cm^{-1} from the hydrogel could still be seen in the spectra after the treatment, proving that the band at 1069 cm^{-1} had no significant increase (Supplementary Figure S6). Thus, it can be concluded that there were no μ -FTIR-detectable remains of the hydrogel. Finally, the best cleaning

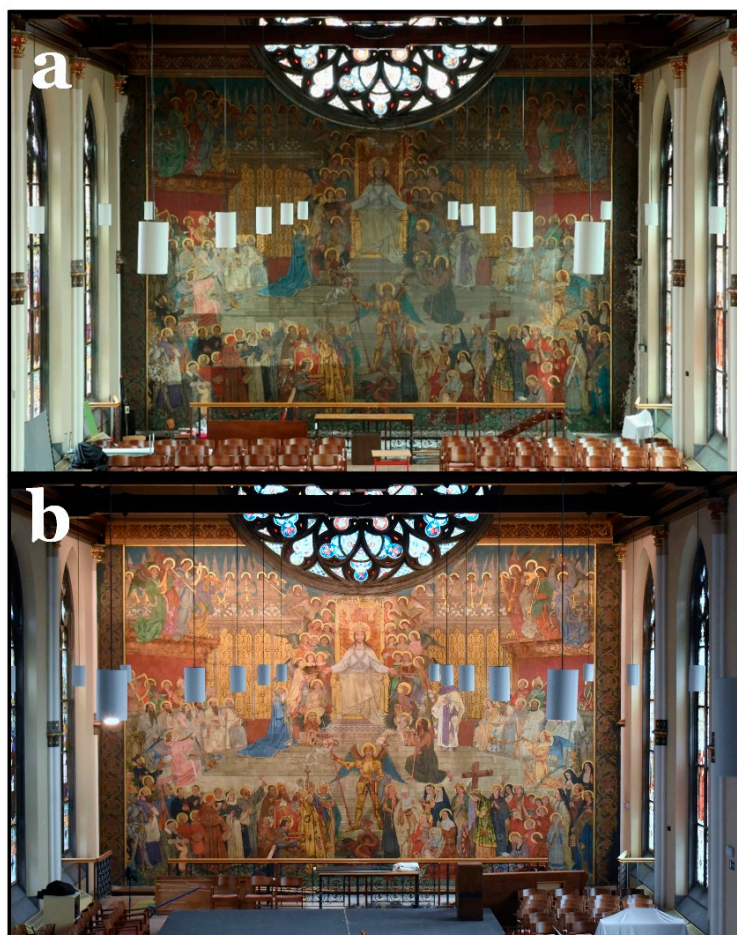
Figure 11. (a) The wall painting during the initial steps of conservation. (b) Final results of the wall painting after conservation and removal of the dark varnish layer.

The final results of the conservation of the wall painting are presented in Figure 11. It can be seen that the dark veil caused by the deteriorated varnish could be completely removed, revealing the original colors of the wall painting. The gilded parts now show a shiny appearance again that was previously masked by the varnish. On the other hand, in the non-gilded areas, the original overall matt appearance of the wall painting could be restored.
