# Endoscopic repair of surgically transected bile duct using overlapping covered metal stents

Thomas Tielleman, MD, Markus Goldschmidt, MD

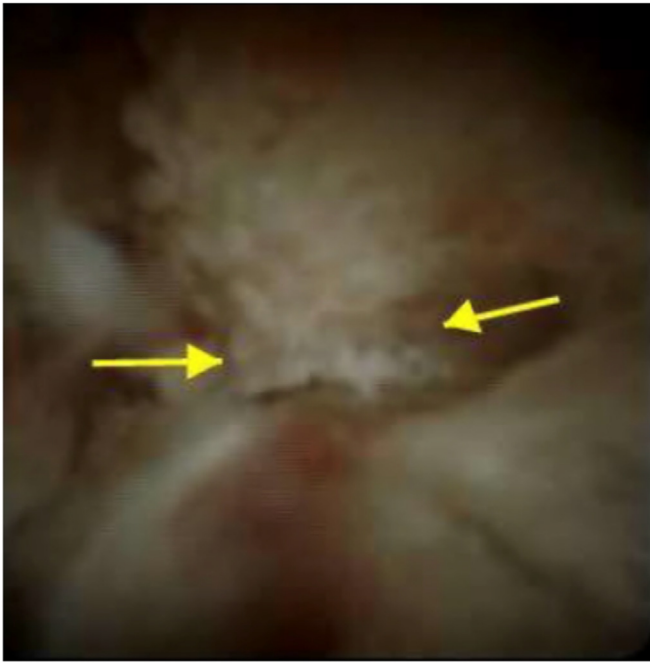
**Figure 2.** Cholangioscopy revealed narrowing at the level of contrast extravasation (*arrows*), raising concern for bile duct transection.

Cholangioscopy of the distal common bile duct as well as percutaneous transhepatic cholangiography confirmed a complete bile duct transection (Figs. 2 and 3). A biliary drain was placed during percutaneous transhepatic cholangiography. Following discussion with representatives from the hepatobiliary surgery department, the decision was made to attempt endoscopic reconnection of the transected bile duct (Video 1, available online at [www.videogie.org](http://www.videogie.org)).

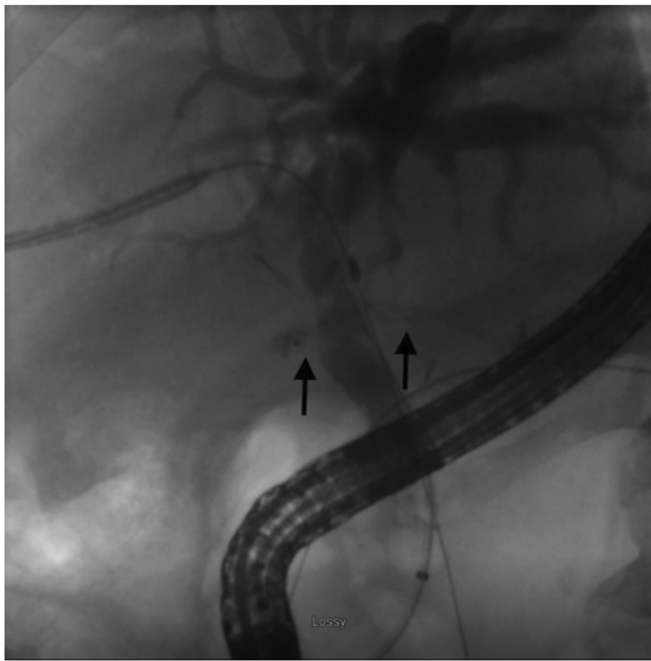
**Figure 6.** Bile duct transection significantly improved after removal of overlapping stents, but a small bile leak remained, requiring repeat stenting with a single fully covered self-expandable metal stent.

Four months later, the stents were removed with raptor forceps under fluoroscopic guidance, with the suprapapillary stent being removed first. The common bile duct was noted to have reconstituted (Fig. 6). There was a small

persistent leak, so a new Boston Scientific 10-mm × 8-cm FCSEMS was placed. Given the resolution of the bile leak after repeat stenting, the biliary drain was removed.
