# Importance of Preoperative Imaging in Acetabular Revision Surgery - A Case Report

H.C. Schmitz<sup>\*1</sup>, C.C. Egidy<sup>1</sup>, H. Al-Khateeb FRCS<sup>2,3</sup>, G. Cárdenas<sup>4</sup>, T. Gehrke<sup>1</sup> and D. Kendoff<sup>1</sup>

<sup>1</sup>ENDO-Klinik Hamburg, Helios Group, Holstenstraße 9, 22767 Hamburg, Germany

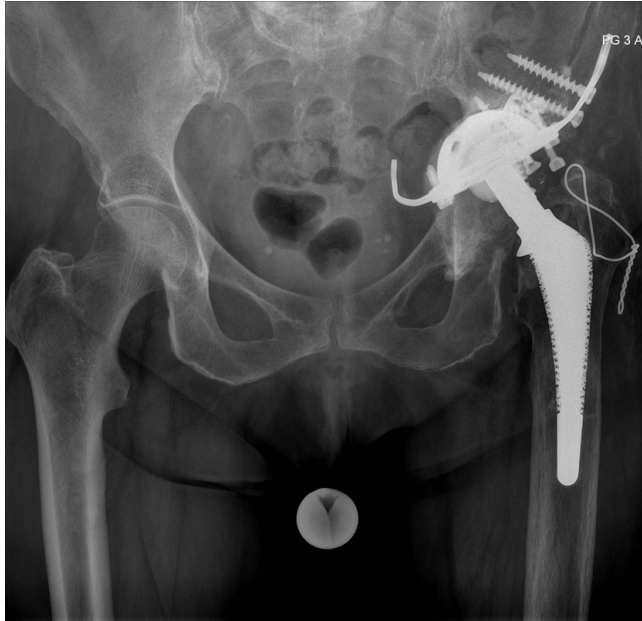
**Fig. (1).** Pelvis AP identifying the migration of the reinforcement hook into the pelvis.

Plain radiographs demonstrated the protrusion of the reinforcement ring into the pelvis and complete migration of the anchoring hook into the pelvis with close proximity to the anatomic structures and other major soft tissue structures. There was no evidence of stem loosening or migration noted (Figs. 1, 2). Based on these findings and particularly the position of the anchoring hook and close proximity to intrapelvic structures, a CT scan was performed (Fig. 3).

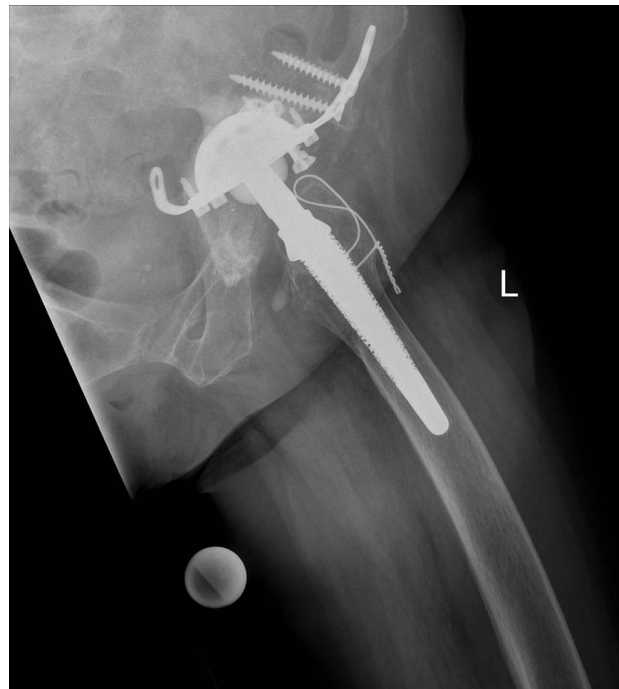
**Fig. (2).** Lateral view preoperative.

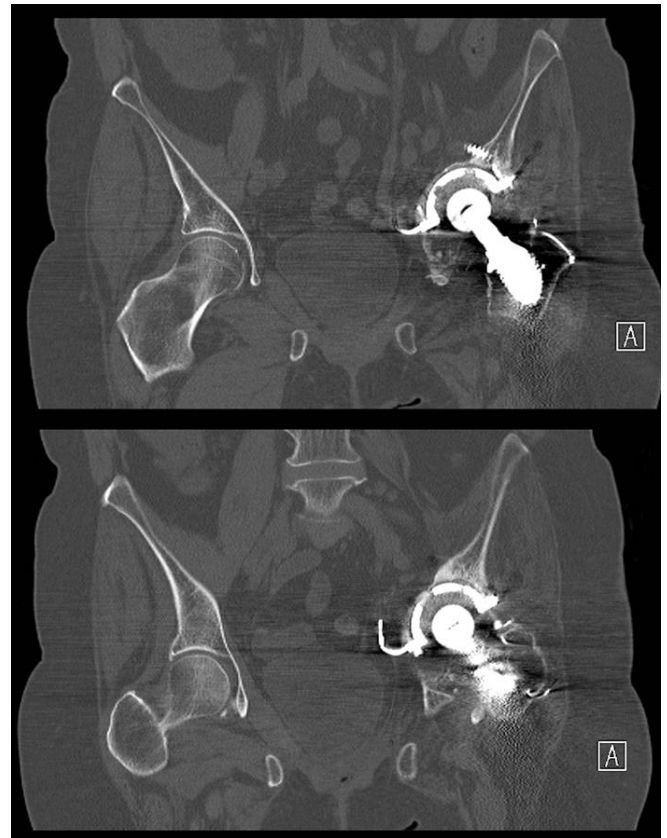
**Fig. (3).** Conventional CT scan preoperatively without contrast agent.

The initial conventional CT-scan revealed the close proximity of the anchoring hook to the urethra, consequently a continuative contrast agent based CT scan was performed, which demonstrated the urethra looped around the hook of the reinforcement ring. No other relevant soft tissue encroachment was noted and an appropriate pre-operative plan was performed accordingly (Figs. 4, 5).

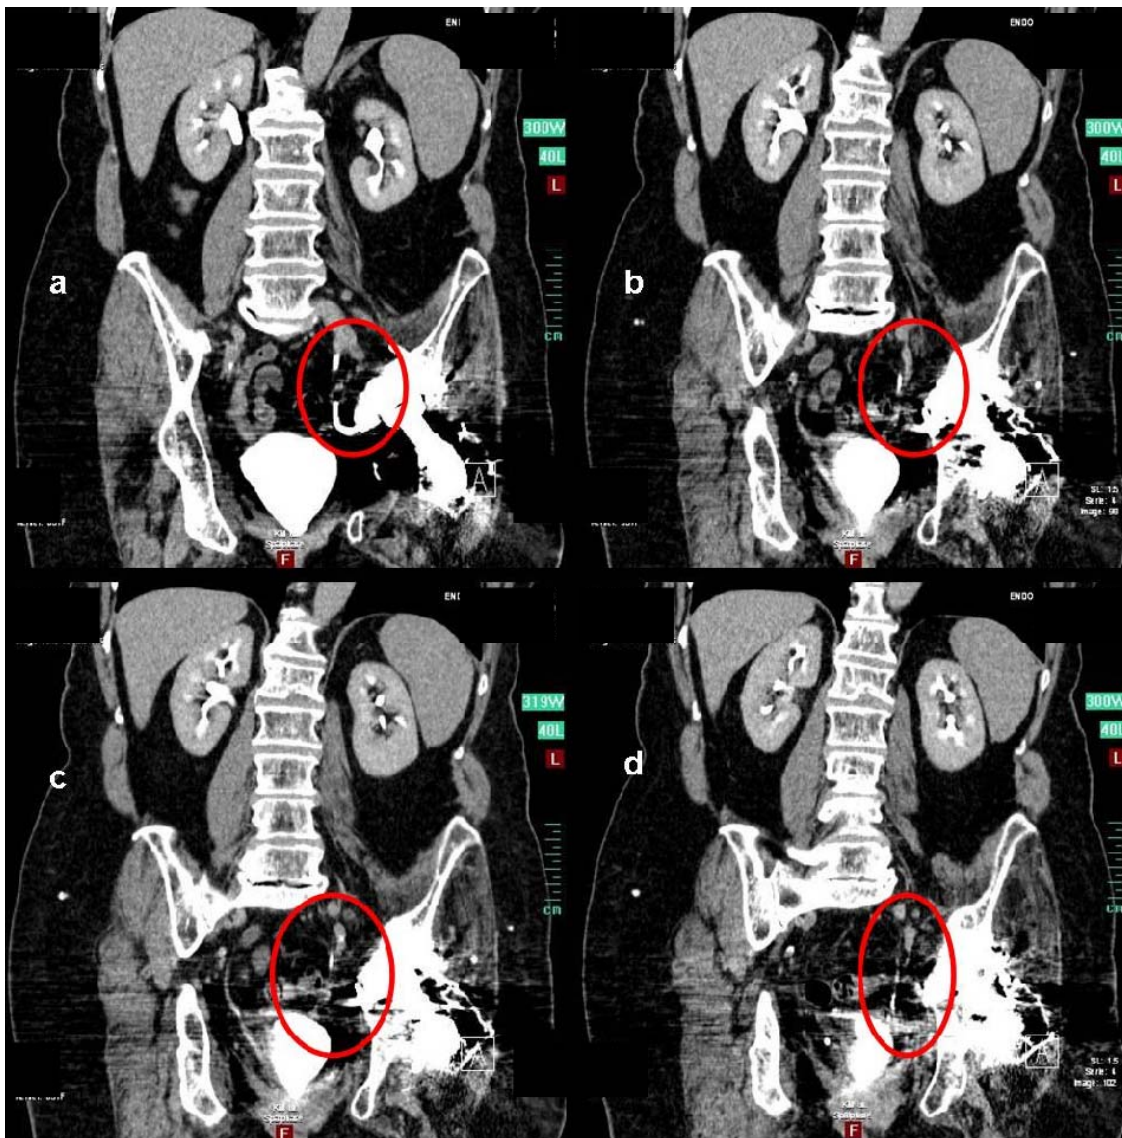
**Fig. (4).** (a-d) CT with contrast agent which clearly identifies the anatomic relation between the hook and the urether within the contrast flow.

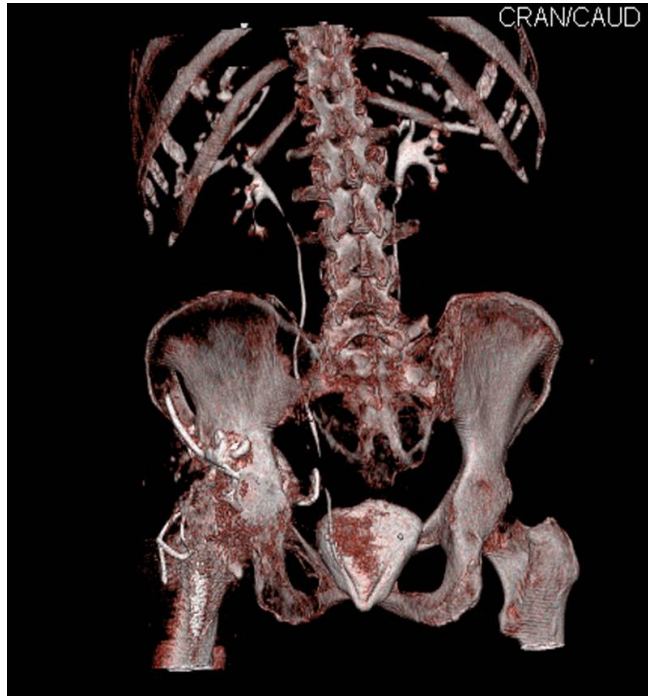
**Fig. (5).** A further 3-D reconstruction and scrolling throughout all slices allows the surgeon to clearly rule out a complete bracing of the hook around the urether.

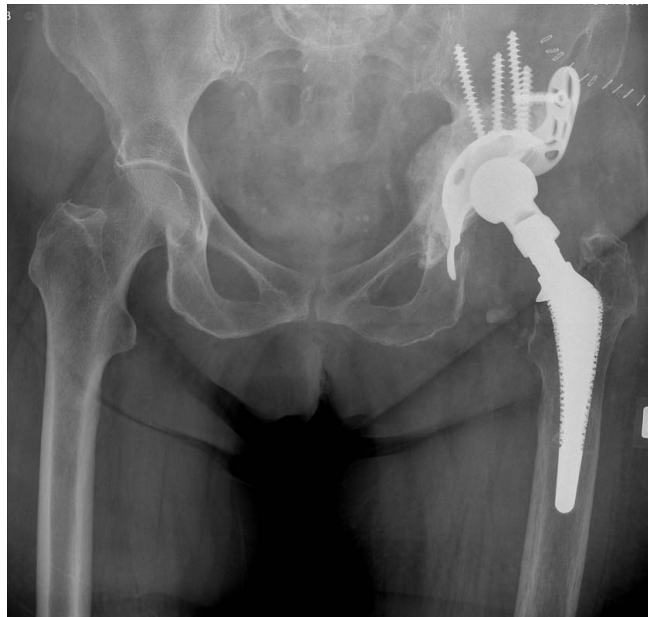
**Fig. (6).** Pelvis AP final result with a complete reinforcement ring and combined allograft impaction grafting to stabilise the all-polyethylene cup.

Through a posterior approach, the complete reinforcement ring was safely retrieved, with particular attention paid to identifying the hook and careful dissection of the surrounding soft tissues performed. Intra-operative findings confirmed that the reinforcement ring had protruded into the pelvis. A large osseous defect was noted in the acetabulum which required further fixation and stabilisation utilising a larger complete reinforcement ring and additional five screws into the ileum were placed. The osseous defect was addressed with a combination of structural allograft and impaction bone grafting. Finally, an all-polyethylene acetabular cup was cemented into place. Leg lengths and soft tissue tensioning was restored using an additional long neck and off set variation (Fig. 6).
