# Traumatic Midsubstance Patellar Tendon Ruptures: A Unique Surgical Repair Technique in the Setting of Poor Tissue Quality

**Abstract:** In the setting of traumatic midsubstance patellar tendon ruptures in which the tissue is unable to be repaired end to end, surgical options are limited. We offer a technique using suture anchors for the native tendon reconstruction, allograft augmentation, and a bioinductive implant.

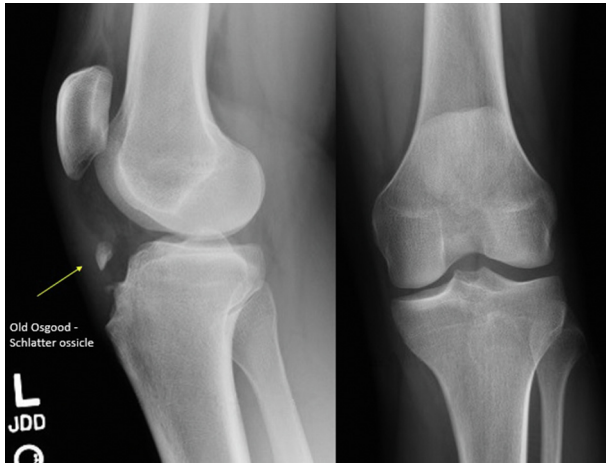
**Fig 1.** Lateral (A) and anteroposterior (B) radiographs of knee. On the lateral radiograph, significant patella alta can be seen, most likely indicative of a patellar tendon tear. An old Osgood-Schlatter ossicle is identified on these films; it is not a fracture. (L, left.)

Prior to surgery, a thorough history and physical examination must be performed. Radiography and magnetic resonance imaging are recommended for a complete evaluation (Figs 1 and 2). It is important to identify the location of the patellar tendon rupture because this will dictate surgical treatment options. As shown in Fig 1, there may be well-corticated ossicles that are consistent with old Osgood-Schlatter disease. This is not an acute fracture. It is also important to obtain contralateral knee radiographs to assess for patellar height. The goal of surgery is to have equal patellar heights.

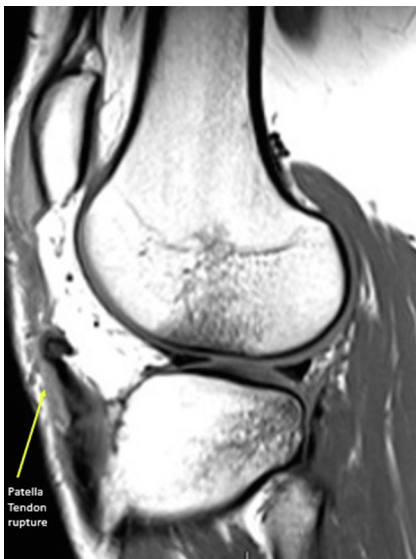
**Fig 2.** T1 sagittal magnetic resonance imaging of the knee shows a patellar tendon tear.

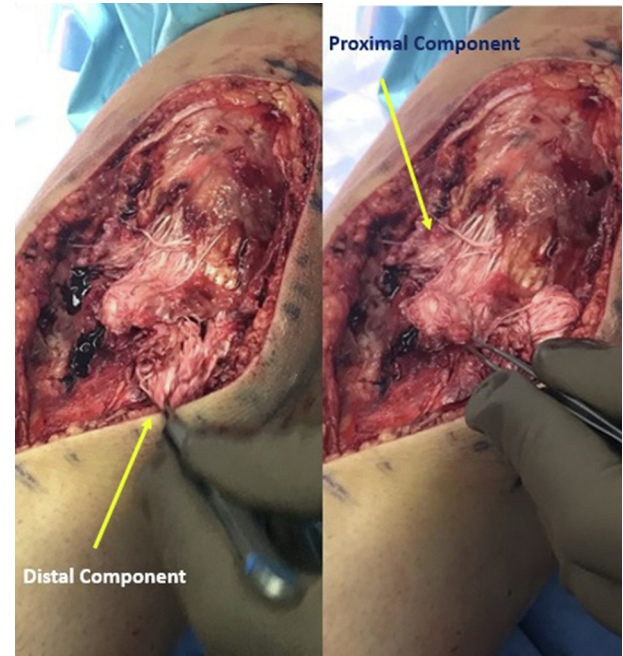
**Fig 3.** With the patient supine on the operating room table, a midline incision is made to expose the patellar tendon. It is critical to evaluate the tendon quality, tear type, and reparability. The midsubstance tendon tear can be seen, along with poor-quality tissue owing to trauma.

A midline incision is made overlying the patellar tendon (Video 1). A thorough evaluation of the tendon quality must be performed. In cases in which the tissue quality of the midsubstance tear is too degenerated for

an end-to-end repair (Fig 3), our technique should be performed.

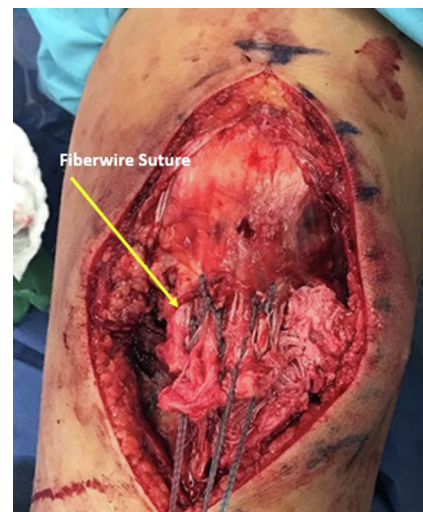
**Fig 4.** FiberWire sutures are placed in a locking fashion in the proximal patellar tendon leaflet. The proximal aspect of the tendon will be anchored into the proximal tibia.

Two No. 5 FiberWires (Arthrex, Naples, FL) are placed in a running locking fashion in the proximal tissue fibers, off the patellar tendon (Video 1, Fig 4). Then, 2 additional FiberTapes (Arthrex) are placed, coming off the tibial tubercle distal fibers, in a running locking fashion.

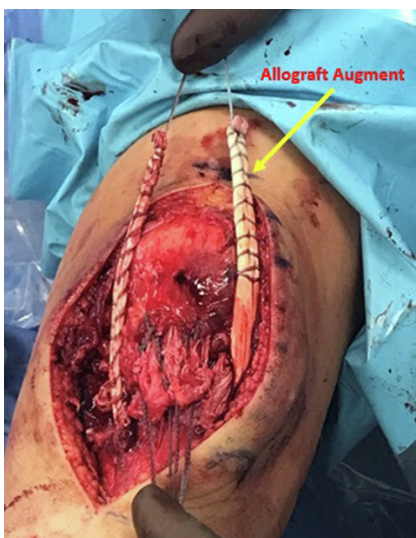
**Fig 5.** An allograft augmentation is chosen to protect the repair. A 6.5-mm allograft is shuttled through the tibial tubercle tunnel and passed proximally.

allograft limbs are brought up along the medial and lateral side of the patellar tendon (Video 1, Fig 5). By use of a tonsil clamp, the graft is passed below the retinacular layer to the superior pole of the patella (Video 1, Fig 6). With the knee flexed to 30°, the allograft is tensioned down and 3 No. 5 FiberWire sutures are placed in a figure-of-8 fashion to help approximate the 2 graft ends (Video 1, Fig 7). This will maintain the allograft in the appropriate position.

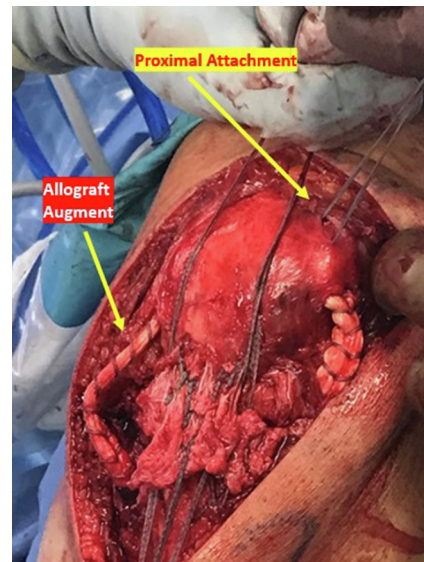
**Fig 6.** The allograft augmentation is passed through the retinacular layer and united at the superior pole of the patella.

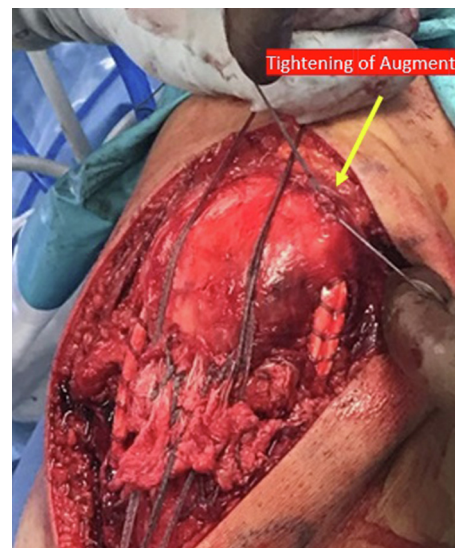
**Fig 7.** With the knee in 30° of flexion, the allograft augmentation is appropriately tensioned and sutured together. This is critical because the augmentation is what protects the tendon repair. The surgeon should ensure that the augmentation is tightened and sutured securely.

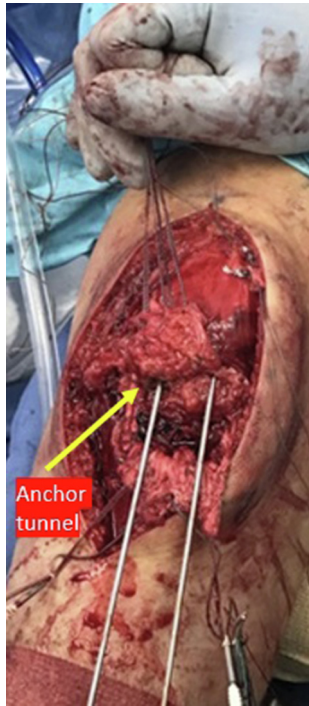
**Fig 8.** In preparation for anchors, 2 guide pins are placed in the inferior pole of the patella and over-reamed. This is where the anchors will be placed for fixation of the distal patellar tendon tissue.

Two guide pins are placed in the inferior pole of the patella, separated by 20 mm (Video 1, Fig 8). Overreaming is performed with a 4.5-mm reamer. Then, the FiberTape suture ends from the distal tendon are preloaded onto two 4.75-mm SwiveLock anchors (Arthrex). The two 4.75-mm SwiveLocks are inserted in the inferior pole of the patella on both sides. The accessory sutures should remain in place. The FiberTapes are appropriately tensioned, and the anchor is seated.

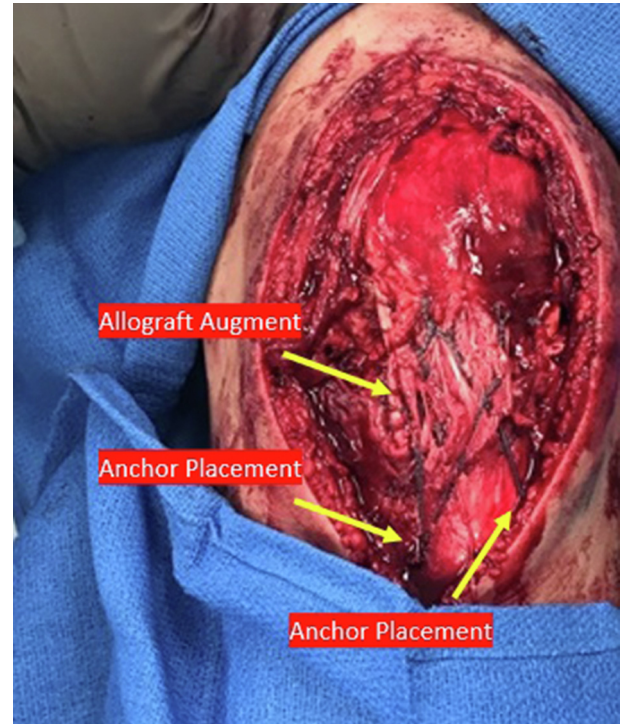
**Fig 9.** The proximal tendon tissue is overlapping the distal tendon tissue and is anchored into the proximal tibia. Not shown is the distal tendon tissue underlying the proximal tissue fibers and anchored into the inferior pole of the patella.

Next, the surgeon preloads 2 additional 4.75-mm SwiveLocks and the remaining FiberTape suture limbs from the proximal leaflet. This is performed in a SpeedBridge fashion (Arthrex). Two guide pins are inserted adjacent to the tibial tubercle and over-reamed with a 4.5-mm reamer. The surgeon then again inserts both anchors simultaneously and appropriately tensions the tapes so as not to over-tension the repair (Video 1). These are both seated. Evaluation shows great overlap of the tendon with appropriate tension (Fig 9).

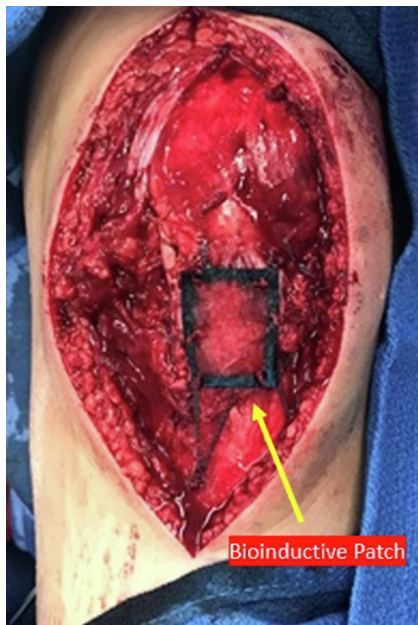
**Fig 10.** Application of bioinductive implant over patellar tendon tear. The implant is secured to the tissue with Vicryl suture. This promotes healing of the tissue.

bioinductive implant consisting of a large Regeneten patch (Smith & Nephew) to stimulate healing. The graft is placed over the midportion of the patellar tendon and sutured with interrupted No. 1 Vicryl (Video 1, Fig 10). Intraoperative radiographs are obtained to ensure the patellar height is restored and equal to that of the contralateral extremity (Fig 11).

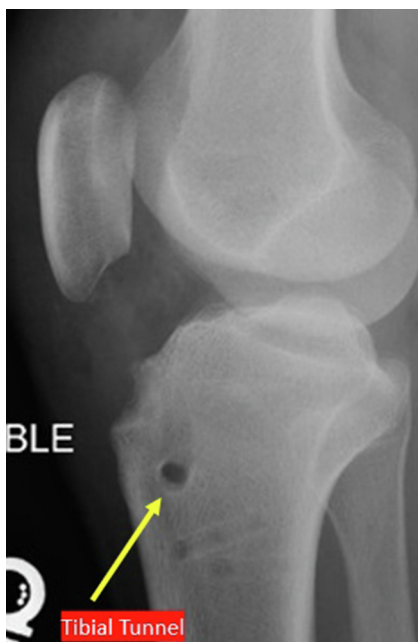
**Fig 11.** Postoperative lateral knee radiographs showing the resolution of patella alta along with the tunnel through the tubercle where the allograft is slid through.
