Acta Orthopaedica et Traumatologica Turcica

Total hip arthroplasty-related pelvic pseudotumor: Unusual presentation with hydronephrosis

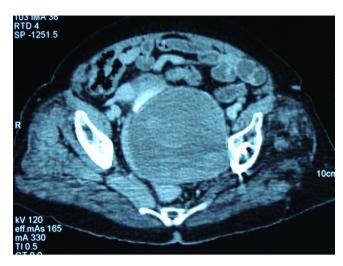
Fig. 1. Abdominal CT. A large hypointense mass displaces the bladder and the rectum, filling rectovaginal space. Close contact between the mass and acetabulum, with a beak-like extension towards the acetabular screws, is evident. Osteolysis of acetabulum is prominent.

Emergency abdominal ultrasound examination demonstrated grade 3 hydronephrosis in the left kidney and a dilated ureter, together with a cystic mass in the pelvis. The mass compressed the bladder and contained multiple echogenic foci within a thin-walled cyst, but no solid components or septae were visible. For further characterization of the mass, an abdominal CT examination with IV contrast material was performed (Fig. 1). Grade 3 hydronephrosis of the left kidney and dilation of the ureter into the pelvis was evident. A large cystic mass of 8 cm in diameter was located in the left hemipelvis, compressing the bladder anterolaterally to the right, separating the bladder and the rectum. Containing heterogeneous material, the mass appeared hypodense without any contrast enhancement either in the wall or within. The mass seemed to be adjacent to the left posterolateral pelvic side wall, where streak artefacts emanating from a total hip arthroplasty caused deterioration of the images. No other pathology could be identified.

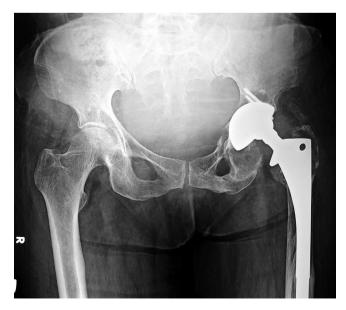
Fig. 3. AP radiograph. Loosening and osteolysis around the acetabular component, loss of the tear drop and proximity of the acetabular component to the Köhler's line.

In direct radiographs (Fig. 3), the femoral head was located eccentrically and superiorly within the acetabular cup, indicating a severe polyethylene wear. A lytic area larger than 1.5 cm was present

in the ischium and also in the superior pubic ramus. Radiographic tear drop was not visible. The acetabular socket was adjacent to the Köhler's line. Despite these severe lytic changes in the inferior acetabulum and ischion, the superior acetabular coverage was almost intact, with a bone defect less than 2 cm. The acetabular defect was classified as grade 2C according to Paprosky classification.¹

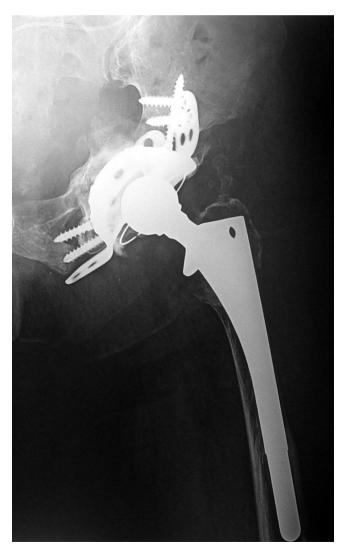
Fig. 5. AP radiograph after revision.

the defect in the pelvic wall (Fig. 4). Decompression was successful and the patient was discharged because she denied a revision hip surgery. After 10 months, she referred to the hospital with recurrent symptoms of abdominal pain. The pseudotumor had reappeared in the same location, having the same size and compressive effect. This time a limiting pain was also present in the left hip joint. Hydronephrosis was relieved after insertion of double I catheter into the left ureter and the patient was referred to orthopedic department for revision of hip arthroplasty. During the revision surgery, following removal of loose acetabular component, the cystic lesion was visible through the acetabular defect and was aspirated. Acetabular defect was reconstructed using an acetabular reconstruction ring (Contour, Smith-Nephew, Memphis, TN, USA) supported with bone grafting and a cemented acetabular component was implanted. (Fig. 5) Femoral component was stable despite moderate osteolysis, thus only the femoral head was replaced. She was discharged after uneventful recovery.
