TECHNICAL NOTE

A technique to remove a well-fixed titanium-coated RM acetabular cup in revision hip arthroplasty

Fernando MJ Judas*, Rui F Dias and Francisco M Lucas

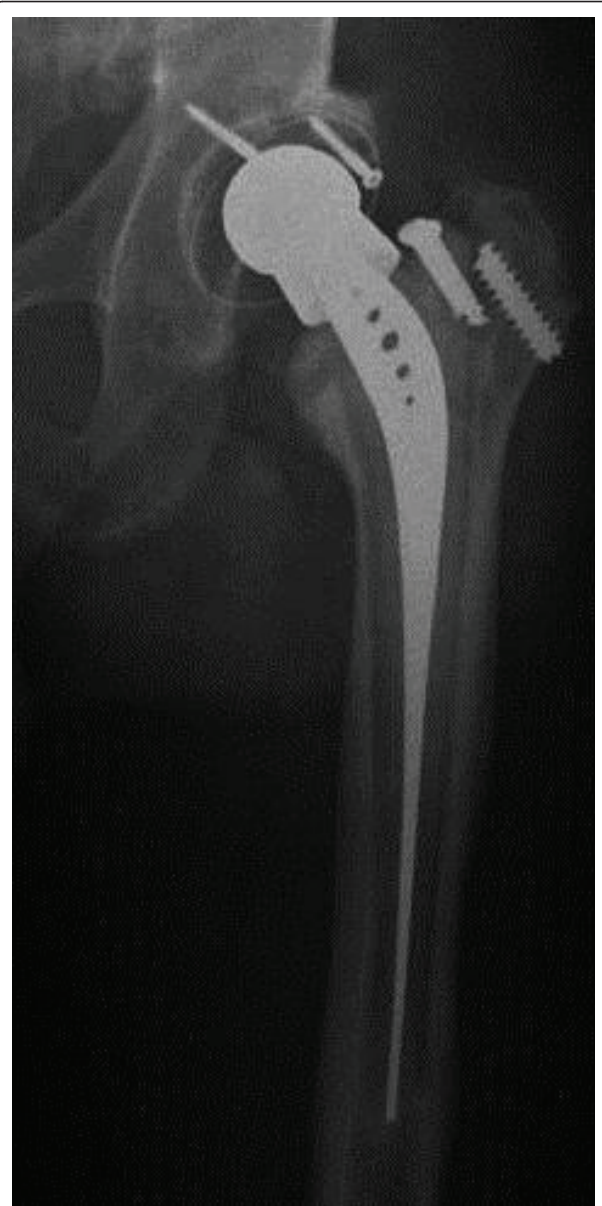
Figure 1 Twenty years after primary hip arthroplasty. The radiograph shows loosening of the isoelastic cementless femoral stem and well-fixed titanium-coated RM acetabular cup.

A 75-years-old man presented a bilateral hip arthroplasty. The clinic and the radiograph showed aseptic loosening of an cementless prosthesis in the left side, with 20 years of follow-up. The polyethylene titanium-coated RM acetabular cup was well-positioned and well-fixed, and no radiolucent lines are present in the bone/implant interface. The isoelastic femoral stem showed a mechanical instability, the two screws of stem being broken (Figure 1).

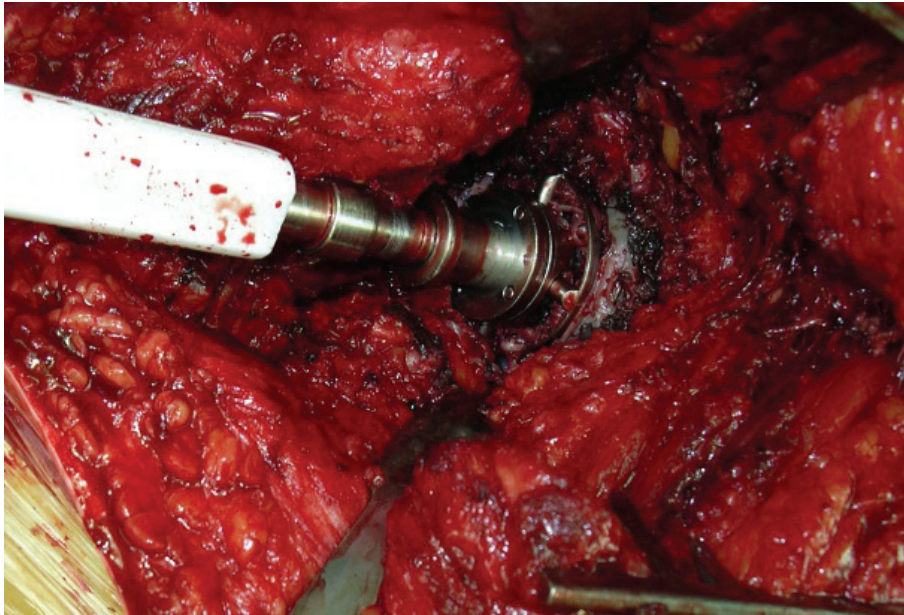
Figure 2 Reaming of the center of the cup with powered acetabular reamers.

The first reamer was a small standard-powered *cheese grater* acetabular reamer (40 or 44 mm). It was placed in the middle of the inner part of the cup (Figure 2). Reamers of increasing sizes are used successively to wear the polyethylene layer (Figure 3). A minimal amount of polyethylene debris ("polyethylene chips") was removed of the articular soft tissues to avoid any biological reaction.

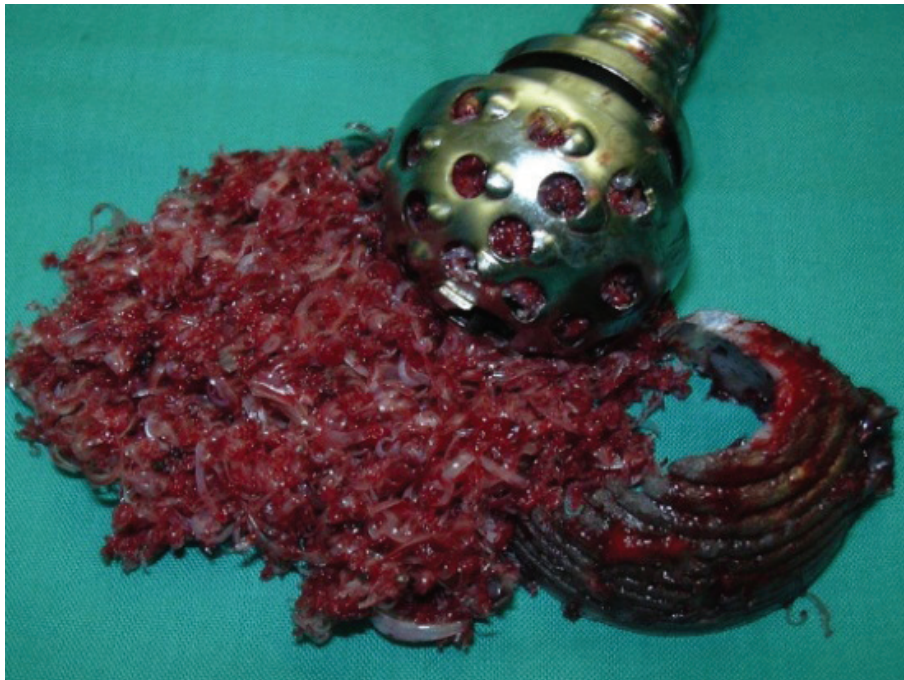
Figure 3 When the polyethylene layer was thin enough, the remaining cup was removed easily by hand tools and bone stock is preserved.

In this case, we used chisels to weak the superior part of the implant and to create a roughness surface for the reamer action. When the polyethylene was thin enough, it was removed easily by hand tools without the risks of

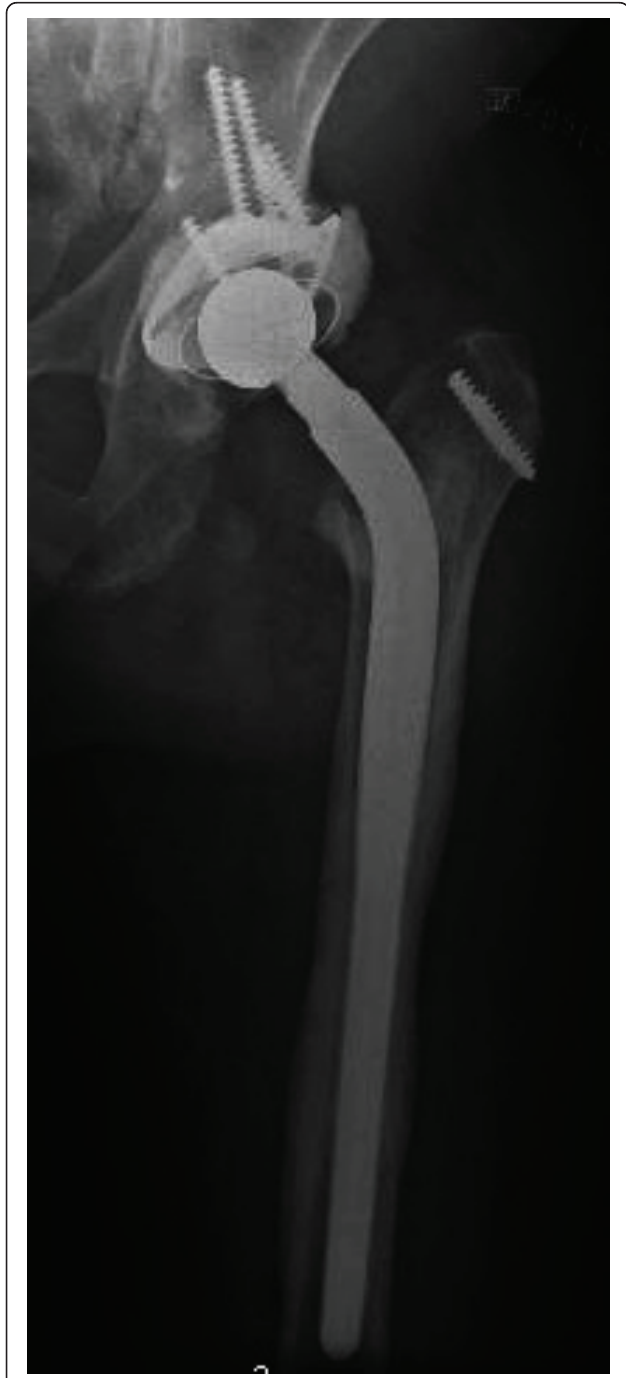
Figure 4 Hip reconstruction with a metallic reinforcement ring and a conical cementless stem, without acetabular bone loss. Cancellous bone allograft was used in the femoral side.

A metallic support ring and a cemented polyethylene cup were implanted. The femur was reconstructed with a revision conical stem and using morselized

cancellous bone allograft cryopreserved [9-11]. The bone allograft was impacted to fill the space between the proximal part of the implant and the cortical native bone (Figure 4).
