Progressive Osteolysis with Hematoma Following Revision Total Hip Arthroplasty using Hydroxyapatite Mesh: A Case Report

Shougo Matsuda¹, Nobuhiro Kaku¹, Tomonori Tabata¹, Hiroshi Tsumura¹

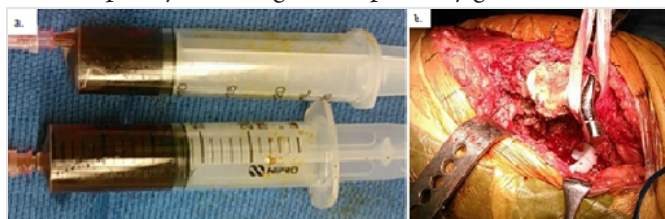
Figure 3: Macroscopic findings. (a) Cystic tumor was observed near the proximal area of the femur and was continuous with the hip joint. The dark red synovial fluid was found on puncturing the cystic tumor. (b) Granulation tissue was seen at the osteolytic lesion of the proximal femur, and powdery hydroxyapatite was found in it and in the hematoma. There were no macroscopic findings, such as fretting process and crevice corrosion, at the stem neck. Moreover, we did not find excessive abrasion or delamination wear at the polyethylene liner.

HA mesh were scattered inside (Fig. 3). We analyzed the granulation tissue through a rapid pathological examination and did not find any pathological findings of infection or tumor. The pelvis showed discontinuity; however, there was no bleeding source. There was no macroscopic damage of implants, such as wear or corrosion of the stem neck, ball head, and PE liner. Hence, the liner, metal shell, and stem were preserved and thoroughly washed after the removal of hematoma, capsule, HA debris, and granulation tissue as much as possible. Only the ball head was replaced. Since a pathological fracture had already occurred distal to the greater trochanter, we performed osteosynthesis with an Accord cable (Smith and Nephew Inc., Memphis, TN, US) after grafting the allograft bone (Fig. 4). Pathological examination under hematoxylin and eosin (HE; pH 2.5) staining for the specimen of granulation tissue retrieved during surgery was performed. The mass was covered with a fibrous capsule, with a high infiltration of histiocytes. Partial invasion of plasma cells was also observed with fibrin deposition. The interior of the tumor had a mix of old and fresh bleeding and some tissue balls phagocytizing hemosiderin were observed. Granulation tissue was infiltrated by giant cells and surrounded the transparent substance. When observed with a polarizing microscope, HA was clearly visible (Fig. 5). At present, 2 years after surgery, there is no sign of infection in the laboratory data and no recurrence of
