Case report

Complete wear-through of a metal-backed acetabular cup in an ambulatory patient

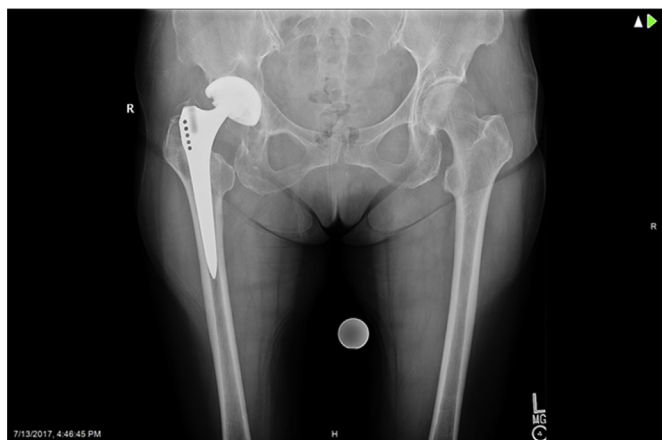
Figure 1. Non cemented right total hip arthroplasty with eccentric position of the femoral head within the acetabular component indicated significant polyethylene liner wear.

The patient reported that she went on to do well until May 2017 when she started noticing trouble walking further distances due to a right limp requiring the use of a cane. She was evaluated in July 2017 by a physician at an outside hospital, and radiographs at that time showed an eccentric position of the femoral head within the

acetabular component indicative of significant polyethylene liner wear (Fig. 1). Moderate osteolysis was identified in the periacetabular region and proximal trochanter, but both components appeared to be well fixed.

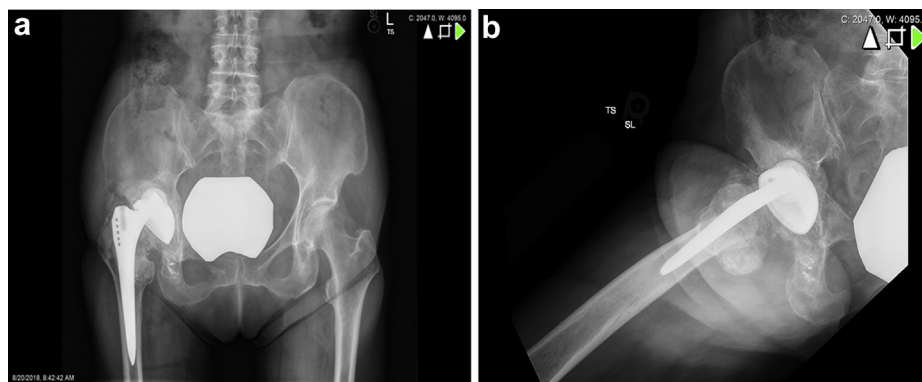
Figure 2. Complete wear-through of polyethylene liner and metal-backed acetabular cup resulting in THA catastrophic failure. (a) Anteroposterior radiograph view. (b) Lateral radiograph view.

Her anteroposterior standing radiograph revealed complete erosion of the ceramic femoral head through the acetabular superior dome of the component with marked periacetabular and proximal femur osteolysis. In addition, a large amount of metal debris could be radiographically identified throughout the right hip (Fig. 2). She underwent a computed tomography scan with 3D reconstruction of her right hip to better assess the extent of the acetabular osteolysis. Inflammatory markers drawn in preparation for surgery were within normal limits (C-reactive protein <0.7 mg/dL, reference range: 0.0–1.0 mg/dL; estimated sedimentation rate 16 mm/h, reference range: 0–20 mm/h), and she denied any recent infections or antibiotic use. Due to severe metal debris observed on the plain radiograph, serum was collected for analysis, which showed highly elevated titanium ions at 620 ppb (normal limit: <10 ppb).

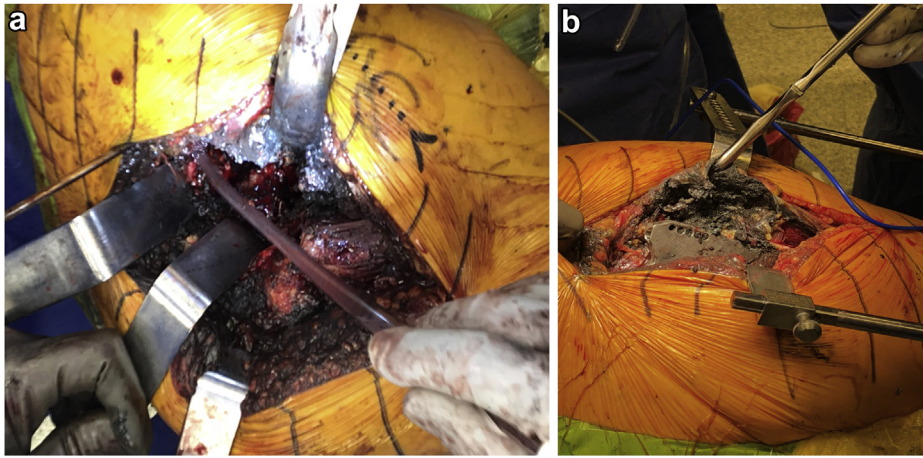
Figure 3. Black metallic wear debris (a) with gross synovitic reaction in all soft tissue layers (b).

Surgery was performed through a posterolateral approach. Black metallic wear debris and a gross synovitic reaction was noted in all soft tissue layers (from subcutaneous tissue through to the joint capsule), and it was excised in its entirety (Fig. 3). Later pathologic examination showed that the amount of particulate metallic debris was quite high, while inflammatory infiltrates usually associated with infection were not identified.

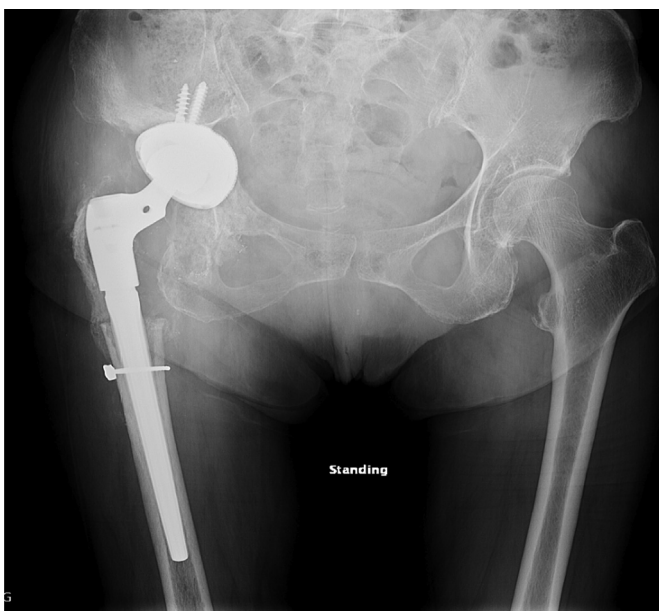
Figure 4. Six-month follow-up anteroposterior radiograph. A prophylactic Dall-Miles cable was placed around the femoral isthmus area.

Allograft consisting of 60 cc cancellous bone chips was placed and reverse reamed in the deficient acetabular medial wall. Consecutively, a dual mobility cementless acetabular component (G7 OsseoTi DM 52 mm, hemispherical, standard offset; Zimmer Biomet) with multiple screws was inserted under computer-assisted navigation (IntelliJoint Surgical, Kitchener, ON, Canada), and a dual mobility liner (G7 DM 28 mm × 42 mm; Zimmer Biomet) was applied. A cementless taper splined revision stem (ARCOS Revision Stem 3° taper blunt spline; Zimmer Biomet; 150 mm length × 13 mm diameter; 50 mm body cone, standard offset) with a 28-mm Biolox G7 femoral head (Zimmer Biomet) was implanted into the femur, and a prophylactic Dall-Miles cable (Stryker Corp., Mahwah, NJ) was placed around the femoral diaphyseal isthmus area prior to stem preparation and insertion. Reattachment of the remaining trochanteric sleeve on the stem was performed with the use of No. 2 Ethibond sutures. The patient tolerated the procedure well without complications. Postoperatively, the patient was rehabilitated as per standard protocols and discharged on postoperative day 4. At 6-month follow-up, gradual restoration of the bone loss was observed in the anteroposterior radiograph (Fig. 4), while the patient was able to walk 2 miles a day without an assistive device.

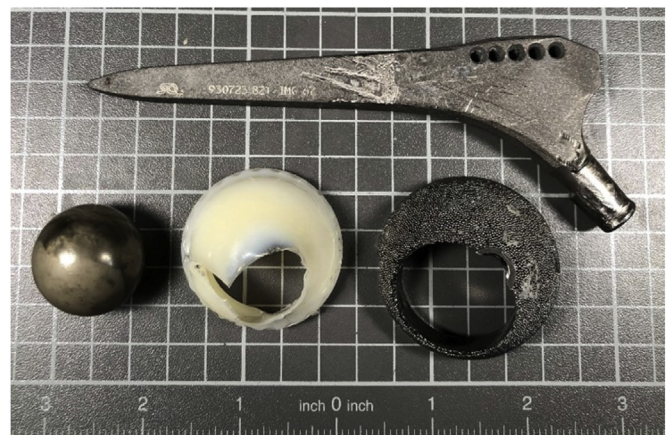
Figure 5. Retrieved implant from pathology with retrieved components from acetabulum and femur.

implant was placed in formalin for 1 week and was then soaked in 10% bleach solution and cleaned with soap and water, following standard procedures in our Institutional Review Board-approved implant retrieval program (Fig. 5). The femoral stem and head catastrophically wore through the polyethylene liner, fracturing the liner, and wearing through the titanium alloy shell. The female head and taper of the femoral head had severe metal transfer from the SL-Plus trunnion. The trunnion of the femoral stem had deformed to become more elliptical in shape and toggled within the female taper of the femoral stem with clear evidence of material loss (Fig. 6). The polyethylene locking mechanism was partially worn but the polyethylene liner was completely disengaged from the cup and free floating since there was a lot of metal debris between the cup and the liner.

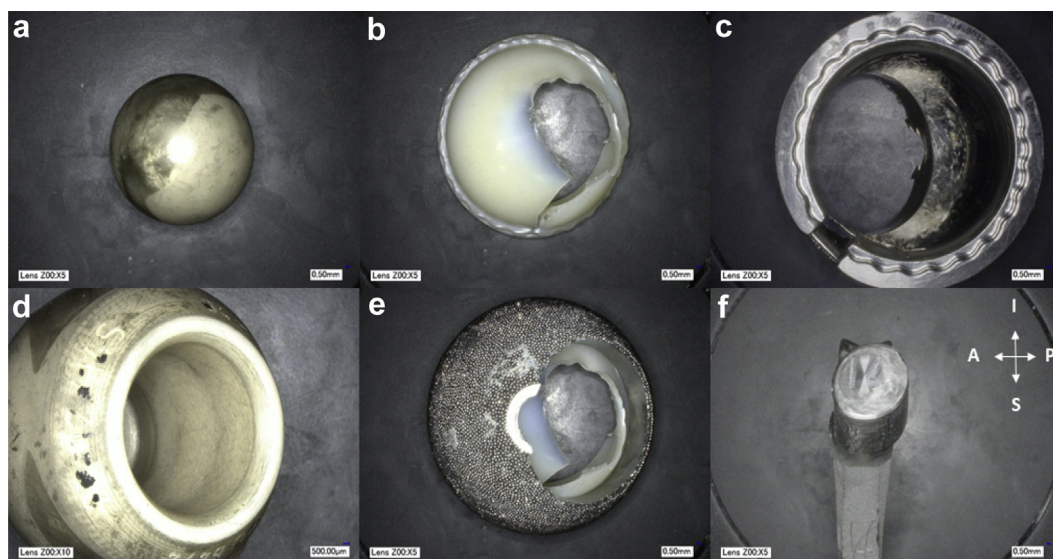
Figure 6. Magnified images of each component revised. Femoral head (a) shows extreme wear and metal transfer observed in female taper as well (d). Fractured liner (b, c, e) and acetabular shell worn through by femoral head. Femoral stem trunnion with material loss (f).

Interestingly, although no trunnion corrosion was found, the trunnion of the femoral stem was severely damaged with clear evidence of material loss. Specifically, in the retrieval analysis, the trunnion was found deformed into an elliptical shape. Our theory is that once the femoral head was locked into the acetabular shell the trunnion started spinning into the femoral head with subsequent deformation. The polyethylene locking mechanism was partially worn but the polyethylene liner was completely disengaged from the cup.
