# Vertebral collapse and polymethylmethacrylate breakage after vertebroplasty

## A case report

Medicine (2019) 98:34(e16831)

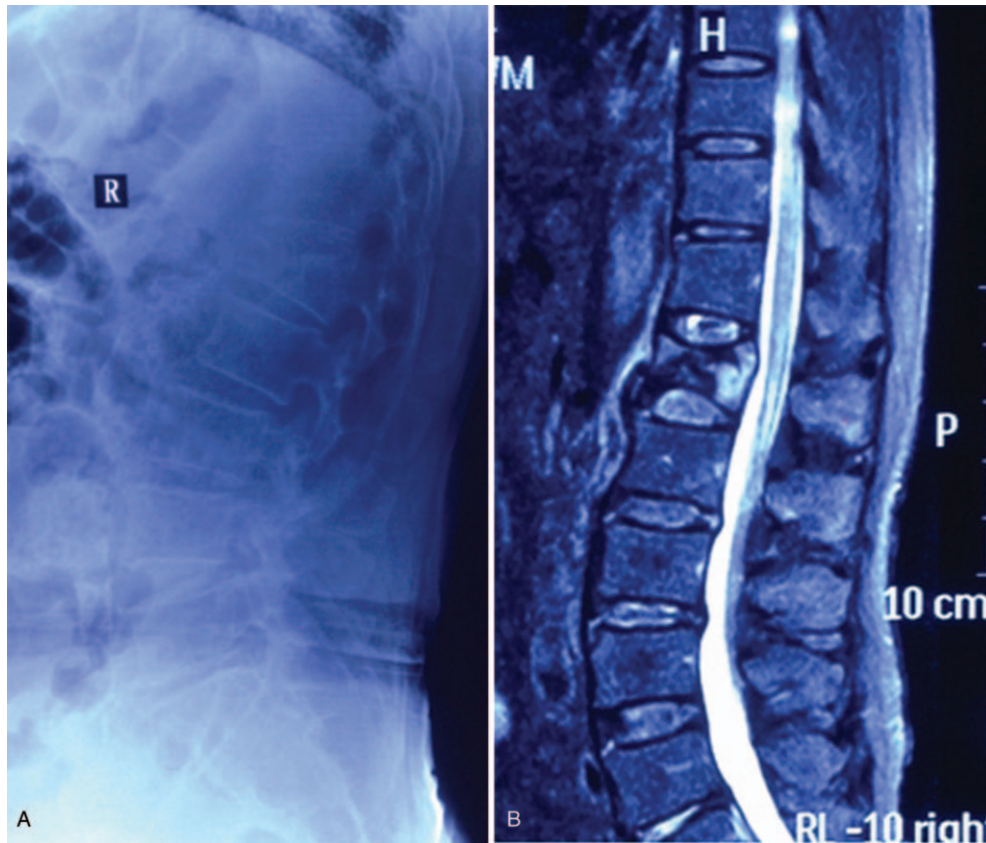
**Figure 1.** Preoperative lateral radiograph and sagittal STIR MRI (Magnetom expert 1.5 Tesla) of the lumbar spine, revealing an acute vertebral compression fracture in L1 (May 2013). MRI = magnetic resonance imaging.

In May 2013, a 72-year-old man suffered back pain after a slight injury caused by a fall at home. X-ray imaging revealed a compression fracture of the first lumbar vertebra (L1) vertebra, and magnetic resonance imaging (MRI) revealed an acute

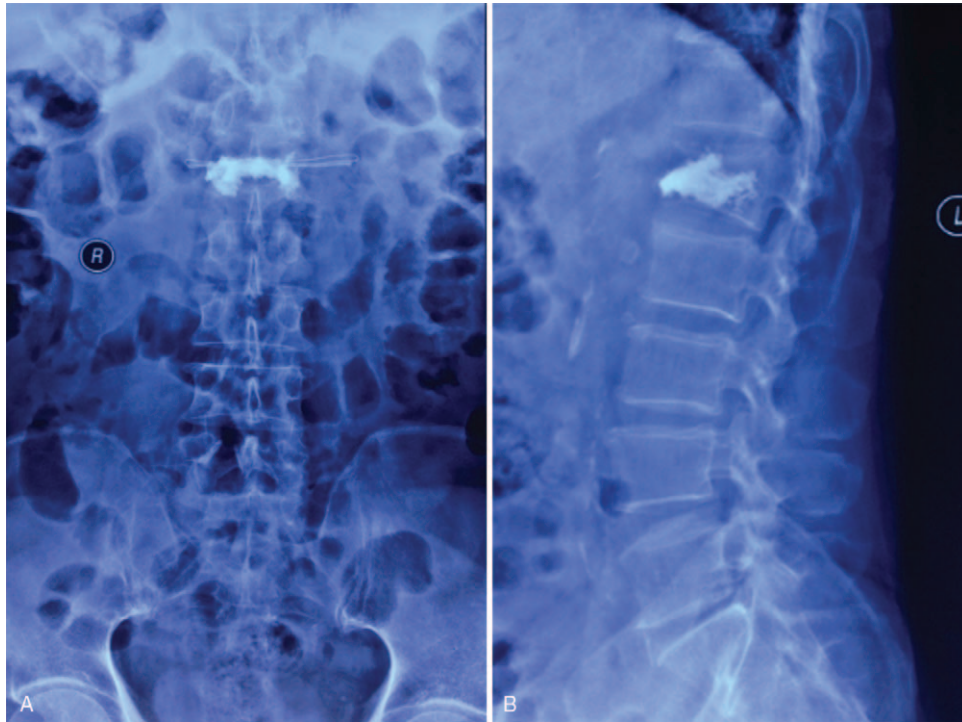
**Figure 2.** Postoperative anteroposterior and lateral radiograph of L1, demonstrating that a total of 4.0 mL PMMA was bilaterally injected through the vertebral pedicle, but the kyphosis had not been corrected (May 2013). PMMA = polymethylmethacrylate.

fracture in the L1 vertebra (Fig. 1). He underwent PVP, and a total of 4 mL polymethyl was bilaterally injected into the vertebra through the vertebral pedicle, under local anesthesia (PMMA [Heraeus Medical GmbH, Osteopal V; Heraeus Medical GmbH, Wehrheim, IN, Germany]). Postoperatively, the patient's backache had been alleviated considerably: the visual analog scale (VAS) score improved from 7 to 2, and the Oswestry disability index (ODI) score had decreased from 75 to 15 after the first day (Fig. 2).

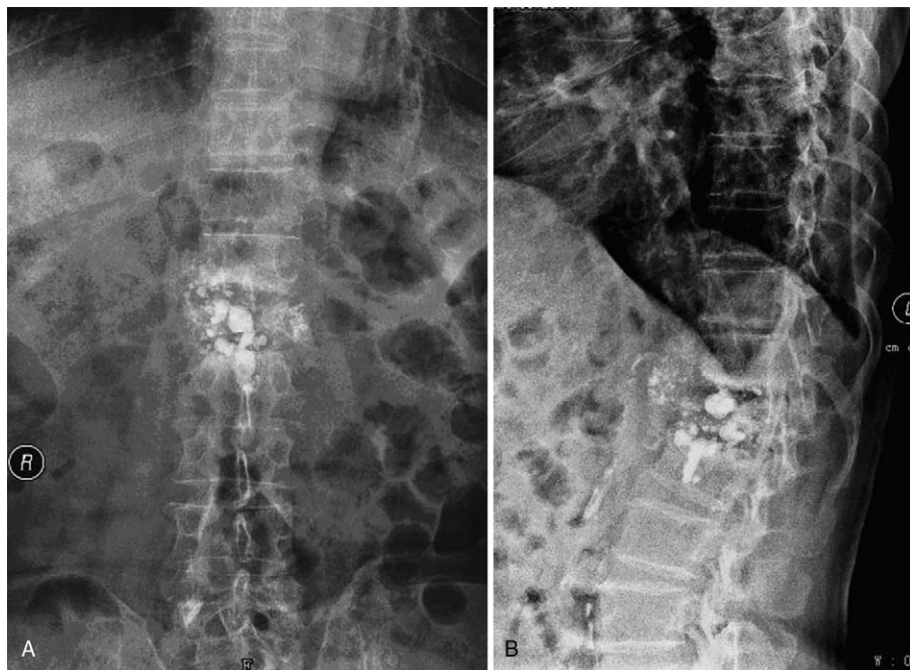
**Figure 3.** Plain radiograph showing L1 vertebral collapse and PMMA breakage, with a kyphosis angle of 25° (March 2016). PMMA = polymethylmethacrylate.

In November 2015, the patient's lumbar back pain recurred. The pain was endurable at first, so he rested at home. The back pain gradually worsened, however, especially when he was standing or sitting. The patient sought treatment at our hospital, and further plain radiographs showed that the L1 vertebra had collapsed and the PMMA cement was comminuted (Fig. 3). He was then admitted to the hospital for further treatment.

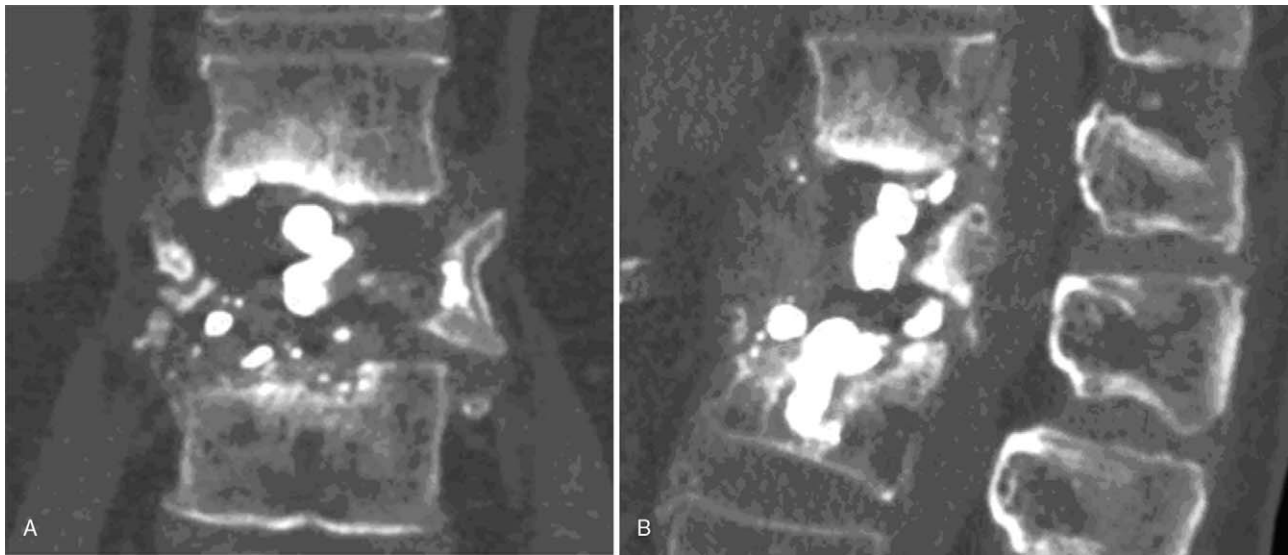
**Figure 4.** Computed tomography reconstruction of the L1 vertebra showing vertebral collapse of L1 after vertebroplasty, with broken PMMA pieces embedded in the L2 vertebra. PMMA = polymethylmethacrylate.

X-ray images showed the Cobb angle was 35° and 20° in flexion and extension positions, respectively. Further computed tomography examination revealed osteolysis of the L1 vertebra, and pieces of PMMA cement were embedded in the L2 vertebral body (Fig. 4). Sagittal T1-weighted and STIR MR images showed low and high signal intensity for L1, respectively, which indicated L1 was full of liquid (Fig. 5). His bone mineral density, measured at the proximal femur and L2–4, was 0.653 g/cm<sup>2</sup> (T score: -2.5, Z score: -1.1) and 1.515 g/cm<sup>2</sup> (T score: 3.6, Z score: 4.4), respectively.

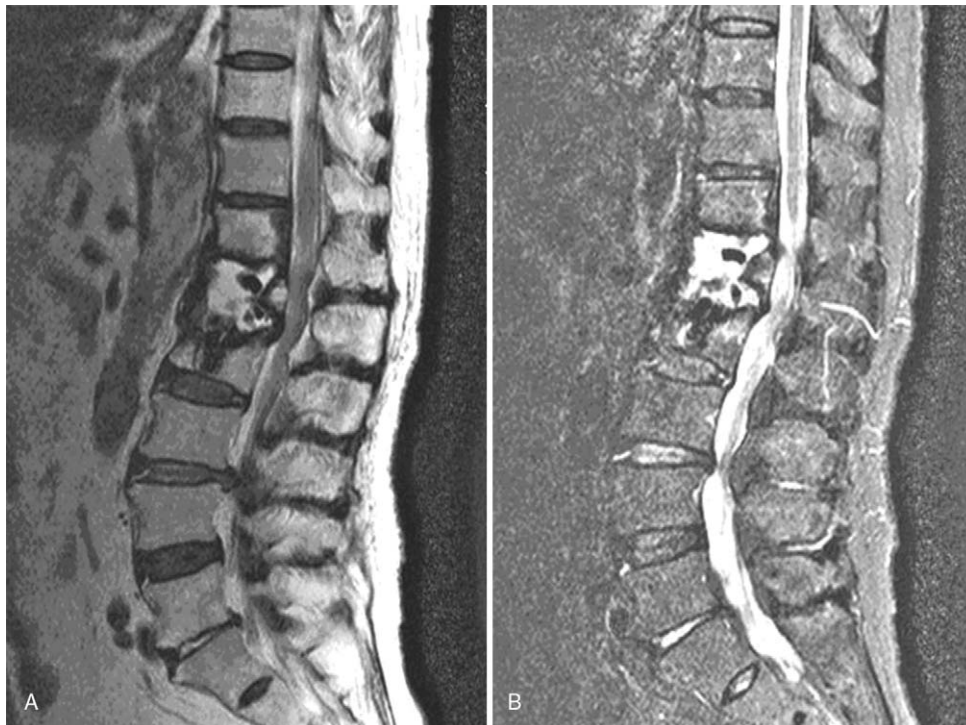
**Figure 5.** Sagittal T1-weighted and STIR MR images (Magnetom expert 1.5 Tesla) showing low and high signal intensity on L1, respectively.

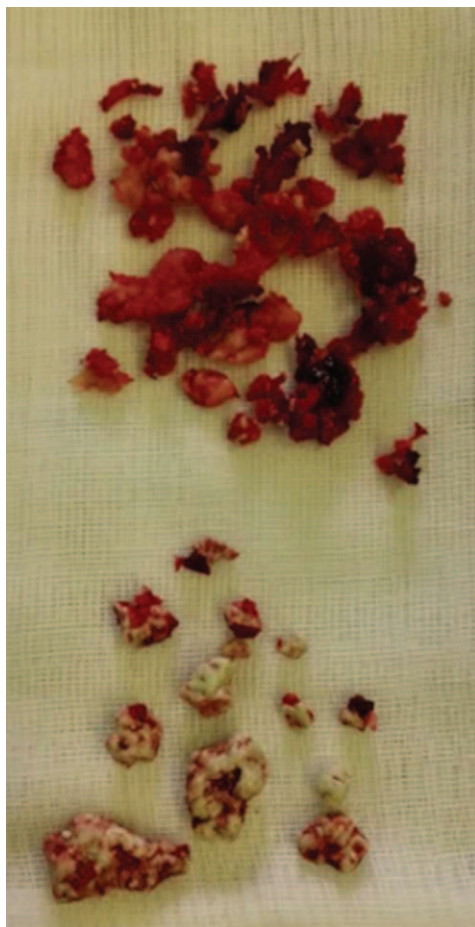
**Figure 6.** Broken bone and PMMA were removed during surgery. PMMA = polymethylmethacrylate.

The patient underwent posterior pedicle internal fixation surgery in a single-stage operation, and most of the broken PMMA was removed through a gap on the left side of the L1 transverse process and the lateral pedicle (Fig. 6). A light-yellow clear liquid was observed in the L1 vertebra, and the liquid was sent for microbial analysis. Then the vertebra was repeatedly irrigated using a hydrogen peroxide solution and diluted iodine. The antibiotic cefthiamidine was used to prevent postoperative infection. The microbial culture was negative, and pathological examination showed broken bone tissue and large amounts of

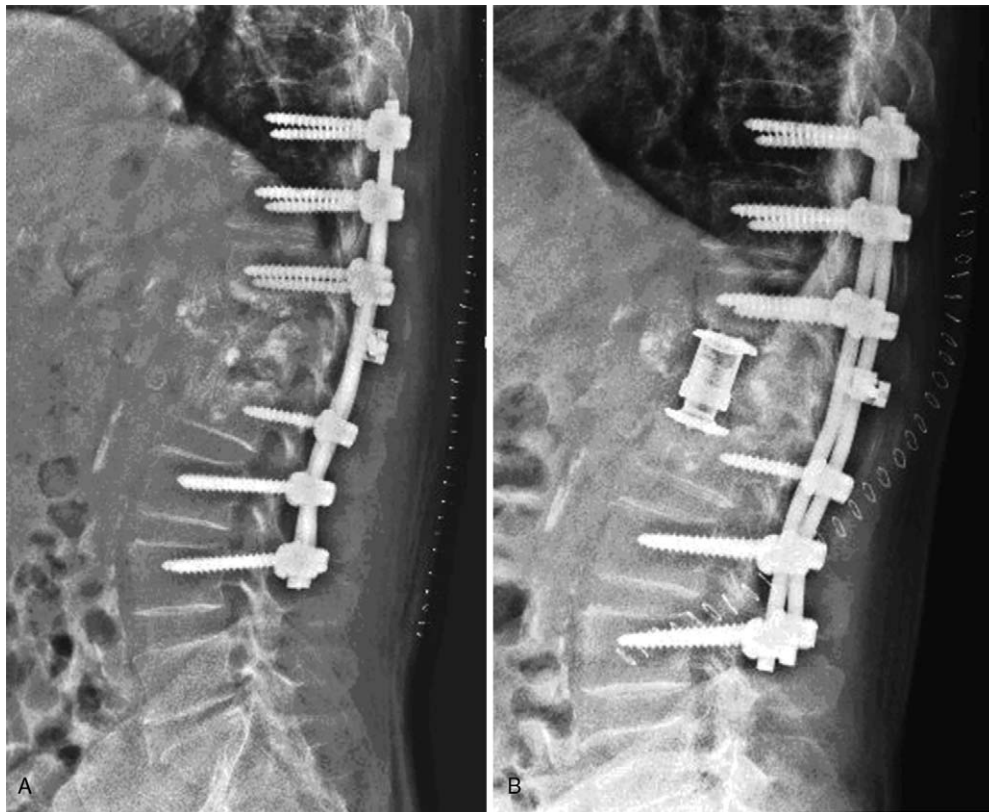
**Figure 7.** Lateral X-rays showing 2 steps of posterior pedicle internal fixation and anterior artificial vertebral body implantation immediately after reconstruction.

cellulose fiber. The 2-stage anterior side of the artificial vertebral body was implanted 2 weeks later (Fig. 7). The patient has been followed up for more than 2 years. He has recovered well, the pain is relieved, and the ODI score decreased from 98 to 27.
