Alterations in magnetic resonance imaging characteristics of bioabsorbable magnesium screws over time in humans: a retrospective single center study

<https://doi.org/10.1515/iss-2021-0032>

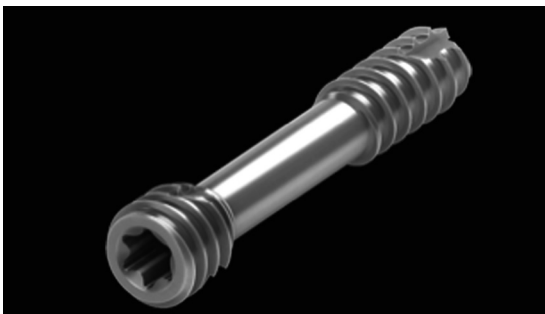
Figure 1: Image of the MAGNEZIX® compression screw with a 3.2 mm diameter.

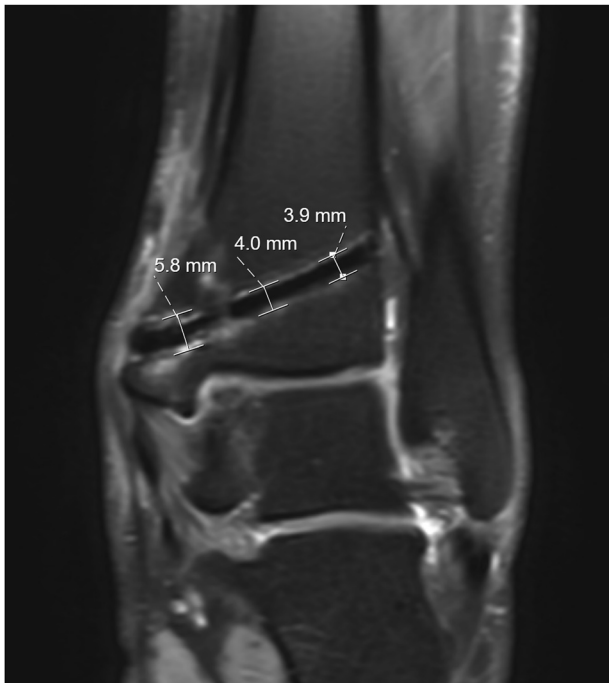
**Figure 2:** Measurement of artifact extent around the screw on a proton density weighted (PDw) coronal MR image.**Table 3:** Results of artifact measurements of all postoperative MRIs for proton density weighted (PDw) coronal and T1 weighted sagittal sequences for 1.5 T and 3 T MRI respectively.

and recorded in millimeters (mm) on the T1w sagittal and PDw coronal planes (Figure 2). In addition, two independent radiologists with 4 and 5 years of experience semi-quantitatively ranked other artifacts (such as signal distortions or pile-up artifacts) generated by the screws using a five-point Likert scale (1 = no artifacts, 2 = minimal artifacts, 3 = considerable artifacts, 4 = artifacts impairing diagnostic validity, 5 = no interpretation of surrounding tissue possible). In case of follow-up MRI, readers were encouraged to compare the artifacts in one patient over time. An additional qualitative evaluation included the assessment of common postoperative changes, such as bone marrow edema (BME), changes in the surrounding tissue or depictability of the directly adjacent anatomical structures.

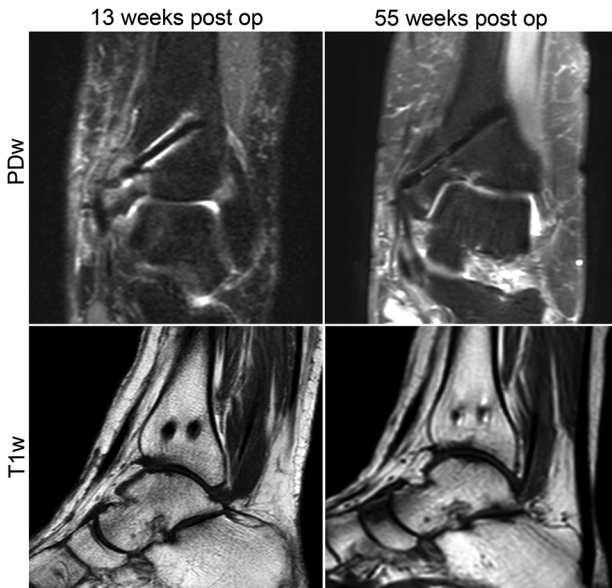
Figure 4: Artifact extent in one patient at two different time points is shown for proton density (PDw) and T1 weight sequences. After 55 weeks (right side) the extent of the artifact is reduced compared to 13 weeks postoperatively (left side).

Figure 3 shows selected measurement results of the patients with two ($n=6$) and three ($n=2$) follow-up MRIs at different time points given in weeks for the dorsal and ventral screws in PDw and T1w images, respectively. In these patients the artifact decreased significantly by 0.058 mm (95% confidence interval [CI] 0.049–0.072; $p<0.001$) in PDw and by 0.036 mm (95% CI 0.030–0.047; $p<0.001$) in T1w per week. Figure 4 illustrates the decrease of artifact extent in one patient 13 weeks and 55 weeks postoperatively.

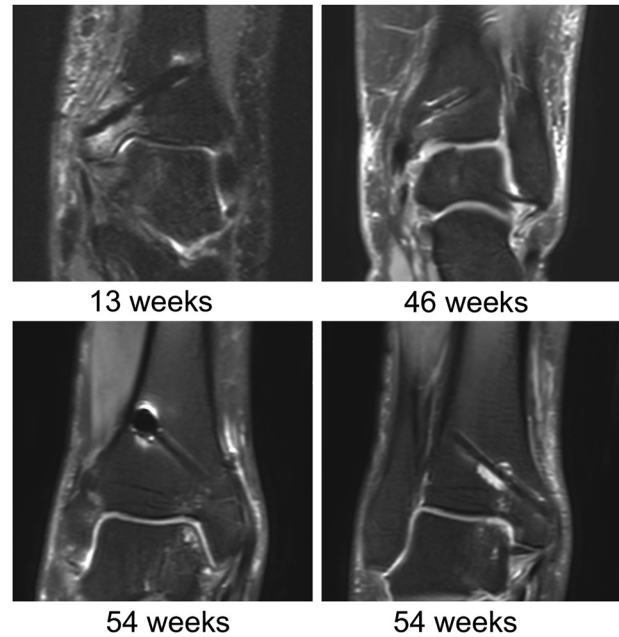
Figure 5: Examples of MRI findings in proton density weighted (PDw) sequences for different time points and patients: bone marrow edema in the medial malleolus (13 weeks postoperatively), visibility of a hyperintense line in the screw center (46 weeks postoperatively), gas accumulation at the screw tip (54 weeks postoperatively), and liquid collection around the screw (54 weeks postoperatively).

$p=0.008$) from the first postoperative MRI to the follow-up controls. Both readers reported different findings without any certain time dependency on the postoperative time interval. Table 4 gives an overview of the reported findings. Figure 5 visualizes some important findings in different patients.
