Case report

Catastrophic Failure of the Tibial Component After Total Knee Arthroplasty: Fracture and Dissociation Between the Baseplate and Stem

Christopher A. Worgul, MD^{*}, Brandon Lentine, MD, Quinten G. Dicken, BA, David M. Freccero, MD

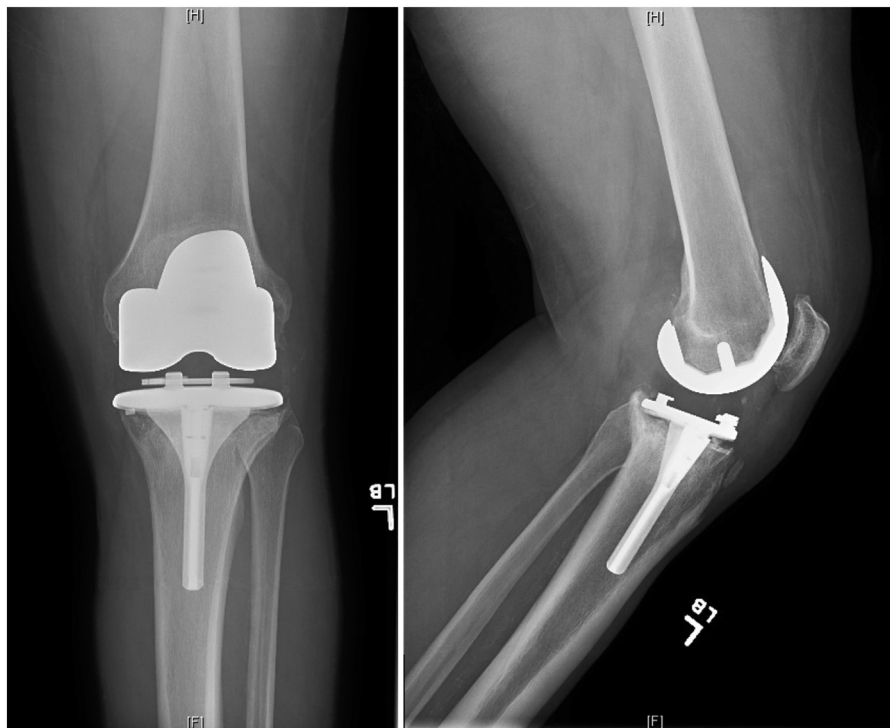
Figure 1. Preoperative radiographs. Anteroposterior radiograph (a) of the left knee demonstrating lucency at the bone–cement interface of the proximal tibia medially and laterally concerning for loosening of the tibial prosthesis. Lateral radiograph (b) shows subtle asymmetry between the tibial baseplate and stem, but no overt evidence of catastrophic failure of the tibial component.

While most reports in the literature describe a fracture of the tibial component occurring at or around the baseplate, a fracture at the stem and baseplate junction of the prosthesis has been infrequently described. Although the preoperative radiographs demonstrated findings consistent with osteolysis and a subtle asymmetry between the tibial baseplate and the stem on the lateral radiograph, no overt signs of gross catastrophic failure of the tibial prosthesis were apparent. It was not until the time of revision surgery that the tibial component was found to be fractured, with the tibial baseplate and polyethylene completely dissociated from the intact stem distally. Delayed diagnosis can often be a contributing factor to poor outcomes since bone loss can continue to occur from the altered loading environment of the knee with implant fracture, if it is not readily identified and expeditiously revised [4]. This highlights the importance for clinicians to maintain a high index of suspicion for potential implant failure if there are findings consistent with implant subsidence or asymmetry between the individual components of the prosthesis.

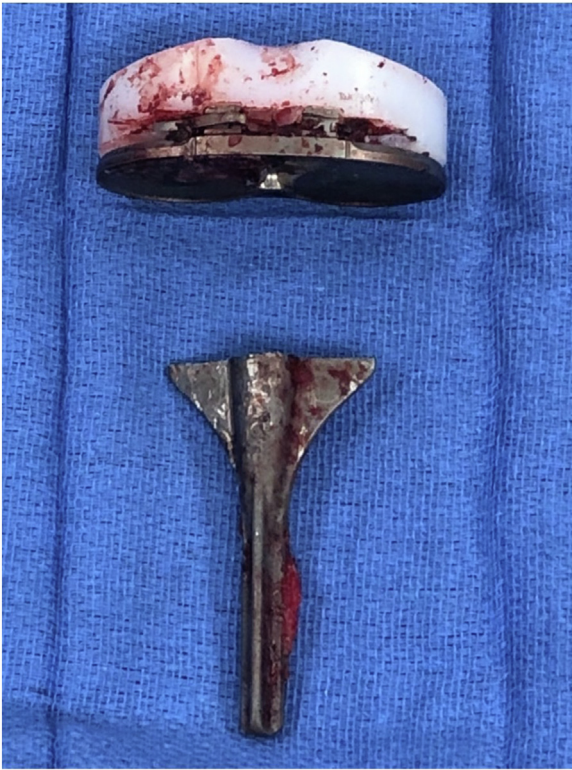
Figure 2. Catastrophic failure of the component. Intraoperative photograph demonstrating fracture and catastrophic failure of the tibial component. The tibial baseplate and well-fixed polyethylene were completely dissociated from the stem portion of the tibial component.

The patient was taken to the operating room, and a medial parapatellar arthrotomy was performed. There was extensive metal debris and pigmented tissue in the suprapatellar pouch and along the medial and lateral gutters. The tibial component was found to have a clear fracture at the stem and baseplate junction, with disassociation between the tibial baseplate and

stem (Fig. 2). The polyethylene was well-fixed and locked into the tibial baseplate, and the baseplate with the locked polyethylene had become loose and separated from the proximal tibia. There was also gross loosening of the femoral component noted intraoperatively as well. Removal of the femoral and tibial components was performed with minimal bone loss. The retained stem portion of the tibial component was extracted using a motorized bur and a combination of rigid and flexible osteotomes. A press-fit condylar Sigma TC3 Knee System (DePuy Synthes/Johnson & Johnson, Warsaw, IN) was implanted, consisting of a size-4 femoral component with a 31-mm sleeve and a 16 × 115-mm stem. The tibial component was a size-3 mobile bearing tibia with a 45-mm sleeve and a 14 × 75-mm stem (DePuy Synthes/Johnson & Johnson). The polyethylene insert was a Gamma Vacuum Foil 10-mm thickness rotating platform TC3 size-4 insert (DePuy Synthes/Johnson & Johnson). The patella was resurfaced with a 38-mm patella button. All components were inserted without complication, and the patient was made weight-bearing as tolerated after the procedure. Immediate postoperative radiographs demonstrated appropriately positioned components (Fig. 3). He was discharged without issue on postoperative day 3 after working with physical therapy.

The etiology of tibial component failure in our patient is likely multifactorial, which is consistent with the modes of failure suggested throughout the literature. Our patient was obese with a BMI of 34 kg/m², which placed increased contact forces through the prosthesis and may have contributed to subsidence at the bone-cement interface between the tibial baseplate and his native bone. This subsidence, when combined with a relatively well-fixed

stem component, likely led to fatigue wear at the baseplate and stem junction, thus propagating the eventual implant's catastrophic failure.

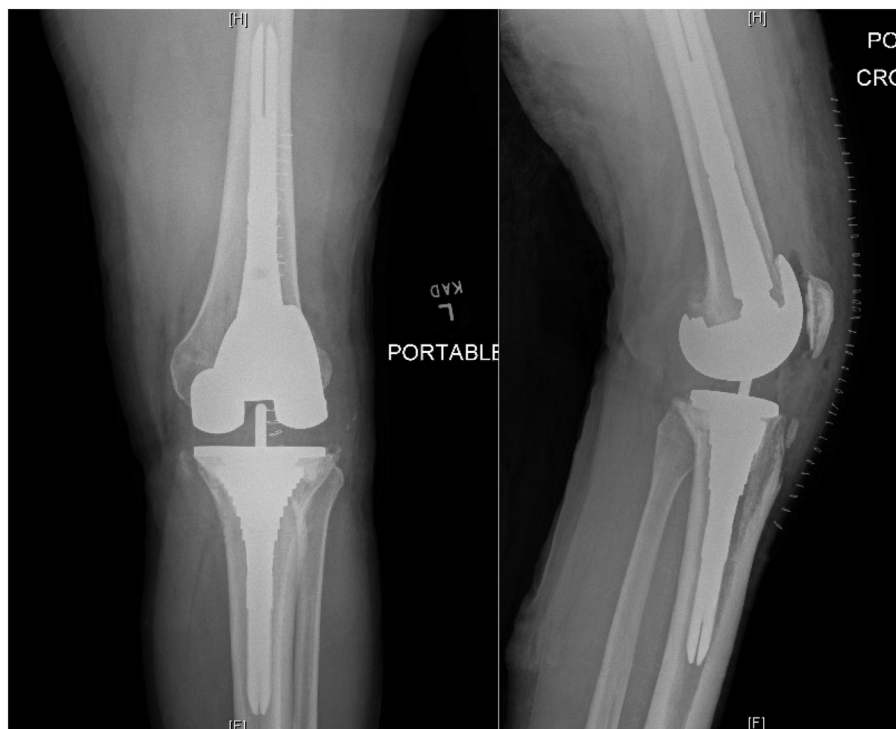
Figure 3. Immediate postoperative radiographs. Postoperative anteroposterior (a) and lateral (b) radiographs.

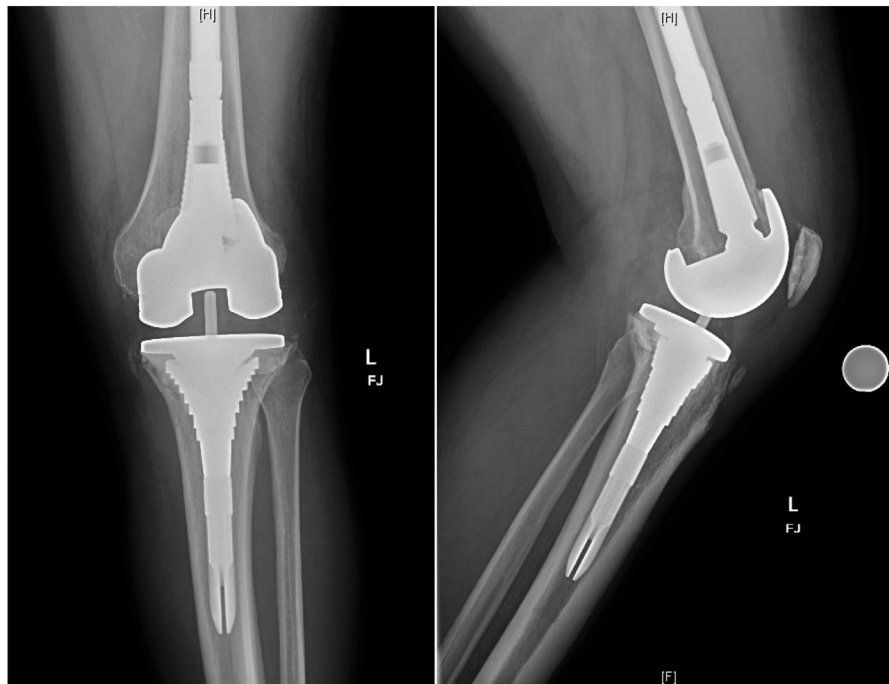
Figure 4. Radiographs at follow-up. Anteroposterior (a) and lateral (b) radiographs demonstrating well-fixed components in appropriate alignment.

The patient was seen in clinic 2 weeks after the revision surgery for staple removal, at which time he reported substantial relief from his pain and no difficulty with ambulation. At the time of his final follow-up appointment at 18 months, examination revealed a well-healed incision with active knee range of motion from 0 to 120° without pain. Radiographs revealed well-fixed components in appropriate alignment (Fig. 4).
