Move the anesthesia workstation cautiously!

Inadvertent damage to lines and cords during repositioning of anesthesia workstation after a patient is anesthetized can occur due to carelessness. However, damage to the blood pressure tubing or the sample line tubing of capnograph can affect the anesthesia monitoring significantly. We present a case of erroneous drop in end tidal carbon dioxide level due to damage of the sampling tube during general anesthesia.

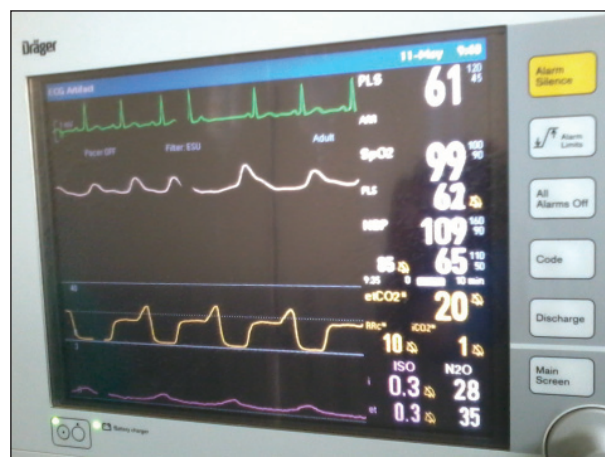
Figure 1: Dual waveform capnogram showing an EtCO₂ level of 20 mm of Hg

Suddenly it was noticed that the capnogram had changed into a dual waveform [Figure 1]. The EtCO₂ level had also dropped from 34 mmHg to 20 mmHg, the inspiratory and end tidal values of isoflurane changed from 0.5% and 0.4%

respectively to 0.3% and 0.3% and that of nitrous oxide from 54% and 53% to 28% and 35% respectively. There was, however, no change in oxygen saturation or hemodynamic parameters. Chest auscultation was again performed to ensure bilateral equal air entry. Integrity of the sample line right from the sidestream connector was checked that revealed a damaged sample line. The sample line was immediately replaced with a fresh one and the EtCO₂ value returned to the baseline. The capnogram now displayed a normal waveform. Surgery and anesthesia continued and terminated uneventfully.

Important causes for a dual wave form capnogram include mechanical factors like sampling leaks, loose connection between sampling tubes and the monitor, and breaks in the water filter of the carbondioxide analyzer. Pathological causes include severe kyphoscoliosis and differential emptying of the lungs.^[1] Physiological condition like pregnancy and obesity can cause an upswing at the end of Phase III.^[2] Iatrogenic causes include endobronchial intubation, which was ruled out in our case.

Mechanics of change in capnogram with a "tail-up" due to damage to the sample line has been investigated by Tripathi and Pandey.^[3] During IPPV, pressure in the breathing circuit is lower during exhalation, allowing air to enter through the hole in the sampling tube causing a low EtCO₂. The authors hypothesized that with inspiration, the positive pressure in the breathing circuit, transmitted to the sampling tube, prevents air admixture and the upsurge in carbon dioxide that is being displayed, giving the capnograph a "tailsup" appearance.

Isolated drop in EtCO₂ value might have confused us about the possible cause of this change. Typical change in the waveform prompted us to search for a leak. During movement of the workstation, the sample line dangling on the floor was crushed inadvertently as the capnogram was normal before

this. Immediately the waveform changed and the level of inhalational agents and EtCO₂ went down. These changes were reproducible by changing the new sample line with the damaged one.

Extreme precaution during movement of the work station is needed to avoid such occurrences as a sudden decrease in EtCO₂ value can lead to confusion especially during procedures like neurosurgery or where carbon dioxide is used as insufflation gas.
