Malposition of Central Venous Catheter: Presentation and Management

Lin Wang, Zhang-Suo Liu, Chang-An Wang

Department of Nephropathy, The First Affiliated Hospital, Zhengzhou University, Zhengzhou, Henan 450052, China

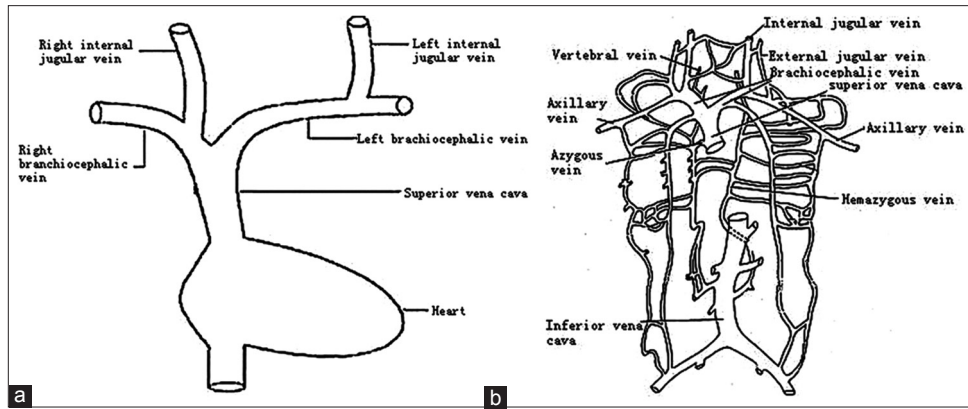
Figure 1: (a) The trunk of the superior vena cava system. It shows that left internal jugular vein negotiates two 90° turns. (b) Tributaries of the superior vena cava system. It shows that the superior vena cava drains venous blood from the upper half of the body in which there would be variable and complicated considerably.

the procedure. The branches and tributaries of SVC system are shown in Figure 1a and 1b.^[6] Physicians often prefer cannulation of the right IJV, the second best for the left IJV, to establish central venous access since it provides a more direct path to SVC.^[6] SVC lies in close anatomical proximity to the mediastinal pleura in the upper thorax.^[6,9] Perforation of the vein wall with a guidewire, dilator, or catheter may cause uncontrolled bleeding into the low-pressure pleural space. The left brachiocephalic vein receives lymph from the thoracic duct [Figure 2]. If the guidewire goes into the orifice of the duct, the catheter is advanced through the wire directly into the thoracic duct.^[6,10] A persistent left-sided SVC (PLSVC), including duplicate SVC, may occur in up to 2.1% of the general population.^[6,11] The left SVC usually drains into the right atrium via the coronary sinus.^[12,13]

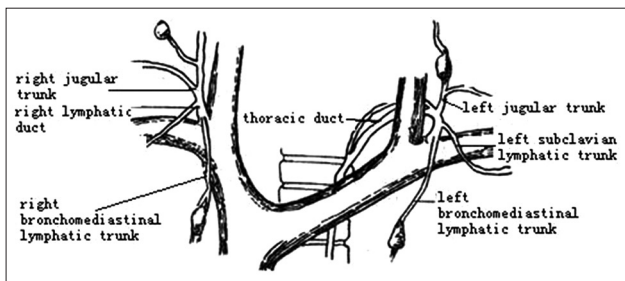
Figure 2: A anatomic illustration of the jugular lymphatic trunk. It indicates that the thoracic duct is medial close to the internal jugular vein in front of the internal jugular vein.

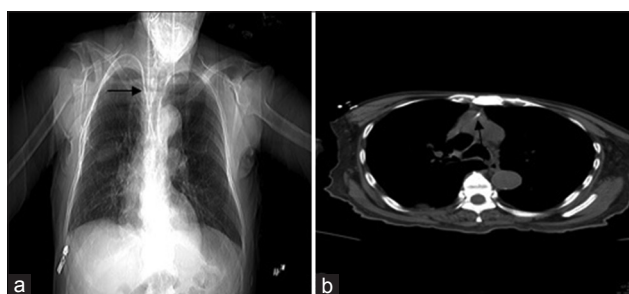
Figure 3: Catheter misplacement to intra-artery. (a) Chest film shows the tip of the catheter passing close to the aortic arch (arrow). (b) Further imaging indicates the tip of the catheter lying in the position of the arterial system (arrow).

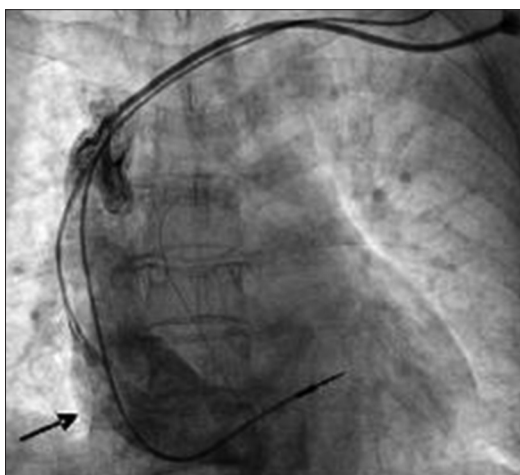
Figure 4: Chest film shows that the guide wire enters to azygos veins system through the left internal jugular vein during catheterization (arrow).

a common trunk with the left superior intercostals vein into the left brachiocephalic vein.^[7] The frequency of accidental azygos vein cannulation during a central venous access through IJV is 0.7–1.2%.^[18] When misplacement to azygos veins, the insertion goes smoothly during the operation but afterward, blood cannot be aspirated from the catheter. It shows that the guidewire enters to azygos veins system

through the left IJV during catheterization [Figure 4]. Complications of the misplacement include pleural effusion, pulmonary edema, chest wall abscess, dyspnea, chest pain, back pain, and cardiac tamponade depending on the site of the catheter. The catheter will be pulled and repositioned under radiological guidance after confirmation.^[30] Contrast-enhanced CT, magnetic resonance imaging studies, and venography alone or in combination will provide definitive information about the location of the catheter.

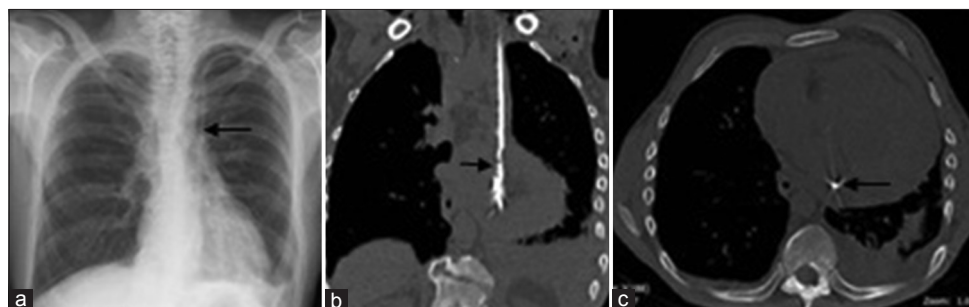
Figure 5: Catheter misplacement to the persistent left-sided SVC.^[32] (a) The chest X-ray demonstrates that dialysis catheter passes down the left side of the mediastinum with pleural effusion and subcutaneous emphysema over the left clavicle (arrow). (b) Computed tomography chest demonstrates the catheter in the persistent left-sided SVC, pericardial and pleural effusion from coronal view (arrow). (c) The arrow indicates the catheter in the persistent left-sided SVC from conventional view. SVC: Superior vena cava.

the dialysis catheter when indwelling in PLSVC. A routine postline insertion chest X-ray is performed [Figure 5a].^[32] The chest X-ray showed that the dialysis catheter is passing down the left side of the mediastinum rather than crossing the midline via the brachiocephalic vein to enter SVC on the right-side. The CT examinations show that the patient has a PLSVC, and the dialysis catheter tip is in the distal part of the left-sided SVC [Figure 5b and 5c].^[32] Misplacement to the vein will bring out serious complications such as pericardial and pleural effusion. Once the misplacement happens, the catheter needs to be removed by cardiothoracic surgeon.^[30]

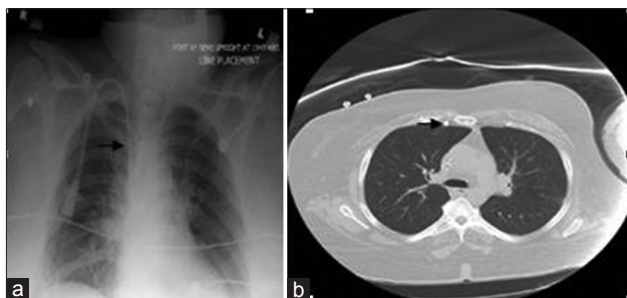
Figure 6: Catheter misplacement to the right internal mammary vein.^[33] (a) Chest X-ray: Anterior-posterior demonstrating what appears to be good position of catheter in the superior vena cava. (b) Computed tomography (axial image): Catheter malposition to the right of the sternum.

the catheter descends in the region of the mediastinum and places in the internal mammary vein [Figure 6a and 6b].^[33] The catheter should be removed under radiographic monitor with the moderate force.

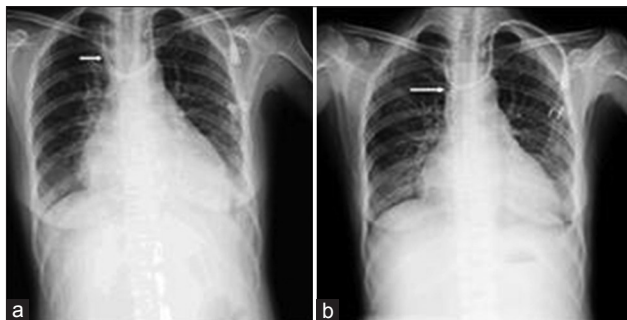
Figure 8: The misplacement of a left internal jugular vein catheter. (a) The chest film shows both of lumens' inadvertent insertion into the right internal jugular vein (arrow). (b) The chest film shows one of lumen dwelling into the right internal jugular vein (arrow).

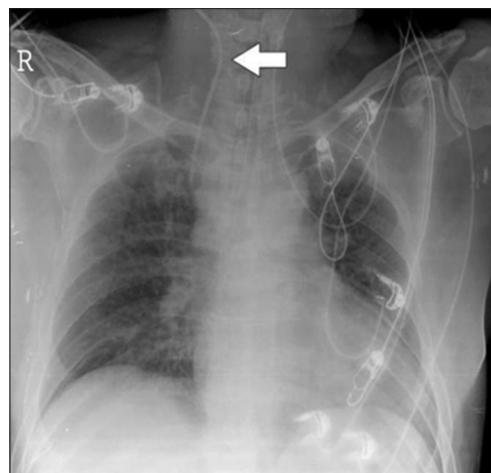
Figure 7: Catheter misplacement to the vertebral vein.^[37] Chest X-ray shows that the central venous catheter passes the transverse processes of the 6th and the 7th cervical vertebrae (arrow).

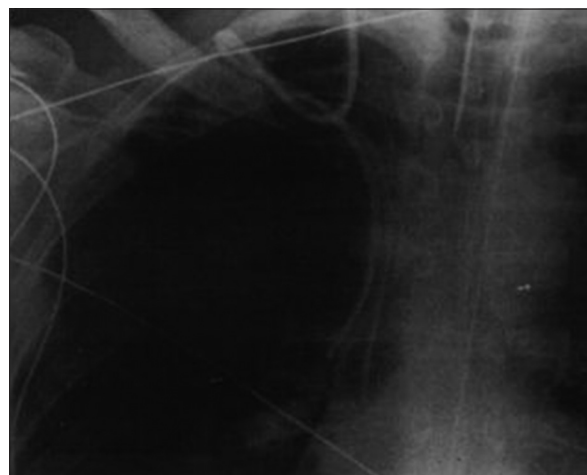
Figure 9: Catheter misplacement to the subclavian vein.^[39] Chest radiograph shows that the catheter is inserted via the right internal jugular vein and loops in the subclavian vein.

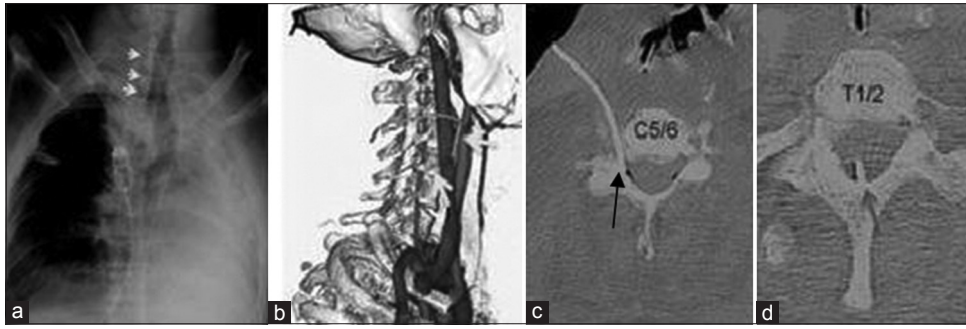
Figure 10: Catheter misplacement to the extradural space.^[41] Cervical computed tomography scans demonstrate that the central venous catheter has penetrated the posterior aspect of the internal jugular vein. (a) Chest radiograph reveals that the tip of the central venous line (arrows) runs inside the normal route of the internal jugular vein and appears to overlap with the cervical spine (arrows). (b) The cervical computed tomography scan demonstrates that the catheter travels posterior to the carotid artery (arrows). (c) The cervical computed tomography scan shows that the catheter penetrates the prevertebral fascia (arrow). (d) The image indicates that the catheter enters the intervertebral foramen (arrow).

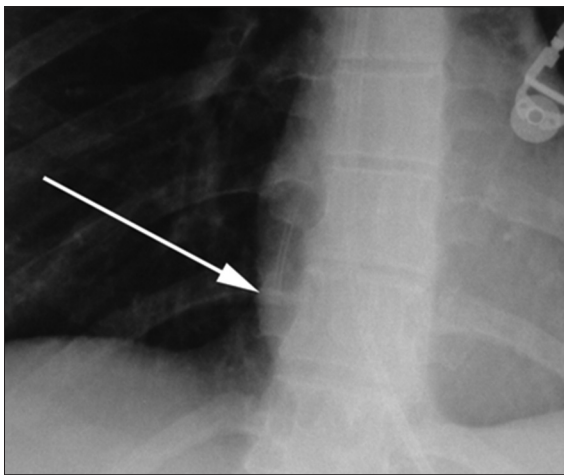
Figure 11: Catheter misplacement to the pericardium.^[6] Chest radiograph reveals that the tip of the catheter is seen to lie within the right atrium (arrow).

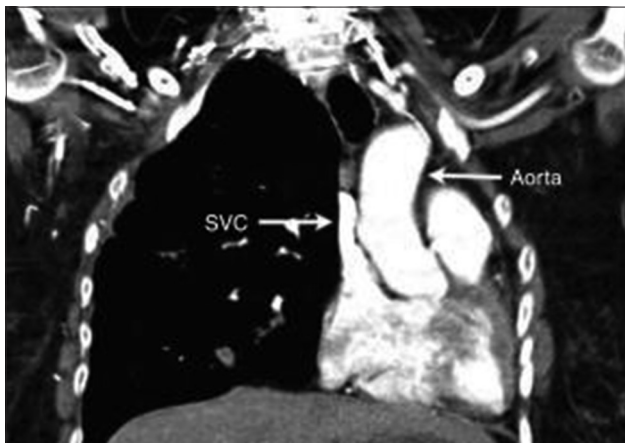
Figure 13: Catheter misplacement to the mediastinum.^[6] The computed tomography image shows the mediastinum grows for the huge hematoma. SVC: Superior vena cava.

A CVC may perforate through a vessel wall entering the mediastinum. There is a particular risk if excessive force has been used to advance the guidewire, dilator, or catheter. It shows an example of a CVC passing into the mediastinum

as confirmed with contrast injection [Figure 13].^[6] Infusion of pressurized fluid through such an opening will lead to extravasation with a risk of swelling, compression of mediastinal or neck structures, or tissue necrosis.^[31] During next insertion after the catheter's extraction, it is as well under the real-time screening or other aids.^[43]

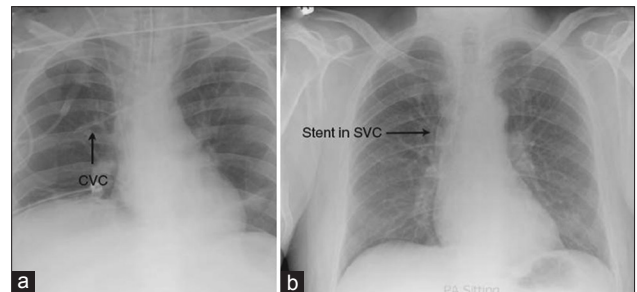
Figure 12: Catheter misplacement to the pleural space.^[6] (a) The left-sided dialysis catheter has perforated through the right wall of SVC, and the tip has entered the right pleural space (arrow). (b) The left-sided dialysis catheter has perforated through the right wall of SVC and kink in the right pleural space (arrow). CVC: Central venous catheter; SVC: Superior vena cava.

Figure 12a and 12b,^[6] left-sided dialysis catheter has perforated through the right wall of SVC and entered the pleural space.^[6] If the catheter tip lies in the pleural cavity, hemothorax or pleural effusions may result from the infusion of blood or fluids through the catheter. It is

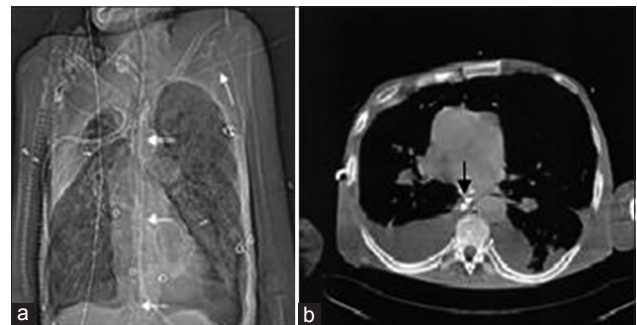
Figure 14: Catheter misplacement to the thoracic duct.^[44] (a) Scout view of the chest computed tomography shows the guidewire (arrows) takes a straight craniocaudal course projecting on the vertebral column reaching caudal to the diaphragm. (b) Computed tomography cross-sectional image at the level of the middle mediastinum. The guidewire (arrow) can be seen in a prevertebral position adjacent to the descending aorta and posterior to the esophagus.
