# Retrieval analysis of alumina ceramic-on-ceramic bearing couples

**Background and purpose** — Ceramic-on-ceramic (CoC) bearings have been in use in total hip replacement (THR) for more than 40 years, with excellent long-term survivorship. Although there have been several simulator studies describing the performance of these joints, there have only been a few retrieval analyses. The aim of this study was to investigate the wear patterns, the surface properties, and friction and lubrication regimes of explanted first-generation alumina bearings.

**Materials and methods** — We studied 9 explanted CoC bearings from Autophor THRs that were revised for aseptic loosening after a mean of 16 (range 7–19) years. The 3D surface roughness profiles of the femoral heads and acetabular cups (Srms, Sa, and Ssk) were measured to determine the microscopic wear. The bearings were imaged using an atomic-force microscope in contact mode, to produce a topographical map of the surfaces of the femoral heads. Friction tests were performed on the bearing couples to determine the lubrication regime under which they were operating during the walking cycle. The diametral clearances were also measured.

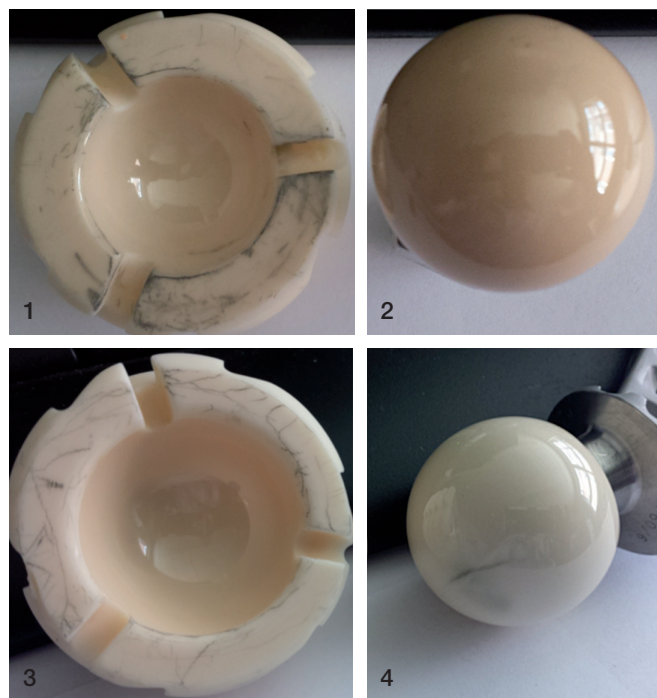
Figure 1. Typical bearings illustrating minimal wear at the cup periphery (1), minimal wear on the femoral head (2), minimal wear at the center of the cup and rim wear peripherally (3), and stripe wear on the femoral head (4).

3 femoral heads showed stripe wear and the remaining 6 bearings showed varying degrees of roughened or darkened areas. 2 of the 3 acetabular components of the bearings with stripe wear showed evidence of rim wear. However, there were minor scratches on the rim of most of the acetabular components, possibly resulting from retrieval of the bearings. There

are no accepted ways of describing wear patterns on retrieved bearings. We described the wear as being predominantly central or peripheral (Figure 1).

After a mean of 16 years in vivo, only 33% (3/9) of the femoral heads showed evidence of stripe wear and 2 of 3 of the matching acetabular cups showed rim wear, suggesting that edge loading may have been a mechanism of stripe wear. The other bearings showed minimal wear, with areas of darkening and roughening only.

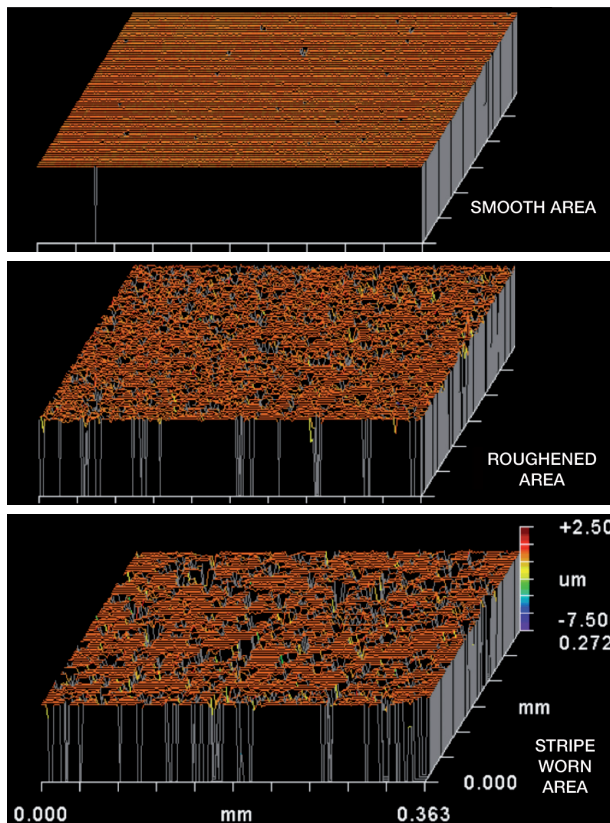
Figure 2. Surface topography of femoral head on smooth (top panel), roughened (middle panel), and stripe-worn areas (bottom panel). The graphs have the same scales on the x- and y-axis as the graph at the bottom with stripe wear.

Surface topography of the femoral heads and acetabular cups showed that the unworn areas had a very smooth surface, but the roughened and areas with stripe wear had more peaks and troughs, as shown in Figure 2.

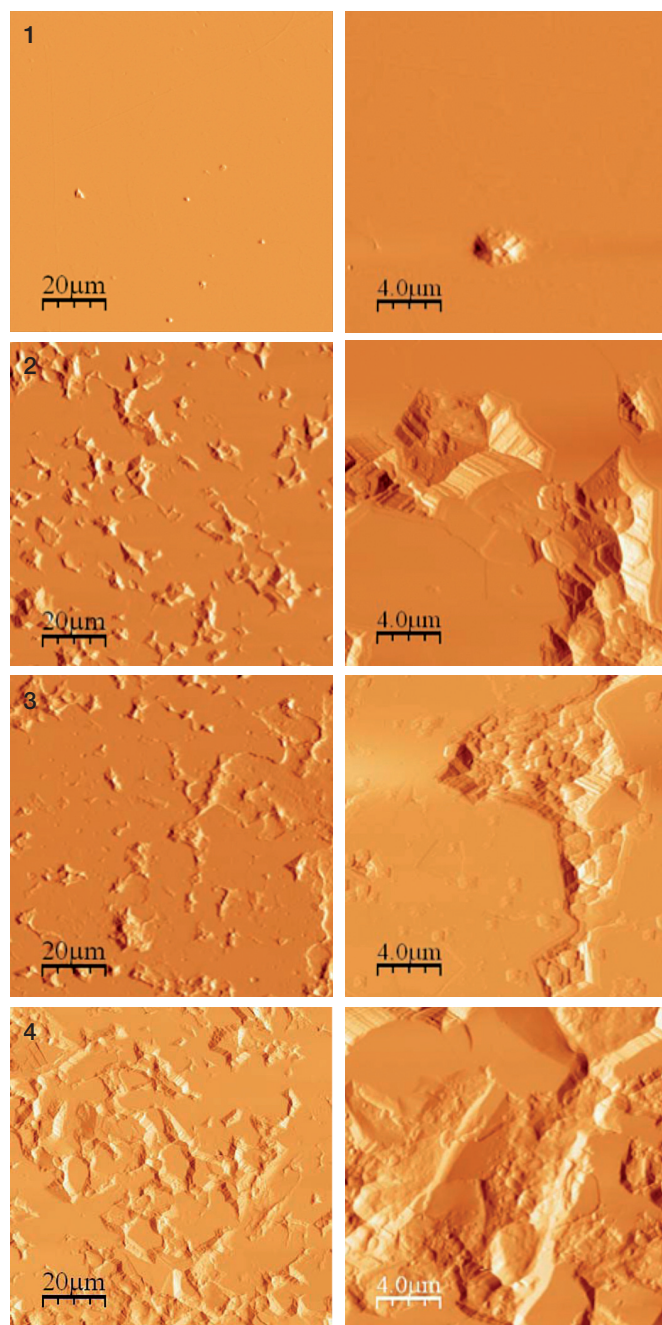
Figure 3. Atomic-force microscope images of smooth areas (1), darkened areas (2), roughened areas (3), and stripe-worn areas (4) of femoral heads, all at 2 magnifications.

Six femoral heads (bearings MF, DD, JF, DAS, RL, and JL) were also imaged using the AFM. Images were taken of the smooth areas, darkened areas, rough areas, and areas with stripe wear. The increasing severity of wear on the bearings is illustrated in Figure 3.

These images showed that the smooth areas were flat and even, displaying just a few incidences of granular pullout resulting in fewer and smaller pits. The majority of these pits were  $0.2\text{--}0.3 \mu\text{m}$  in depth and  $2 \mu\text{m}$  wide. The darkened, roughened areas and the areas showing stripe wear showed higher peaks and valleys with more substantial granular pullout, and also some material deposition. In the roughened areas, the pits were up to  $1 \mu\text{m}$  deep and  $10 \mu\text{m}$  wide. Areas of stripe wear showed pits measuring  $1 \mu\text{m}$  deep and  $15 \mu\text{m}$  wide.

The surface topographical and AFM observations of these first-generation bearings suggest that the wear process is a continuum with the initially smooth bearings experiencing granular pullout, to produce roughened areas.

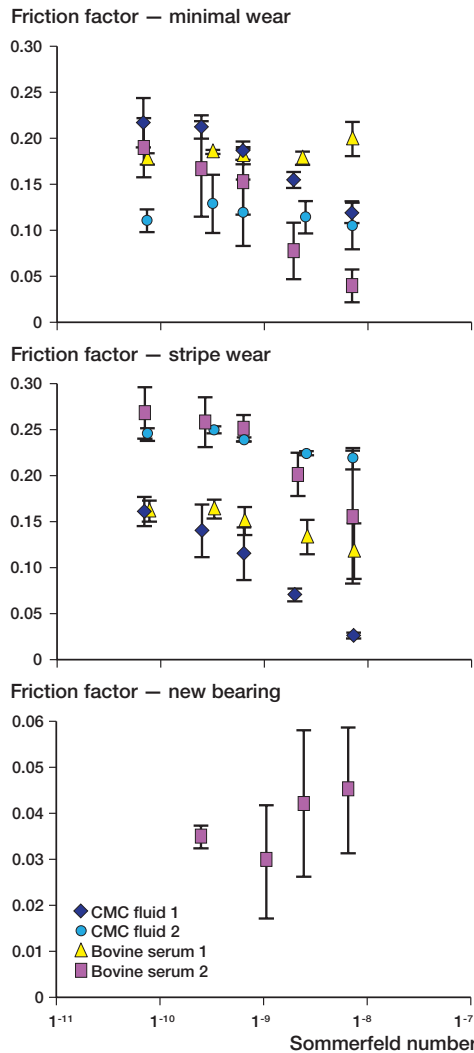
Figure 4. Stribeck plots of bearings with minimal wear and stripe wear, and of a newly manufactured bearing.

The lubrication regime was inferred from the Stribeck plots of bearing couples (Figure 3). The explanted joints tested operated in a mixed/boundary lubrication regime with a decreasing friction factor observed with increasing Sommerfeld number.

The damage apparent on the explanted joints created a far higher degree of friction, and these joints appeared to be working within mixed/boundary lubrication, resulting in considerable contact between the bearing surfaces. When bovine serum was used as the lubricant, it is likely that a protein layer formed on the bearing surfaces. When testing the joints as manufactured, Scholes and Unsworth (2006) discovered that this protein layer resulted in an increase in the friction factor developed because the protein adsorption disrupted the fluid film lubrication to give higher friction. In the current study, however, no fluid film lubrication was found, so this protein layer resulted in similar or lower friction since the shear stress of the proteins was lower than that of unlubricated ceramic. Thus, the damaged explanted joints produced similar or lower friction using bovine serum as the lubricant than when using CMC fluids, and this may have been due to protein-protein contact producing lower friction than ceramic-on-ceramic contact.
