The Effect of Pulling Out Cochlear Implant Electrodes on Inner Ear Microstructures: A Temporal Bone Study

Ingo Todt, Rainer O. Seidl, and Arne Ernst

Department of Otolaryngology, Unfallkrankenhaus Berlin, 12683 Berlin, Germany

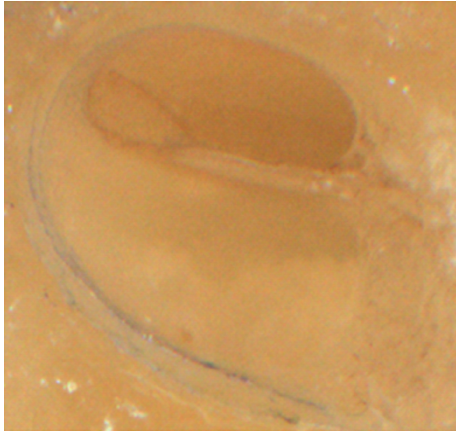
FIGURE 1: Scalaer overview. No sign of pull-out-related lesion.

3.1. Metacrylate Embedding of TB (Series A). The histological analysis of the cochlear microstructures revealed no major changes in all 5 TBs, particularly not at or around the modiolar wall (Figures 1 and 2). In one TBs, the basilar membrane was elevated up at the basal part of the scala tympani (Figure 2). However, neither a disruption of the basilar membrane was found, nor was a breakup of the osseous lamina spiralis. The lateral cochlear wall was also without changes (Figures 1 and 2). If this finding should be classified due to the so-called “intracochlear trauma scale” by Eshraghi et al. [1], one grade 1 trauma was found (Table 1).

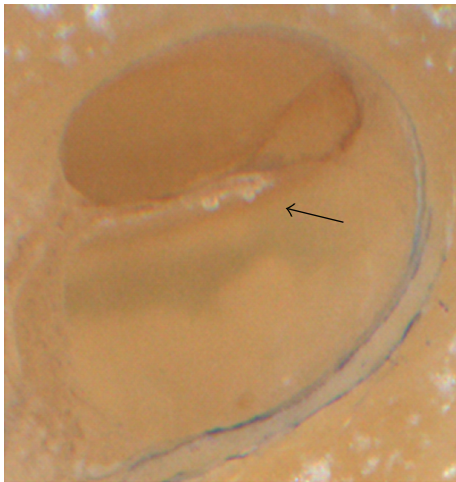
FIGURE 2: BM lifting. Bubble formation with tissue shearing under the BM as a sign of BM lifting.

Our present study suggests that the modern, perimodiolar electrodes only cause minor trauma to the cochlear microstructure. Apart from a lifted basilar membrane, no serious damage was found even when applying two different techniques as done in series A and B. The modiolus, which is very closely related to the electrode, remained unaffected.

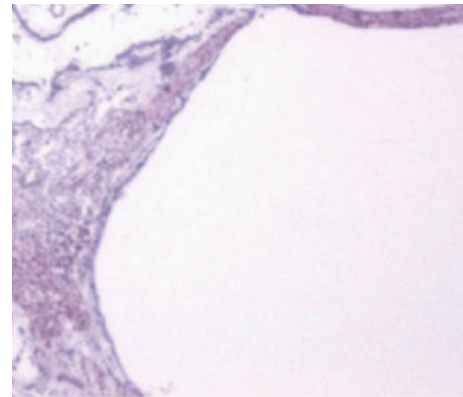
FIGURE 3: Exemplaric regular modiolar wall.

3.2. EDTA Staining of TB (Series B). The histological microanalysis revealed no microtraumatization of any intracochlear structure in any of the 5 TBs in series B (Figure 3) (see also Table 2).

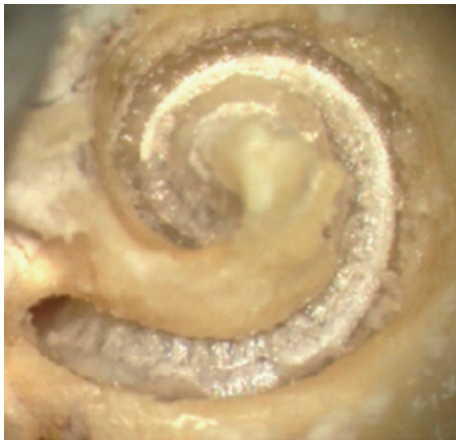
FIGURE 4: Cochlea with prepared basilar membrane before pull-out. CI array positioned under the BM.

3.3. Image Analysis of the Pull-Out Procedure. The analysis of the pull-out procedure showed in 1 out of 9 TBs that the electrode tip was tilted upwards by a 90° turning of the tip (Figures 4 and 5). When the pull-out was manually

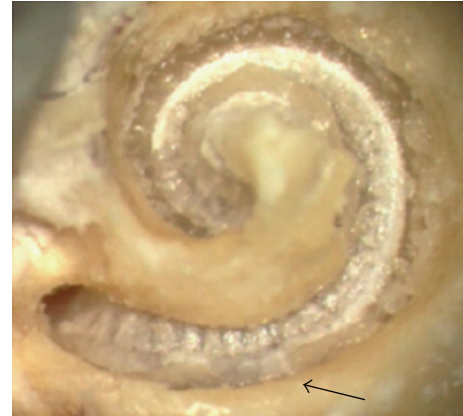
FIGURE 5: Cochlea with prepared basilar membrane while pulling out. Regional reflex change of the basilar membrane with the array tip underneath as sign of a BM elevation.

The only minor change after electrode extraction was found at the basilar membrane as related to an upward tilting of the electrode tip. However, we could not finally differentiate between an insertional or an extractional mechanism. The video analysis revealed the tip turning during the extraction of the array (Figures 4 and 5) but as outlined above, a gentle and guided pull-out of the electrode (e.g., with forceps) can prevent a lifting-up of the basilar membrane by a tilted electrode tip.
