Case report

Mechanically assisted crevice corrosion of the head-neck taper in a large head metal-on-metal total hip arthroplasty

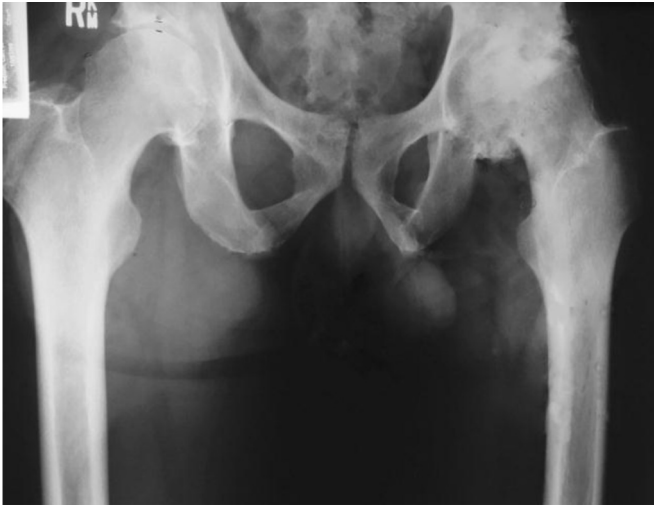
Figure 1. Pre-surgical anteroposterior pelvis radiograph showing arthritic left hip.

A 53 year old African American male (BMI 30, UCLA activity level 6) presented to the clinic with end stage osteoarthritis of the left hip (Fig. 1). He underwent an uncomplicated left total hip arthroplasty in November of 2009 using primary, cementless components with a MoM articular bearing surface (Summit [DePuy, Warsaw, IN] titanium alloy stem size 8 high offset with a 12/14 taper, a Pinnacle modular 62 mm cup with a neutral cobalt chrome liner, 44 mm cobalt-chrome head, +1.5 neck length). He had an uneventful inpatient post operative course and was discharged home on post operative day 2. The patient was seen at 2 weeks, 6 weeks, and one year without complications. X-rays were taken at each visit showing no change from post-operative x-rays (Fig. 2). The patient was instructed to followup yearly; however he did not show until his 3 year anniversary in December of 2012. He was without complication and x-rays were benign (Fig. 3).

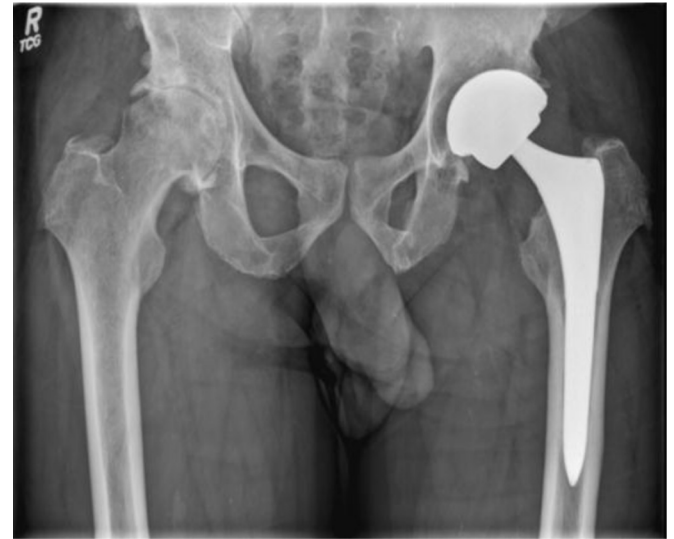
Figure 3. 3 year post-operative anteroposterior radiograph.

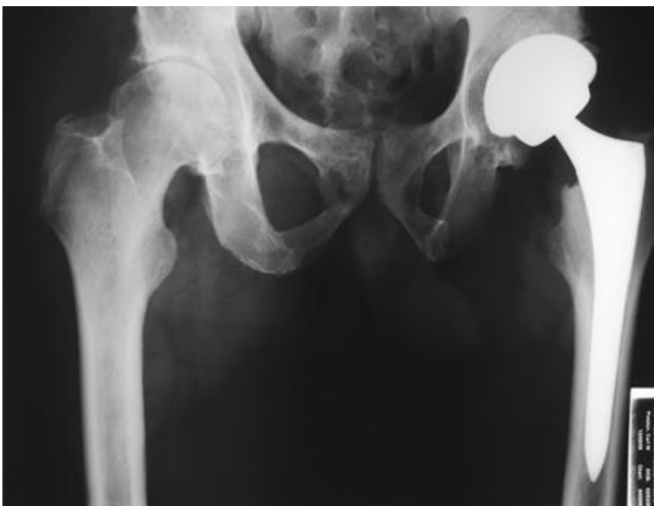
Figure 2. 2 week post-operative anteroposterior radiograph showing left MoM THA.

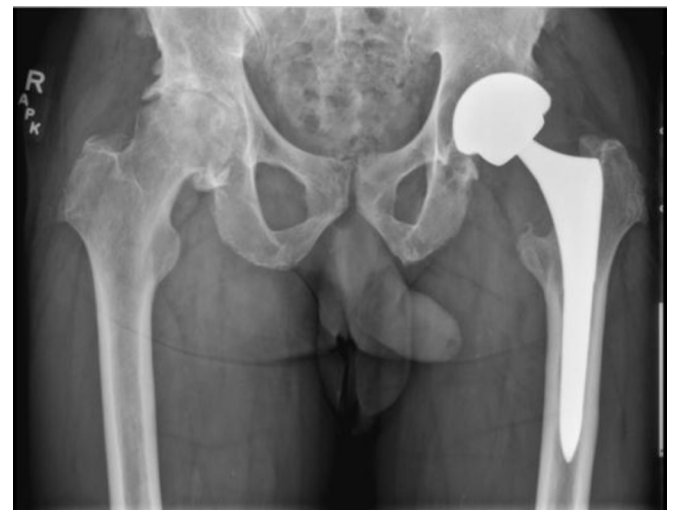
hip. X-rays at this visit did show extensive medial calcar erosion and what appeared to be soft tissue swelling around the prosthesis (Fig. 4). Diagnostic workup included a MARS MRI of the left hip which showed a large joint effusion with particulate debris, however no soft tissue mass was seen. The abductor complex appeared intact. Plasma Ion levels were collected showing a cobalt level of 2.0 ppb (normal 0.1–0.4 ppb) and a chromium level of 0.1 ppb (normal 0–1.4 ppb). Aspiration of the left hip was performed by a musculoskeletal radiologist, who was able to aspirate approximately 85 cc of brownish-black fluid (Fig. 5). Aerobic and anaerobic cultures of the hip aspirate were negative. Given the patient's x-ray, elevated serum cobalt level, and abnormal MRI, the decision was made to proceed with a revision of his left total hip arthroplasty due to increased calcar osteolysis with a MoM bearing surface.

Figure 4. 5 year post-operative anteroposterior radiograph showing extensive osteolysis of the medial calcar.

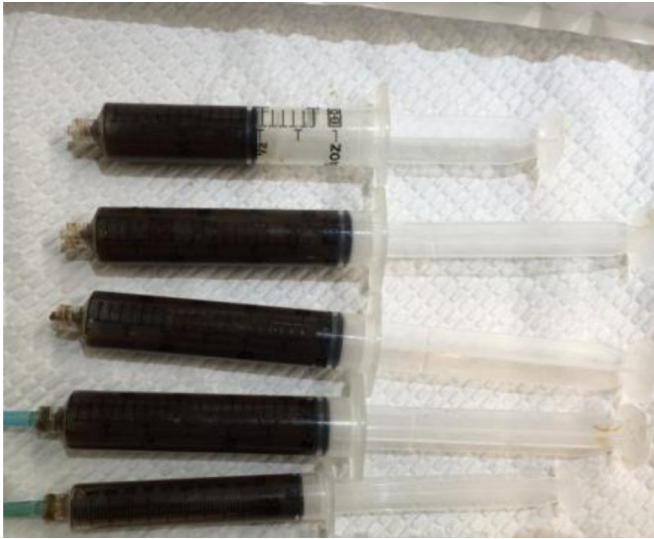
At the time of the revision surgery, a large amount of brownish-black fluid and inflamed synovium was encountered within the capsule. There was a moderate to large soft-tissue mass and some surrounding tissue damage noted around the implant. The pseudocapsule was hypertrophic, somewhat blackened, and avascular appearing. Pathology specimens showed areas of tissue necrosis consistent with ALTR. No frozen sections were obtained.

Figure 5. Photograph showing brown-tinged aspirate from the left hip.
