Case Report

Bilateral Femoral Component Fractures After Primary Total Knee Arthroplasty With Cruciate-Retaining Femoral Component

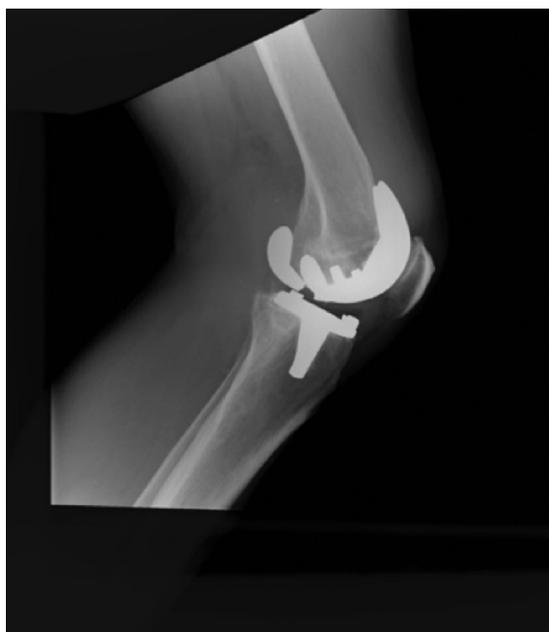
Figure 1. Radiographic right femoral component fracture. The right knee radiograph obtained after injury to the right knee 5 years ago. The lateral view demonstrates fracture of the right femoral component.

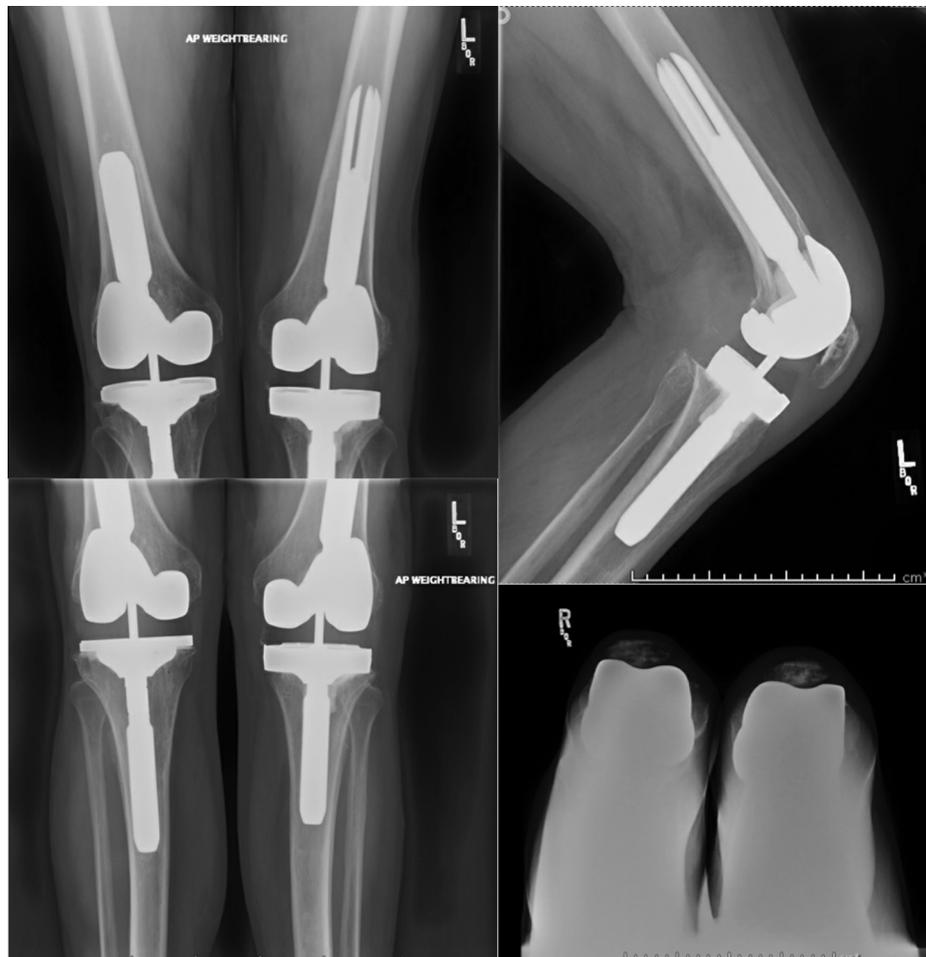
Figure 6. Radiographic revision knee prostheses. Multiple postoperative radiographs of the bilateral knees showing good alignment of the revision prostheses.
