Shaping Sustainable Urban Environments by Addressing the Hydro-Meteorological Factors in Landslide Occurrence: Ciuperca Hill (Oradea, Romania)

Abstract: Romania is one of the countries severely affected by numerous natural hazards, where landslides constitute a very common geomorphic hazard with strong economic and social impacts. The analyzed area, known as the “Ciuperca Hill”, is located in Oradea (NW part of Romania) and it has experienced a number of landsliding events in previous years, which have endangered anthropogenic systems. Our investigation, focused on the main causal factors, determined that landslide events have rather complex components, reflected in the joint climatological characteristics, properties of the geological substrate, and human activity that further contributed to the intensive change of landscape and acceleration of slope instability. Analysis of daily precipitation displays the occurrence and intensive distribution between May and September. Higher values of rainfall erosivity (observed for the 2014–2017 period), are occurring between April and August. Erosivity density follows this pattern and indicates high intensity events from April until October

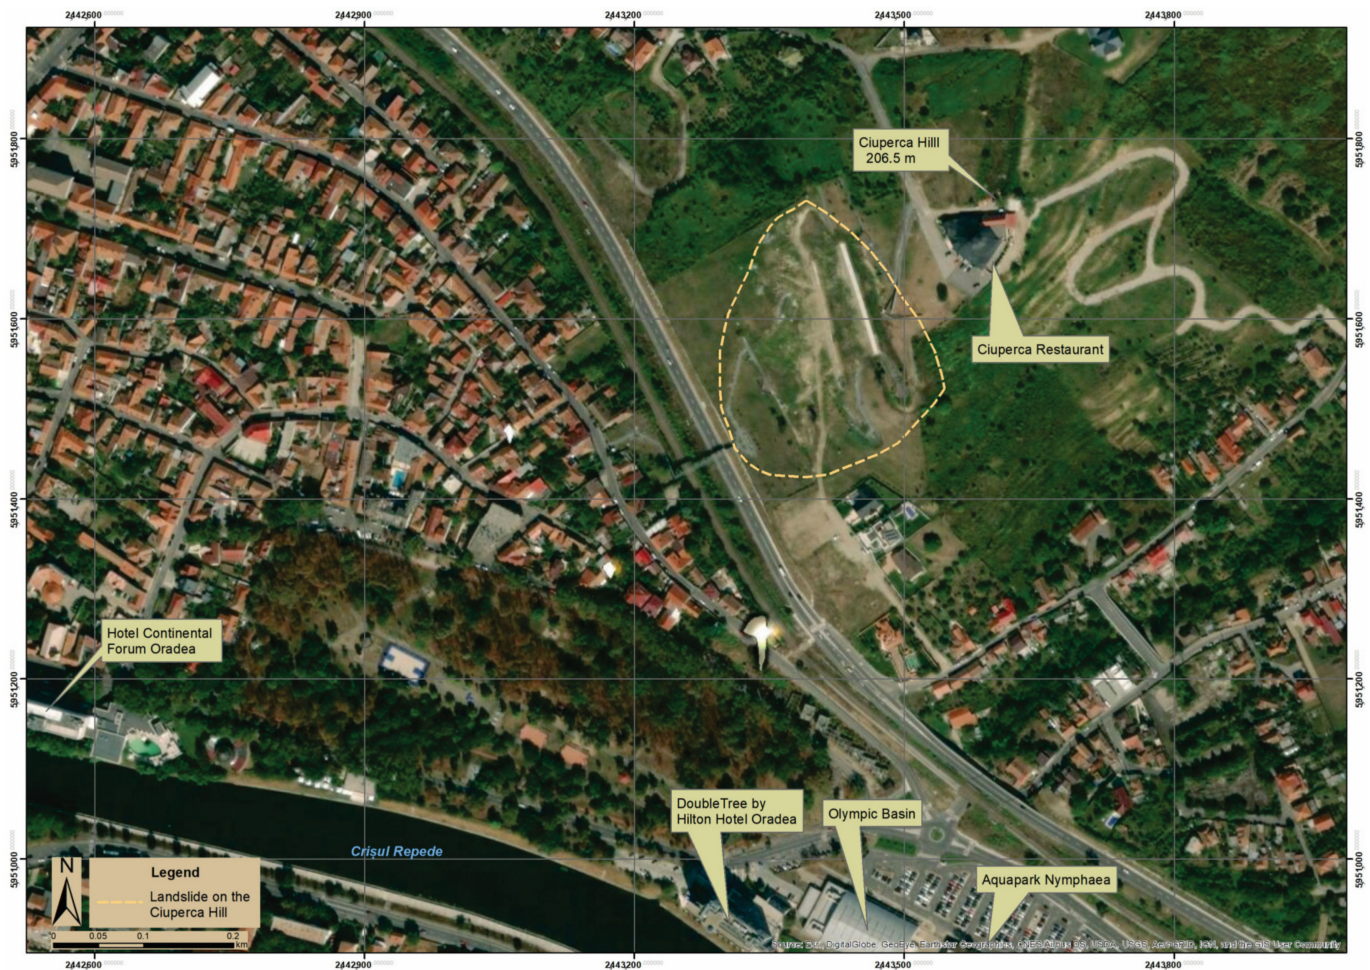
The study area is located in the city of Oradea and is known locally as Ciuperca Hill (elevation of 206.5 m) (Figure 3). It is the southwestern terminal part of the Oradieii Hills (component of the Western Hills of Romania). The hills are developed northeast of the city and look like long east–west oriented ridges. The neighboring plain area’s relief is displayed longitudinally, with higher altitudes (150–200 m) in the Pleistocene deposits of the eastern part and lower altitudes (80–120 m) in the Holocene deposits of the western part [39].

Figure 3. The Ciuperca Hill–Crișul Repede River Green Areas. Data source: modified after [40].

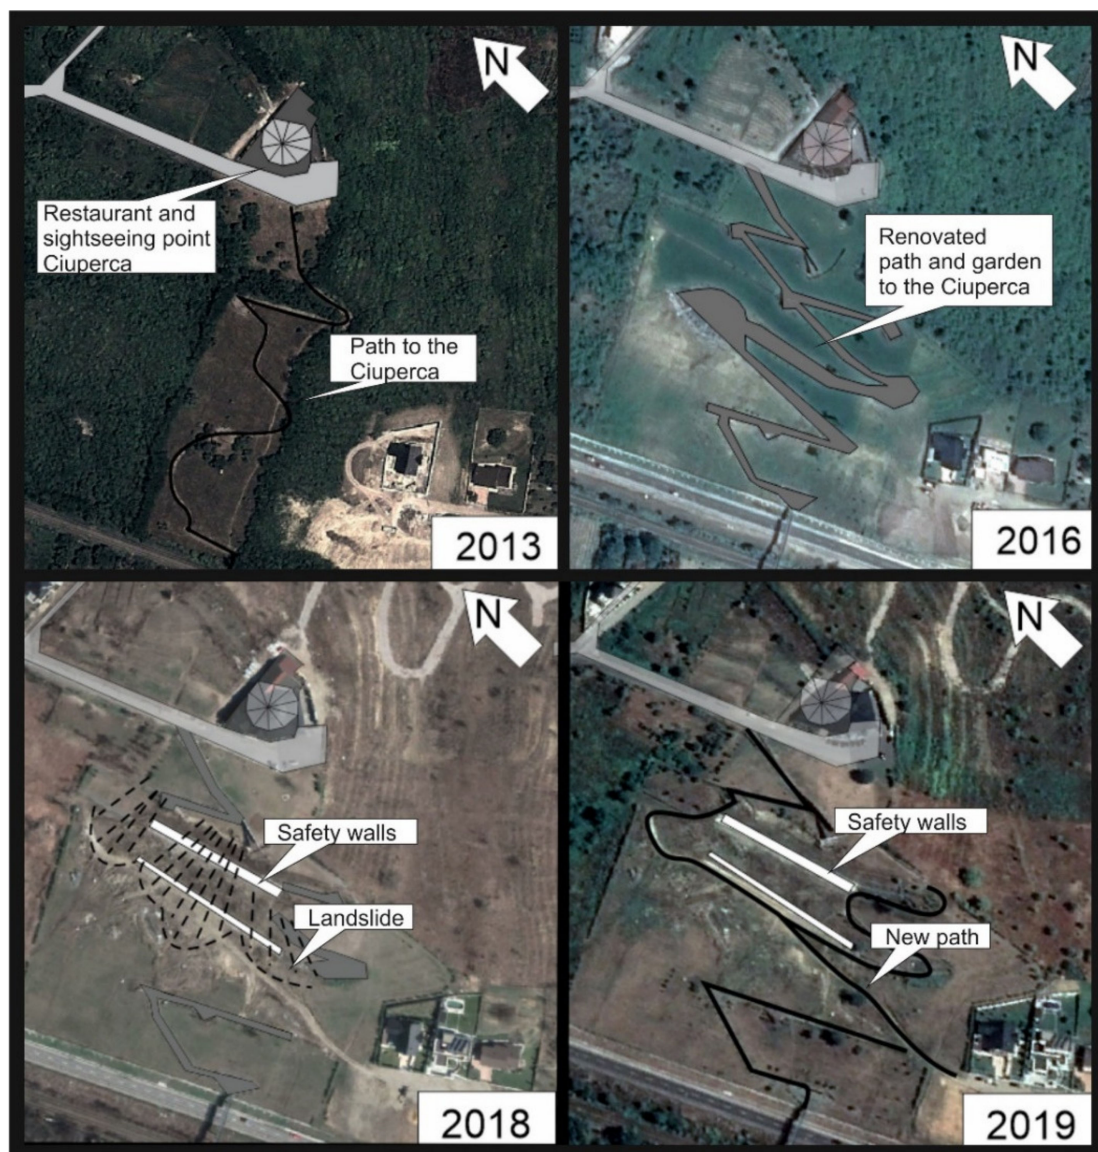
Between 12 and 13 of November 2016, the landslide area encompassed a surface of approximately 5300 m² on the recently rehabilitated Ciuperca Hill in Oradea (Figures 5 and 6). The 70 m landslide damaged the stone walls, the stairs, the promenade and paths, as well as water and electricity utilities and systems. The park became unusable, so the municipality of Oradea closed the hillside because of possible hazards (Figure 6). A specialist investigation was requested to determine the causes of the landslide. At the moment the landslide occurred (in November 2016), Ciuperca Hill had already been closed since the end of October 2016, as the Oradea City Hall urged the contractor to repair the works, after some parts of the trail split and cracked due to the unevenness of the soil. The repair costs were to be borne by the contractor, but the works were not undertaken before the landslide happened.

Figure 6. The evolution of the Ciuperca Hill landslide. Data source: modified after [40].

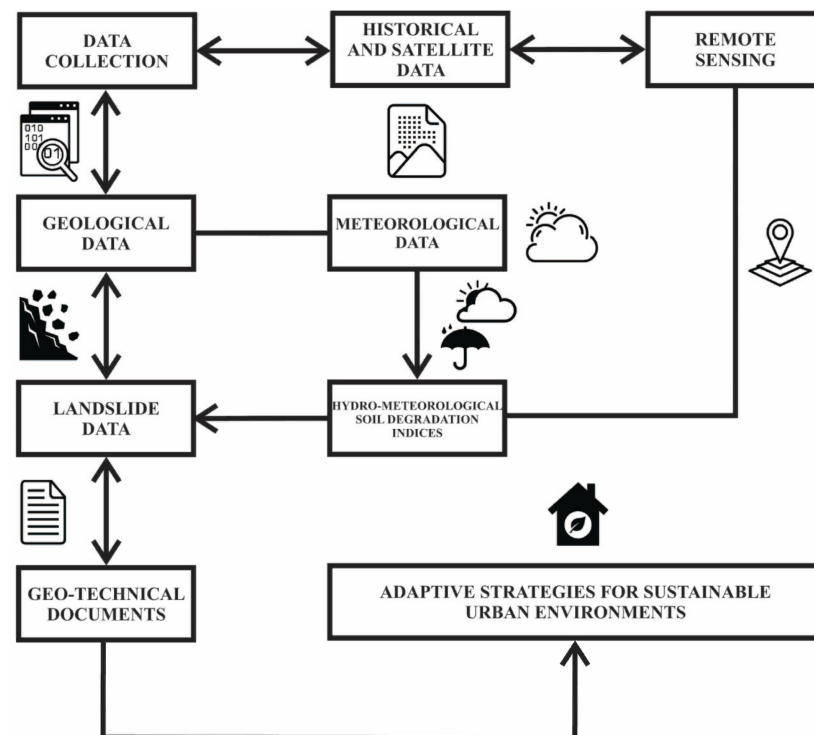
All the procedures and approaches used for the purpose of this research are presented in the following flow chart (Figure 7).

Figure 7. Flow chart of the procedures used in this research.

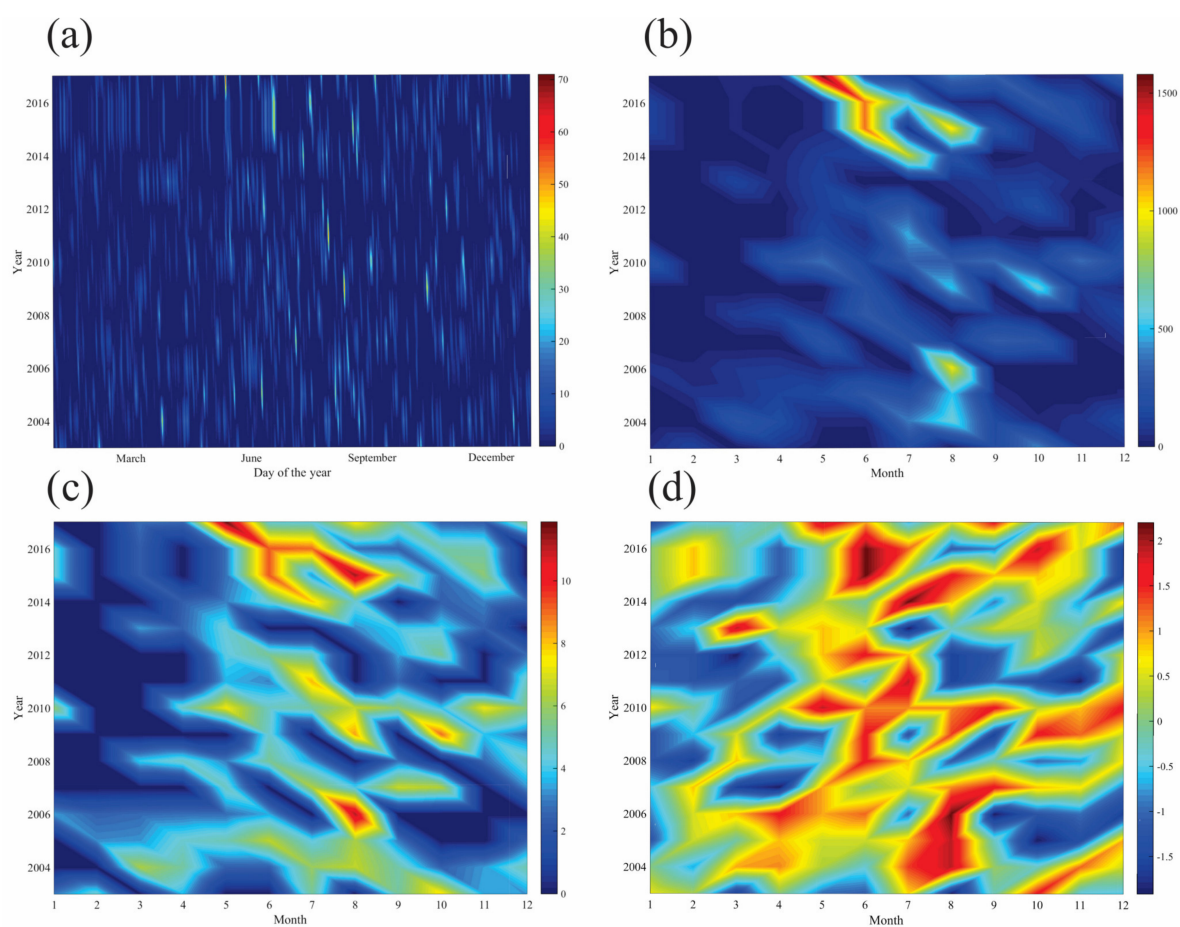
Obtained results of the *PCI* suggest the presence of uniform, moderate and irregular precipitation concentration for the observed period (values from 9.2–15.1). The *MFI* based on monthly mean values yields diversity in terms of erosion classes: 13.3% of very low, 33.3% of low and 33.3% of moderate aggressiveness, with several extreme values (144, 133 and 132 respectively), indicating very high erosivity classes for 2010, 2015 and 2016. Analysis of daily precipitation displays the occurrence and intense distribution between May and September. Higher *RE* is observed for 2014–2017, occurring between April and August. *ED* follows the pattern of *RE* and indicates high-intensity events from April until October. *SPI* index reveals the greater presence of various wet classes, especially during the month of June in 2015 and 2016, where index values of 2.2 indicate the occurrence of extremely wet conditions. The majority of drought index classes vary from moderately to extremely wet (index values of 1.2–2.2 in the period June–October) (Figure 8a–d).

The precipitation values for 2016 indicate higher precipitation rates just prior to the largest landslide event. The corresponding *MFI* values for 2015 and 2016 (133 and 132 index units respectively) fall within a very high erosivity class. These suggest that the high precipitation recorded in 2016 occurred in a few torrential events over a short period of time, thus increasing the susceptibility of the geological substrate to erosion and landslides. It is important to note that activation of the landslide event in 2016 was additionally backed up by mishandled activities performed on the hill (Figure 9). Results from this study correspond well with the findings of Bălteanu et al. [49], who produced a national-scale landslide susceptibility map of Romania in a European methodological framework. According to this research, the Oradea area has low values when it comes to distribution of densities of landslides at the municipality level (0–10 landslides per 100 km²). In regard to spatial analysis units, 0.7% of the area has high values of slide and flow susceptibility, which are outlined and addressed in the presented study (Figure 10).

Figure 8. Temporal variability of selected meteorological and erosion parameters: daily precipitation amount in mm (a); rainfall erosivity— RE in $\text{MJ} \cdot \text{mm} \cdot \text{ha}^{-1} \cdot \text{h}^{-1}$ (b); erosion density— ED in $\text{MJ} \cdot \text{ha}^{-1} \cdot \text{h}^{-1}$ (c) and standardized precipitation index— SPI (d). Data source: calculations based on [80].

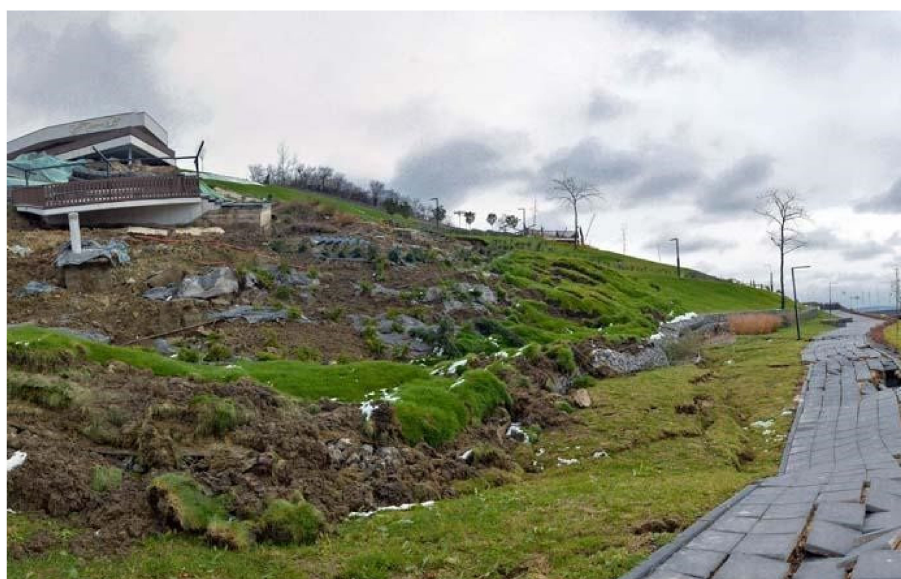
Figure 9. Perspectives over the landslide from Ciuperca Hill in Oradea (12–13 November 2016). Source: [81].

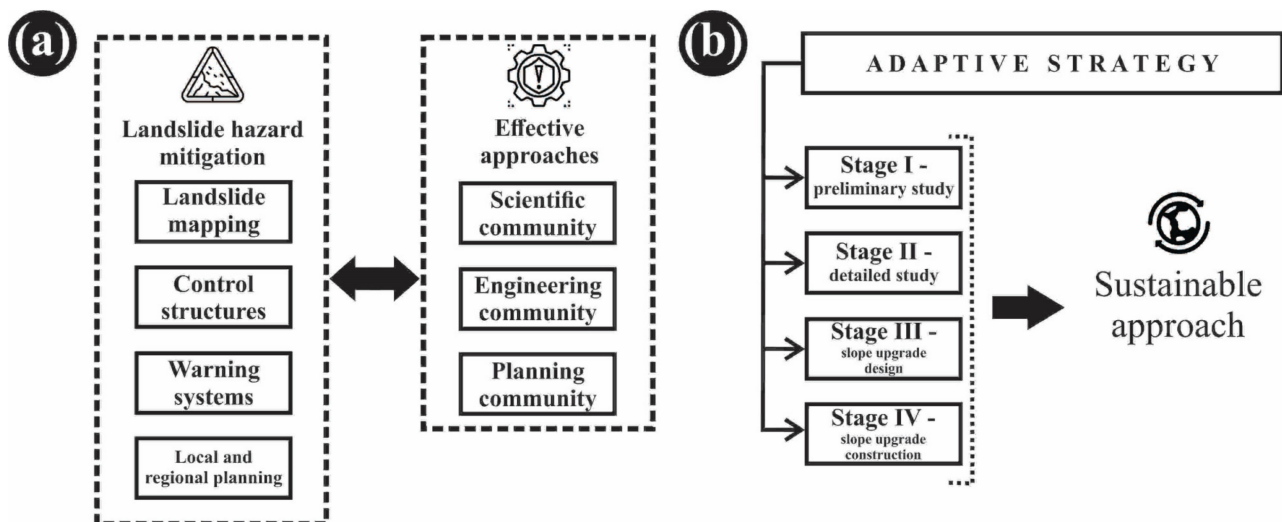
Figure 11. The landslide hazard mitigation approach (a) and sustainable adaptive strategies (b). Data source: modified after [83,84].

According to Gori et al. [83], qualitative landslide hazard mitigation generally involves landslide mapping, control structures, warning systems, local and regional planning. Most effective approaches include a combination of the aforementioned strategies, with good coordination between the scientific, engineering and planning communities (Figure 11a). Furthermore, Larsen [84] highlights that communities can reduce their exposure to landslide hazard if they understand the threat, its potential impact, and mitigation options. National policy in disaster risk reduction field in Romania is expressed through various legislative documents for risk types, administrative authorities, public institutions, and specialized institutions with responsibilities in disaster prevention and response management. Therefore, the most adequate approaches need to be carried out in order to enhance and implement an institutional and legal framework fully harmonized with European Union (EU) requirements, following examples of good practice which stand in good agreement with sustainable principles [85]. In this way, local community can address and solve problems related to risk management in a quality manner. Even though landslides along the Ciuperca Hill slopes present a lasting problem for the inhabitants of Oradea, landslide control, mitigation, and management are not administered in a sustainable manner. Local officials only take action after landslide occurrences, resulting in adverse economic impacts for the area. A potential lasting solution for the present situation lays in preparedness, requiring Oradea officials to introduce and conduct qualitative mitigation strategies by implementing a long-term slope stabilization program. Examples of good practice are evident in man-made slopes worldwide (e.g., [16,69,86–88]). This adaptive strategy would imply a four-stage program (instead of a proposed three-stage program) for the design and construction of slope upgrading as presented on Figure 11b. Current rehabilitation of the abandoned and under-used green area of Ciuperca Hill, a cultural symbol of Oradea city, from the standpoint of sustainability and interplay between natural and anthropogenic processes that occur in susceptible natural environments, is based on the three main approaches of the proposed adaptive strategy. This adaptive strategy takes into account the perspective of local authorities and 2017 official technical expertise [79] and implies a three-stage program for the slope upgrading and stabilization:

1. Strengthening restaurant and tourist information point buildings. This involves two categories of work:
 - a. Groundwater drainage—three drains (depth ditches with a width of approximately one meter) are to be constructed along the hill, so that the bottom of the drains is at the boundary between the stable land and the land susceptible to sliding;

- b. Surface drainage—drains are required on the support walls and on the access roads area that collect the water and transport it downstream for discharge into the emissary.

2. Stabilization of the slope—at the bottom of the area, drilling of pilots will be accomplished, constituting a support area.
3. Rehabilitation works: architectural (architectural works on the restaurant, landscape observation point, alleys, visiting paths, amphitheater etc.), structural (for stabilizing, structurally constructed), landscaping (planning with tree planting, shrubs etc.) occur in 2019–2020 within the framework of the project “Redevelopment of the Public Garden Ciuperca Hill (2,600,000 RON)” [89,90].
