Case report

Incarcerated fracture fragments of Longevity polyethylene liners after total hip arthroplasty

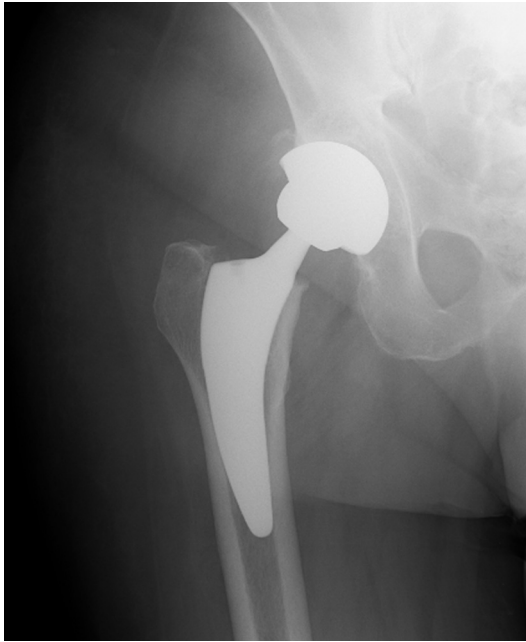
Figure 1. Case 1: Initial postoperative right hip radiograph.

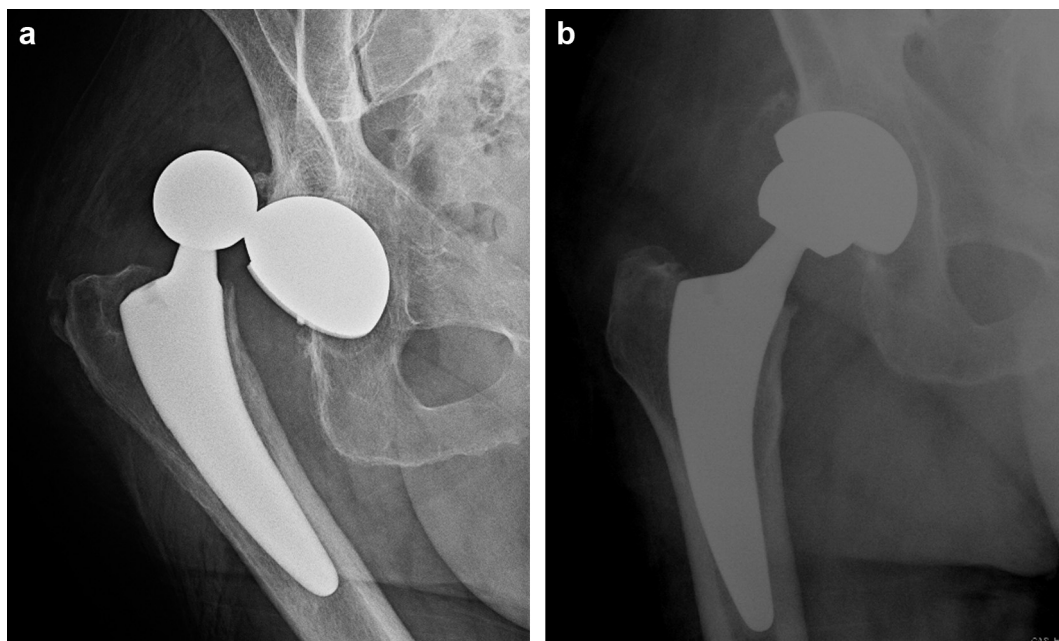
Figure 2. Case 1: Anteroposterior hip radiographs. (a) Dislocation of the right hip. (b) Interval relocation of the femoral head within the acetabular cup. The head is subtly eccentric and proud in comparison to the initial postoperative radiograph.

was evaluated by members of the orthopaedic team (Fig. 2b). On exploration of the hip joint, a fragment of the posterior lip of the HXLPE liner was found incarcerated between the femoral head and the acetabular cup liner which had been blocking successful reduction (Fig. 3). Cultures showed no sign of infection. The liner and femoral head were revised with a PE cobalt-chrome 32-mm bearing and 10°-augmented, oblique-face constrained liner (Zimmer, Warsaw, IN). The acetabular shell and femoral stem remained in good position and were not exchanged (Fig. 4). After revision, the patient experienced an uneventful recovery and has had excellent function to date. He is currently two and a half years

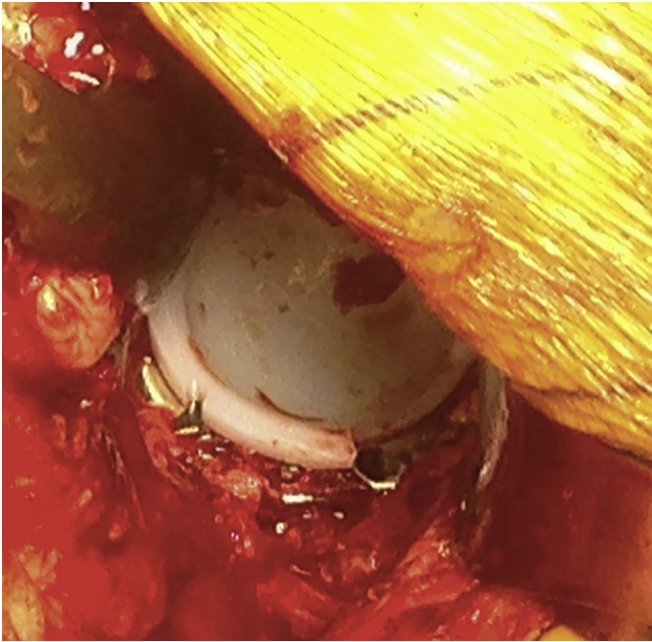
Figure 3. Case 1: Intraoperative picture during right THA revision showing a poster-superior defect in the acetabular liner. The fracture fragment has been removed from its position interposed between the head and cup.

cleavage plane between the segmental indentations of the liner. We believe that it is likely that, in this instance, dislocation occurred with the fragment remaining tethered on one end and that, with relocation, the fragment was pulled into the acetabular component by the returning femoral head where complete dissociation occurred.

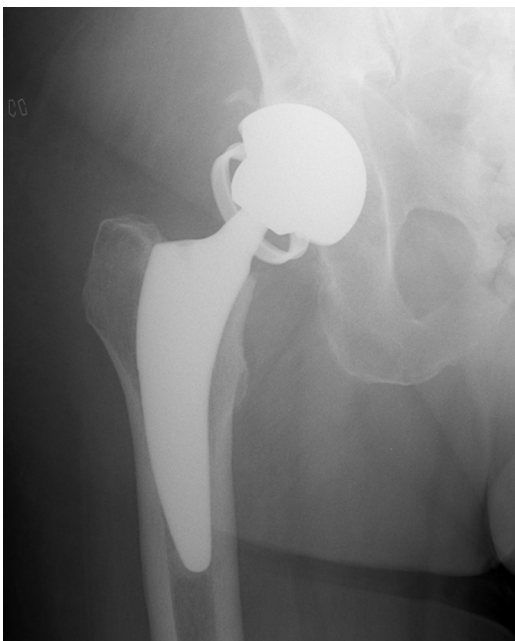
Figure 4. Case 1: Postoperative right hip radiograph after revision to a constrained liner.

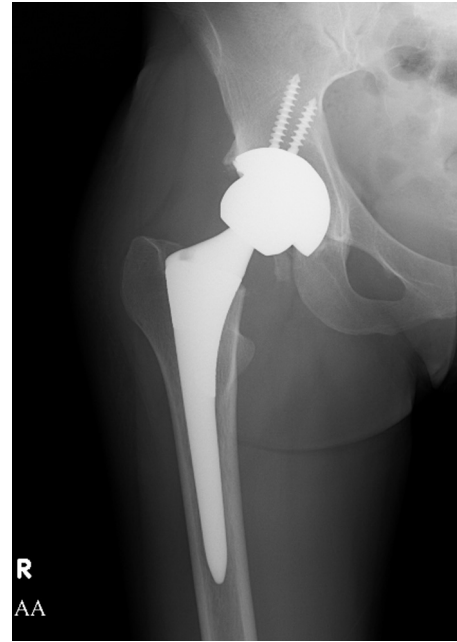
Figure 5. Case 2: Initial postoperative right hip radiograph.

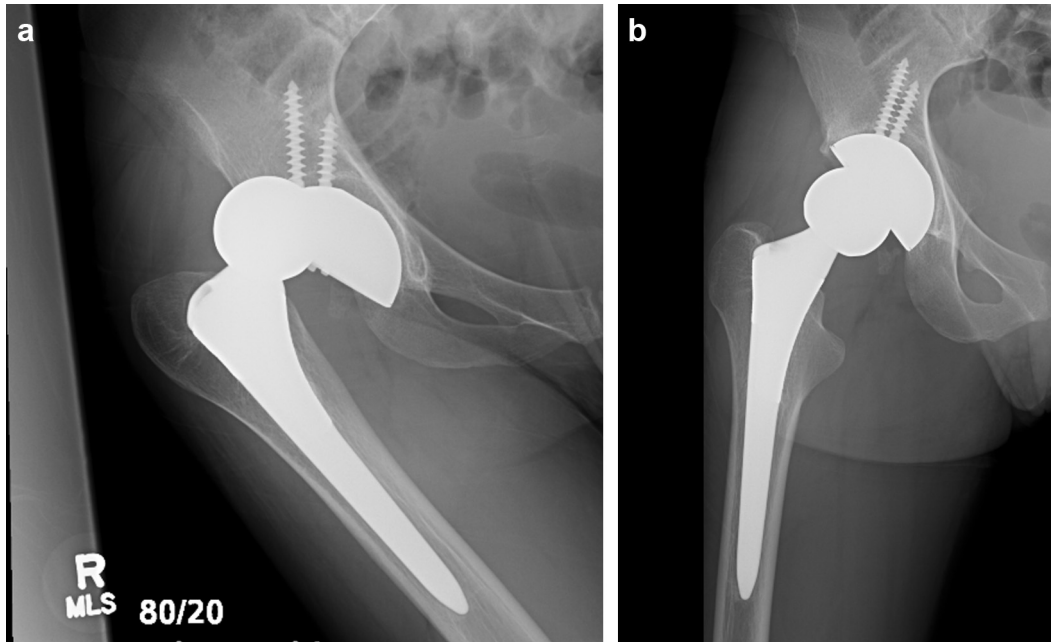
Figure 6. Case 2: Anteroposterior hip radiographs. (a) Dislocation of the right hip. (b) Interval relocation of the femoral head within the acetabular cup. The head is concentrically reduced but proud of the initial postoperative position.

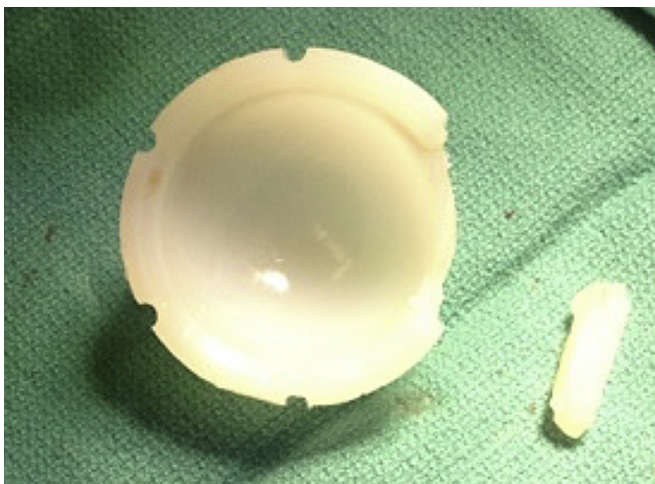
Figure 7. Case 2: Highly cross-linked polyethylene acetabular liner with posterior rim fracture fragment. Intraoperatively, the fragment was found incarcerated between the liner and the femoral head.

The liners used in these cases accommodated the largest femoral head diameter for the shell selected. Consequently, the liners, each with a dome thickness of 6.8 mm and rim thickness of 3.2 mm, were the thinnest liners available for the implant. The liner

thickness was insufficient to prevent PE failure in our patients which further supports the suggestion made by previous researchers that hips with large femoral heads and thin liners are predisposed to such events. Acetabular liner fracture is a known complication that may occur at higher rates with the use of large femoral heads and thin HXLPE liners with unsupported rims especially in the circumstance of vertical acetabular positioning. Since the time of revision in case 2, the frequency and widespread nature of rim fracture associated with this liner design has been generally recognized. The authors have since abandoned the use of components whose design includes an unsupported PE liner. These cases highlight the importance of a careful review of postreduction films for complete and concentric seating of the femoral head within the acetabular cup. It is important to consider the possibility of an incarcerated liner fracture fragment in poorly reduced prosthetic hips and hips that experience multiple dislocations and subjective instability, especially in those with large femoral head components and thin acetabular liners.

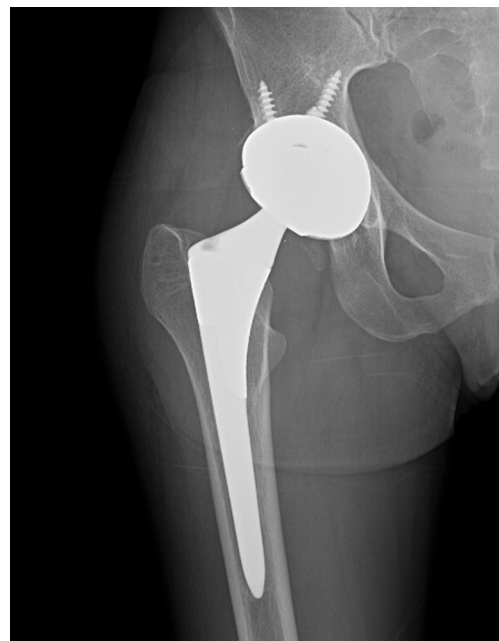
Figure 8. Case 2: Postoperative right hip radiograph after acetabular revision with correction of the abduction angle and liner replacement.
