Research Article

Assessment of the radiant emittance of damaged/contaminated dental light-curing tips by spectrophotometric methods

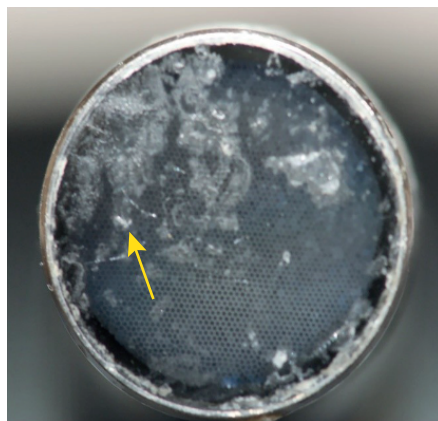
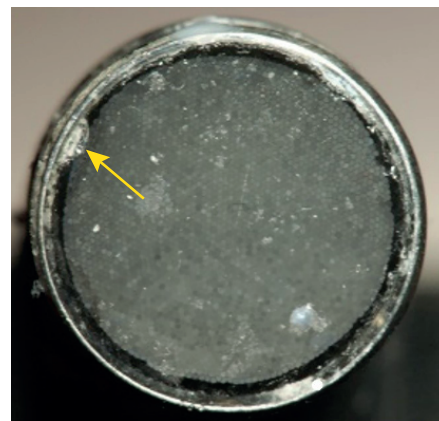
A Light tip contaminated with composite and debris

B Light tip damaged by scratches, dents or chipping

Figure 1. Contaminated and damaged light tips. (A) Light tip contaminated with resin composite and debris. (B) Damaged light tip by scratches, dents, and chipping.

Figure 1 illustrates the appearance of the tip surface with damage or contamination. Light-curing units of the corresponding design without damage that were free of contamination were used as a control group. The radiant emittance values were recorded via a laboratory-grade integrating sphere, laboratory-grade thermopile, and portable light collector (checkMARC). Three measures were performed for each sample using the 3 different devices. **Figure 2** illustrates the 3 devices used in this study. Damaged/contaminated light tips of light-curing units (experimental) and light-curing units with no damage or contamination (control) were assessed.

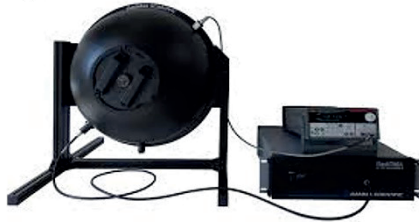
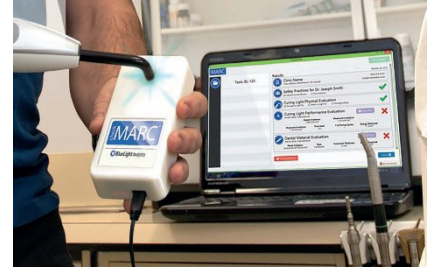
**B** Laboratory-grade integrating sphere spectrometer

**C** checkMARC portable calibrator spectrometer

Figure 2. The radiant emittance values were recorded via spectrophotometric methods. (A) A laboratory-grade thermopile system. (B) A laboratory-grade integrating sphere spectrophotometer. (C) An in-office checkMARC portable spectrophotometer.

A laboratory grade thermopile with a power of 10 W (S310C, Thor Labs, Newton, NJ, USA) was used to quantify the amount of radiant emittance produced by each light-curing unit. Radiant emittance power between 400 and 490 nm is expected to be measured by this device with an accuracy of $\pm 5\%$ [29]. The distance between the tip and the sensor was minimized to the extent possible. The amount of radiant emittance was then calculated as the power divided by the cross-sectional surface area (cm^2) of the tips [29].

The output of each light-curing unit was analyzed using a 6-inch integrating sphere (Labsphere, North Sutton, NH, USA) attached to a fiberoptic spectrophotometer (USB 4000, Ocean Optics, Dunedin, FL, USA) [30]. The spectrophotometer was calibrated using a National Institute of Standards and Technology (Gaithersburg, MD, USA) traceable light source (Labsphere). Each light-curing unit tip was placed at the entrance of the sphere to calculate the light-curing unit output using Spectrasuite v2.0.162 software (Ocean Optics). The radiant emittance values were obtained from the power output emitted between 340 nm and 550 nm [31].

The portable spectrophotometer analyzed in this study (Managing Accurate Resin Curing; checkMARC, BlueLight Analytics, Halifax, NS, Canada) was a system connected to a laboratory-grade spectroradiometer (USB 4000, Ocean Optics). The sensor is connected to a spectrophotometer with a bifurcated fiber optic cable. A pre-configured laptop computer with custom software (MARC Light Collector) was used to collect and export the data. Based on the light-curing unit selected in the software, checkMARC can quantify the radiant emittance of the light-curing unit [32,33].

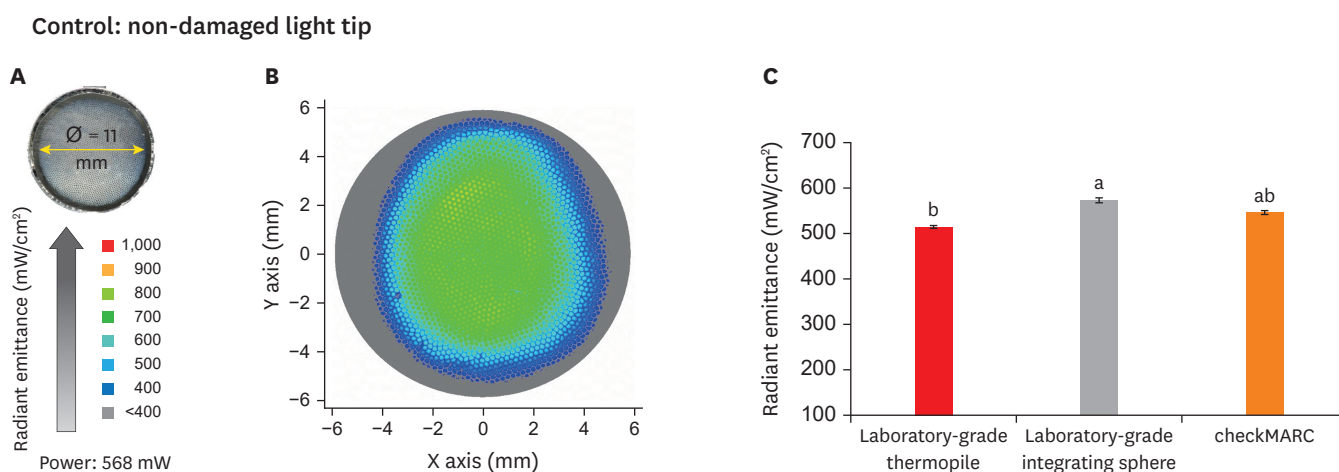
Figure 3. Radiant emittance levels of the control tip. (A) An appearance of the control tip and the measured active tip diameter. (B) Representative image of the light beam radiant emittance profile for the control tip. The color bar on the right shows the visual representation of radiant emittance expressed in mW per cm² corresponding to the colors seen. The profile presents an abundance of the green color representative of the range of 600–700 mW/cm² with scattered dots in a hot color (yellow-orange) representing radiance with emission in the range of 800–900 mW/cm². The profile beam image also shows peripheral areas in blue and gray colors, representative of radiance at 400 and below 400 mW/cm², respectively. (C) Radiant emittance assessment of non-damaged and non-contaminated tips by the 3 spectrophotometric methods. No significant difference was found between the checkMARC spectrophotometer and the other methods (*p* < 0.05). Values with different letters are significantly different (*p* < 0.05).

Figure 3A displays the appearance of the control tip and the measured active tip diameter. **Figure 3B** shows a representative image of the light beam radiant emittance profile for the control tip. The color bar on the right shows the visual representation of radiant emittance expressed in mW/cm² corresponding to the colors seen. The profile presents an abundance of the green color, representative of the range of 600–700 mW/cm², with scattered dots in a hot color (yellow-orange) representing radiance with emissions in the range of 800–900 mW/cm². The profile beam image also shows peripheral areas in blue and gray colors representative of radiance at 400 and below 400 mW/cm², respectively. In **Figure 3C**, the

radiant emittance assessment of the non-damaged and non-contaminated tips by the 3 spectrophotometric methods are shown. The radiant emittance assessed by the thermopile for the control tip was significantly ($p < 0.05$) lower than the values for the laboratory-grade sphere. No significant difference was found between the checkMARC spectrophotometer and the other methods ($p > 0.05$).

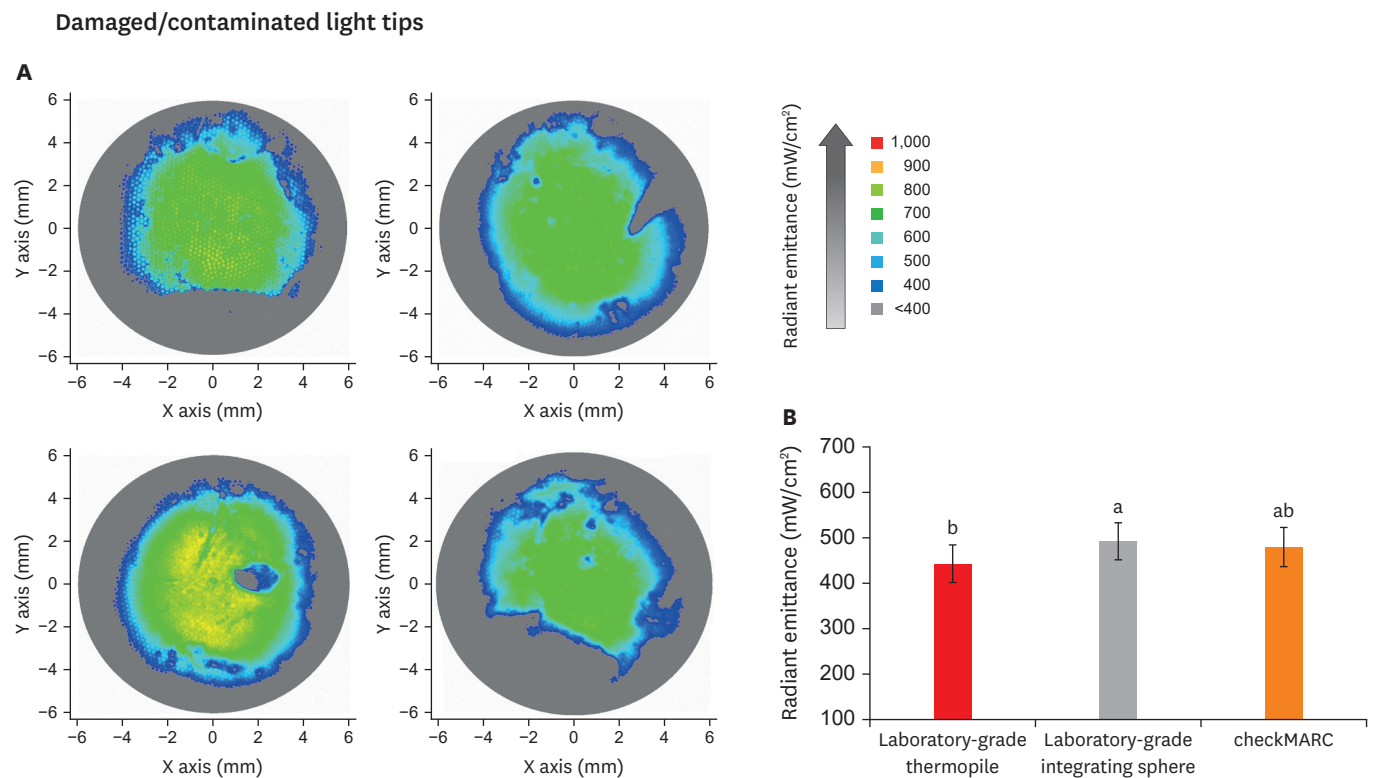
Figure 4. Radiant emittance levels of the damaged/contaminated tips. (A) Representative images of the beam profile of damaged/contaminated light tips. The colors in the beam profile represent the amount of radiant emittance captured at each area across the light-curing unit tip. The higher the normalized radiant emittance value, the better the performance of the light-curing unit (high-value areas: light green). The color bar on the right shows the visual representation of radiant emittance expressed in mW per cm^2 corresponding to the colors seen. The profile beam images for damaged/contaminated tips show an increased abundance of peripheral and central areas in blue and gray colors representative of radiance at 400 and below $400 \text{ mW}/\text{cm}^2$, respectively. In B, the radiant emittance assessments of damaged/contaminated tips ($n = 9$) by the 3 spectrophotometric methods are shown. The radiant emittance assessed by the thermopile was significantly ($p < 0.05$) lower than the values for the laboratory-grade sphere. No significant differences were found between the checkMARC spectrophotometer and the other methods ($p < 0.05$). Values with different letters are significantly different ($p < 0.05$).

Figure 4A displays representative images of the beam profile of the damaged/contaminated light tips. The colors in the beam profile represent the amount of radiant emittance captured at each area across the light-curing unit tip. The higher the normalized radiant emittance value, the better performance of the light-curing unit (high-value areas: light green). The color bar on the right shows the visual representation of radiant emittance, expressed in mW/cm^2 , corresponding to the colors seen. The profile beam images for damaged and contaminated tips show an increased abundance of peripheral and central areas in blue and gray colors, representative of radiance at 400 and below $400 \text{ mW}/\text{cm}^2$, respectively. The surface area of the radiant emittance value of $> 700 \text{ mW}/\text{cm}^2$ across the tips is smaller for the damaged/contaminated light tips compared to the control. The surface area with a lower radiant emittance ($400\text{--}534 \text{ mW}/\text{cm}^2$) is more prominent and can be seen more extensively in the peripheries and as small dots in the middle of the tip.

In **Figure 4B**, the radiant emittance assessment of the damaged/contaminated tips by the 3 spectrophotometric methods is shown. The mean radiant emittance value measured using the thermopile (456.1 ± 39.8 mW/cm²) was significantly ($p < 0.05$) lower than measured using the laboratory-grade sphere (502.0 ± 45.8 mW/cm²). No significant difference was found between checkMARC (488.9 ± 40.5 mW/cm²) and the other spectrophotometric methods. The lowest reported values in a damaged/contaminated tip were 376, 407, and 412 mW/cm² for thermopile, laboratory-grade sphere, and checkMARC, respectively, using the same tip. The highest reported values were 489, 538, and 520 mW/cm² when the thermopile, laboratory-grade sphere, and checkMARC, respectively, were used.

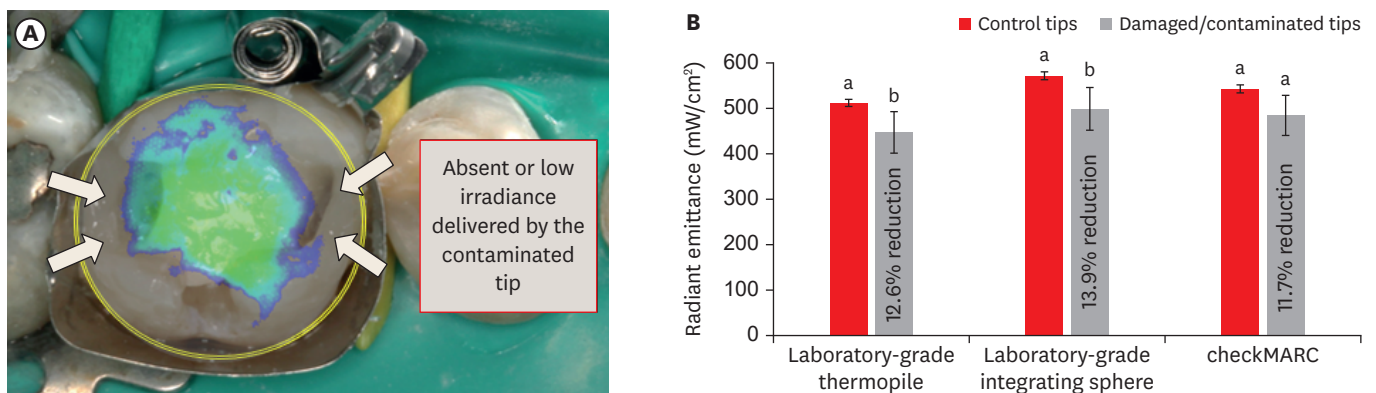
Figure 5. Impact of damage/contamination on radiant emittance. (A) Representative illustration of a clinical restorative scenario where a mesio-distal occlusal composite restoration is placed and cured by a damaged tip. The overlapping image of the non-uniform beam profile over the composite restoration should be noted. The lack of homogeneity in the produced radiant emittance profile could compromise the optimal polymerization of the restoration. The black arrows indicate areas that may not receive the radiant emittance appropriately. (B) Radiant emittance results and percentage reduction of radiance relative to the control. On the first y-axis, the bar plot shows radiant emittance results expressed in mW/cm². Each method was used to capture the radiant emittance values from damaged/contaminated tips and compared to those with no damage or contamination (control). The difference in the power output between the damaged/contaminated and control tips was significant when the thermopile and the laboratory-grade sphere spectrophotometer were used. Damaged/contaminated tips significantly demonstrated lower radiant emittance values than the control ($p < 0.05$). In this plot, values with different letters are significantly different ($p < 0.05$).

Figure 5A presents a representative illustration of a clinical restorative scenario where a mesio-distal occlusal composite restoration is placed and cured by a damaged tip. The overlapping image of the non-uniform beam profile over the composite restoration should be noted. A lack of homogeneity in the produced radiant emittance profile could compromise the optimal polymerization of the restoration. The black arrows indicate the areas that may not receive appropriate radiant emittance.

In **Figure 5B**, the radiant emittance results of each spectrophotometric method in both damaged/contaminated and control tips are shown. Each method was used to capture the radiant emittance values from damaged/contaminated tips and compared to those of the non-damaged/non-contaminated tips (control). The difference in the power output between the damaged/contaminated and control tips was significant when the thermopile and laboratory-grade sphere spectrophotometer were used. The damaged/contaminated tips significantly demonstrated lower radiant emittance values than the control ($p < 0.05$). In this plot, values with dissimilar letters are significantly different ($p < 0.05$). However, using the checkMARC portable device, no significant difference was found between the damaged/contaminated and control tips ($p = 0.05$). The amount of reduction observed with the thermopile and laboratory-grade sphere spectrophotometer was 12.6% and 13.9%, respectively. For the checkMARC portable collector, the reduction in the percentage was 11.7% in relation to the control.
