RESEARCH ARTICLE

Design and evaluation of a laboratory-based wheelchair castor testing protocol using community data

Citation: Mhatre A, Reese N, Pearlman J (2020) Design and evaluation of a laboratory-based wheelchair castor testing protocol using community data. *PLoS ONE* 15(1): e0226621. <https://doi.org/10.1371/journal.pone.0226621>

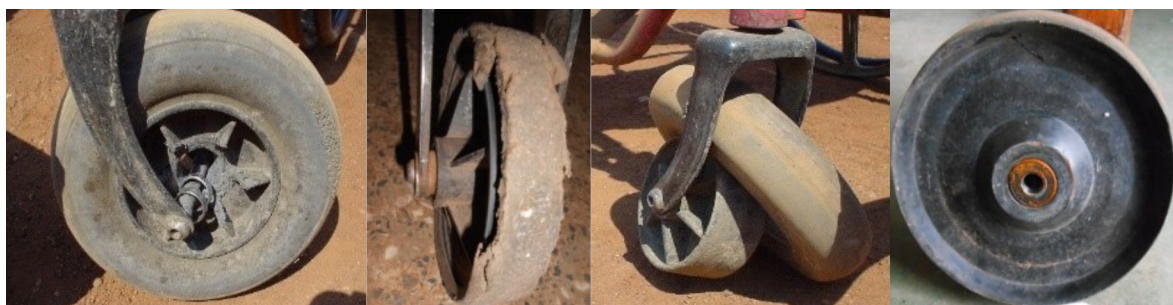
Fig 1. Castor axle bearing failure (left), tire cracking and worn-out (middle left), tire Roll-off (middle-right) and axle bearing corrosion (right).

Wheelchair castors are reported to experience frequent failures in the community due to different failure modes [1–3,5,9,19–21]. Studies documenting wheelchair incidents and repairs in the United States and Scotland found that nearly one-third of all wheelchair part failures are castor failures [9,20]. One study reported that castors and wheels contributed to 42% of the recorded wheelchair failures and 44% of adverse user consequences including physical, social and economic consequences [22]. Castors from wheelchair models designed for use in adverse environments with unpaved, rough terrains and hot and humid climates have been found to undergo multiple part failures in Kenya [1,5]. Locked and missing bearings, damaged bolts, fractured wheels and forks, worn-out tyres and missing fasteners are common castor failures (see Fig 1) [1,5,19,21]. In addition to community failures, castors are known to fail during laboratory-based ISO-7176 standards testing [23–35].

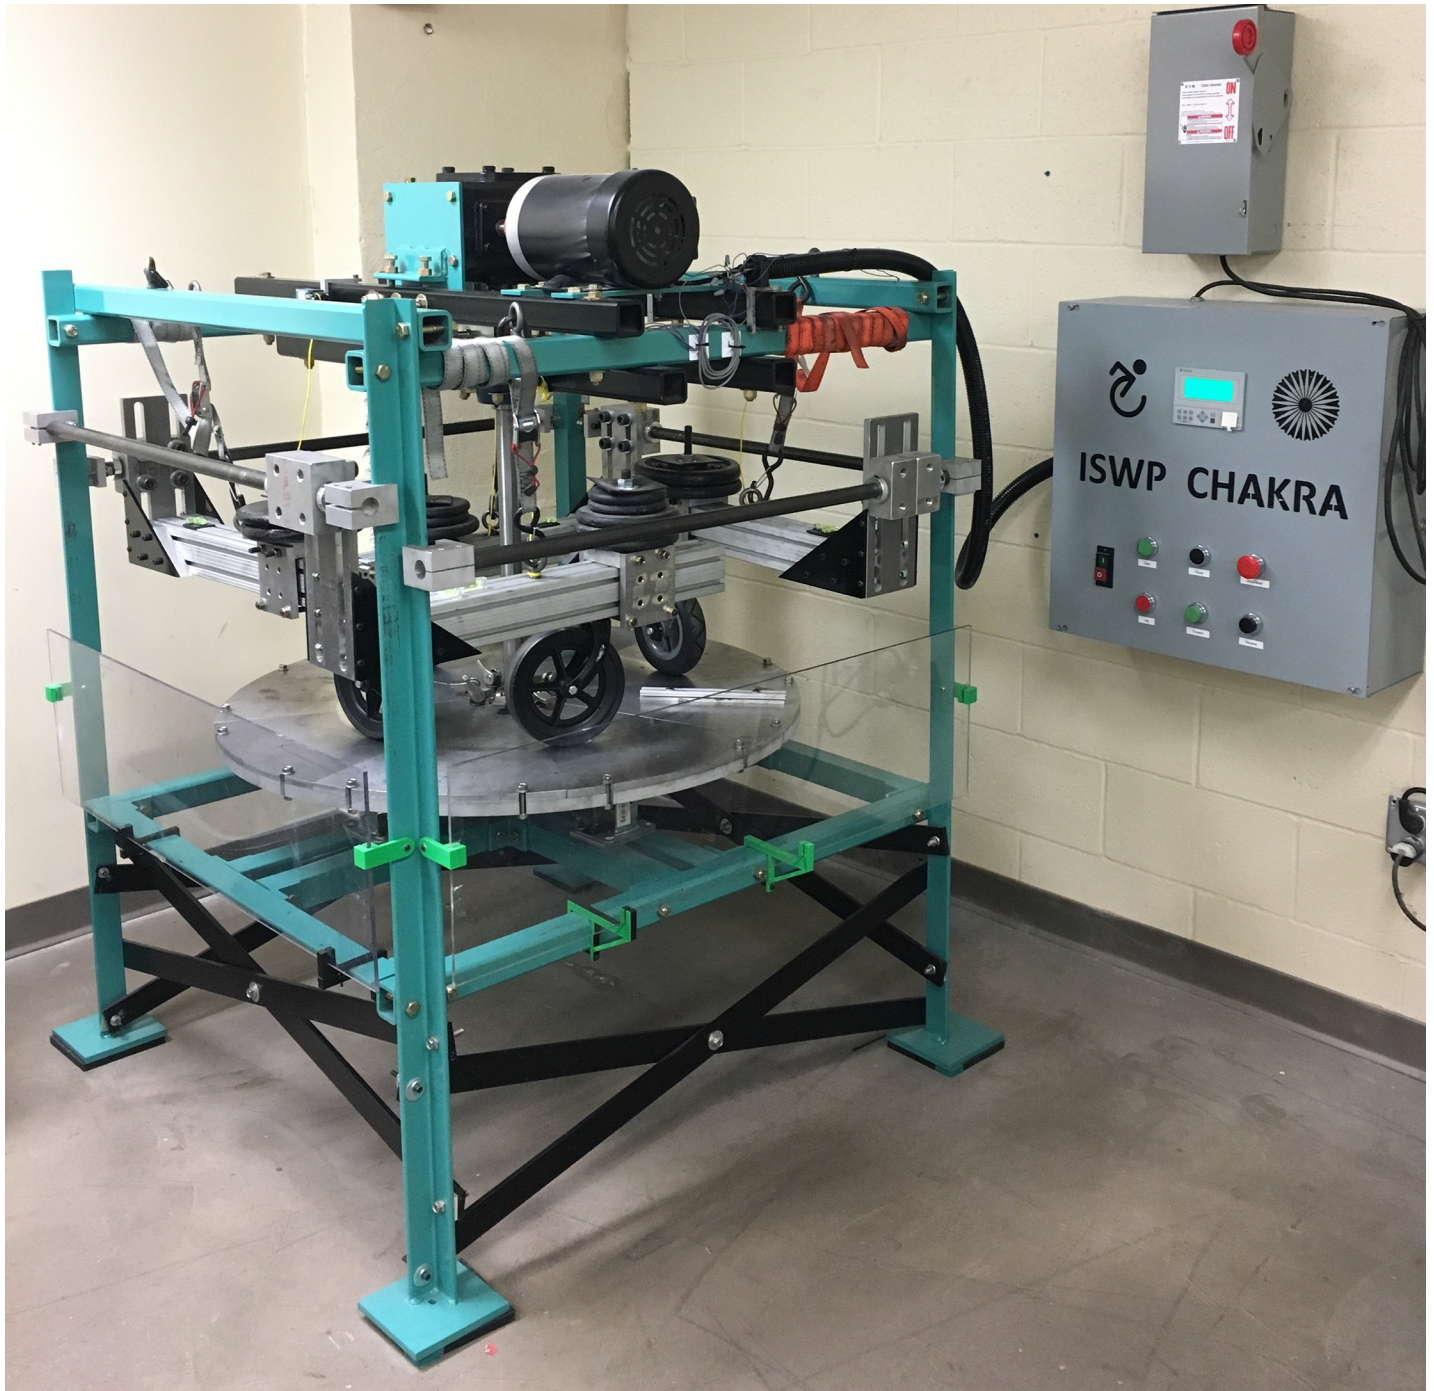
Fig 2. ISWP castor testing system.

To improve quality of castors and wheelchair products overall, several international organizations including the World Health Organization (WHO) and International Society of Wheelchair Professionals (ISWP) are promoting the provision of high-quality, appropriate wheelchairs [36–39]. Further, the WHO Guidelines on the provision of manual wheelchairs in less-resourced settings (LRS) recommend product testing specific to adverse environments witnessed in LRS and rural areas of resourced settings (RS) [40]. Based on this recommendation, the ISWP convened a Standards Working Group (ISWP-SWG) to guide wheelchair testing methods that could be proposed as amendments or extensions to the current suite of published ISO-7176 wheelchair standards that are more suitable for products used in urban areas in resourced settings [41,42]. The ISWP-SWG recommended that among several test methods that need to be developed or strengthened [41], castor testing is a high priority given their high rate of failure and associated injury risk. Based on these recommendations, the ISWP-SWG group has developed a laboratory-based castor testing system (see Fig 2) through an iterative design and expert review approach which was previously published [19], and is consistent with ISO/AWP 7176–32 [43]. Castor systems are suspended from arms on a turntable mimicking the way they are mounted on a wheelchair. The turntable accommodates triangular-shaped plates on which different types of obstacles and surfaces can be attached. Since shock is a primary environmental factor affecting castor durability, shock testing conditions similar to the ISO-7176 double drum fatigue testing machine were incorporated by attaching obstacles of 12.7mm thickness on diametrically opposite plates on the turntable [44,45].

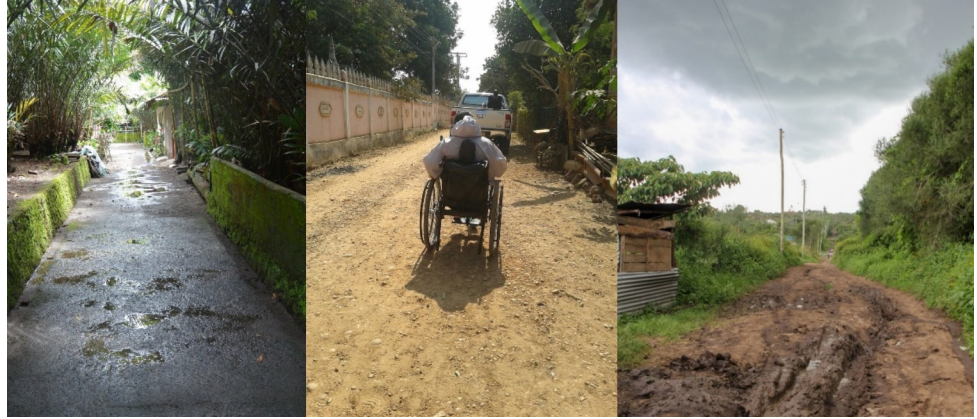
Fig 3. Examples of adverse conditions in LRS [46]. Picture on the right is reprinted under a CC BY license, with permission from Partners for Care, original copyright 2018.

To address the primary goal of developing the testing protocol, community data and failed castor samples collected by ISWP partners were used in this study. The co-author NR collected the data and materials as a part of another study that was approved by the Letourneau University's Institutional Review Board. The shock data from the community was collected from Kenya as an environment typical of many LRS (Fig 3).

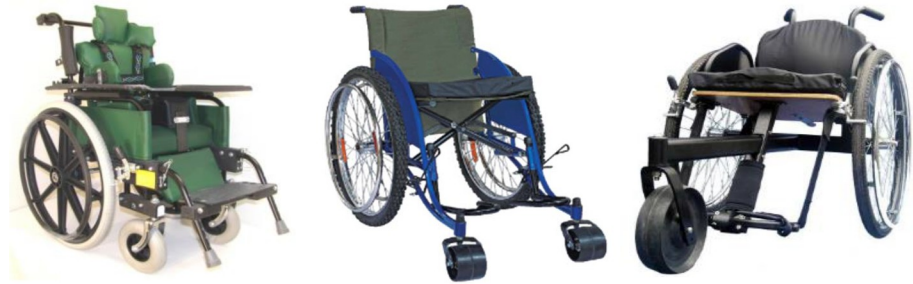
Fig 4. Hopehaven Kids Wheelchair (left), Whirlwind Roughrider (middle) and Motivation Rough Terrain Wheelchair (right) [41].

Accelerations on castors of three wheelchair models commonly used in adverse environments—Whirlwind Roughrider (n = 1), Hopehaven Kids Wheelchair (n = 2) and Motivation Rough Terrain Wheelchair (n = 1) (Fig 4) were recorded in Kenya for eight days of use. The paediatric users were from a boarding school setting in a high-altitude area with uneven

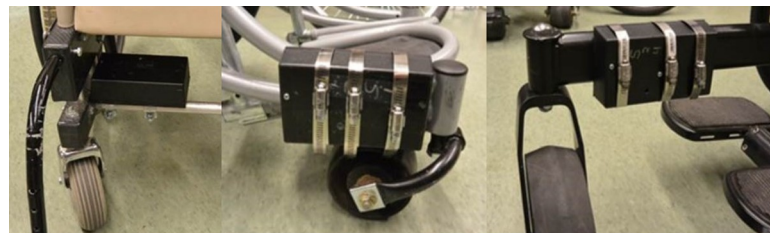
Fig 5. Accelerometers installed in a black box attached to the wheelchair frame.

Shock exposure is caused by abrupt loads applied to the castors due to bumps, curbs, and drops. Failures due to shock are typically a yielded component after a major sudden load, or fatigue fracture after repetitive, fluctuating loads. In this study, shocks suffered by wheelchair castors were measured using accelerometers mounted on frames near castors.

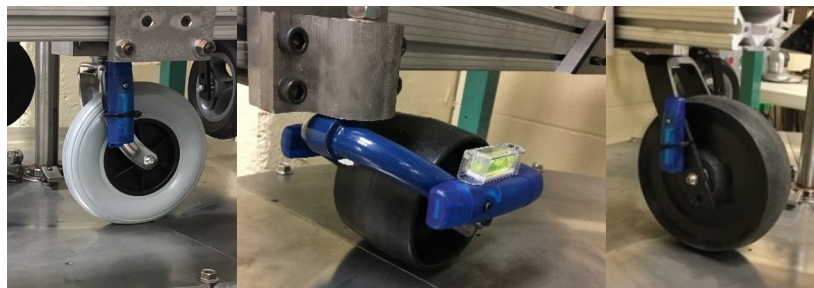
Fig 6. Accelerometers installed on test castors. The Hopehaven castor (left) is a 185mm solid tyre castor that mounts on a plastic castor wheel. The Whirlwind castor (middle) is a 127mm solid tyre castor mounted on the axle bearing similar to the Motivation castor (right) which is a heavy, 216mm solid castor.

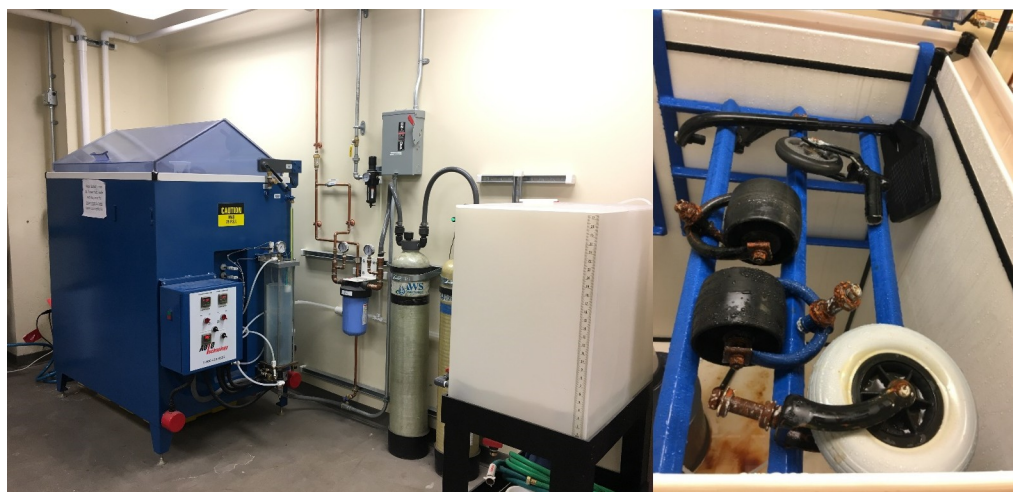
Fig 7. Salt fog chamber for corrosion testing (left) and corrosion testing of sample parts (right) [50].

Outdoor steel corrosion rates reported in different parts of the world were collected. Corrosion testing in the laboratory was carried out as per the ASTM B117 standard [48]. The standard recommends a salt fog apparatus (Fig 7) and procedures for corrosion evaluation. An experiment with mass loss test panels was performed to determine the amount of corrosion seen in the salt fog over time. Based on the results, the corrosion rate experienced in the salt fog was calculated using ASTM G1 [49] and correlated with outdoor corrosion rates.

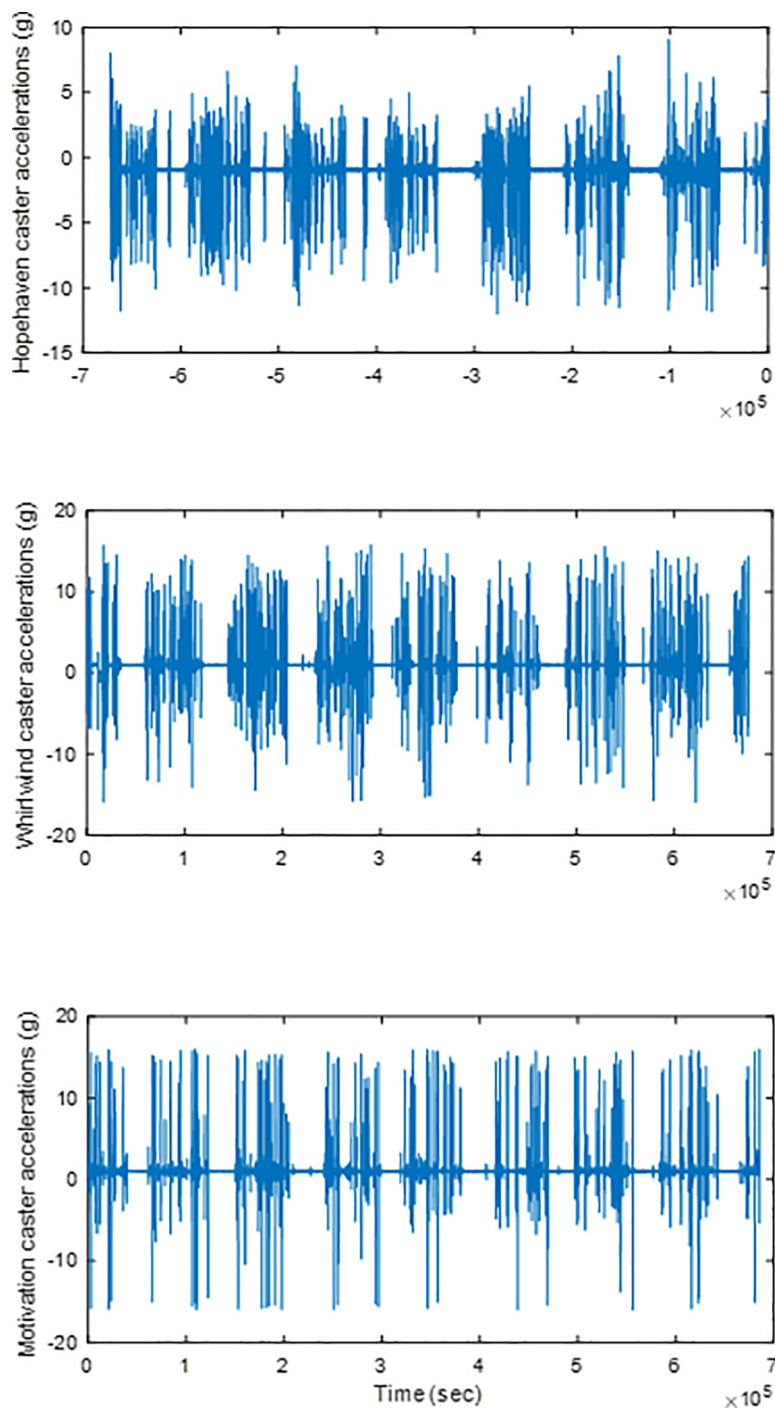
Fig 9. Community accelerations in the vertical direction for three caster models. Out of the two users of Hopehaven wheelchairs, data from the user with higher accelerations is displayed and was selected for analysis to represent the worst-case scenario.

Correlating shock exposure between community and castor test. Castor accelerations collected in Kenya for a week are shown in Fig 9. Initial testing and data recording with the Motivation castor showed that higher size obstacles of 25.40mm-31.75mm thickness reproduce community accelerations. This generated shocks that caused the castor test equipment to vibrate significantly. Considering the damage risk, the castor model was omitted from further analysis and testing.

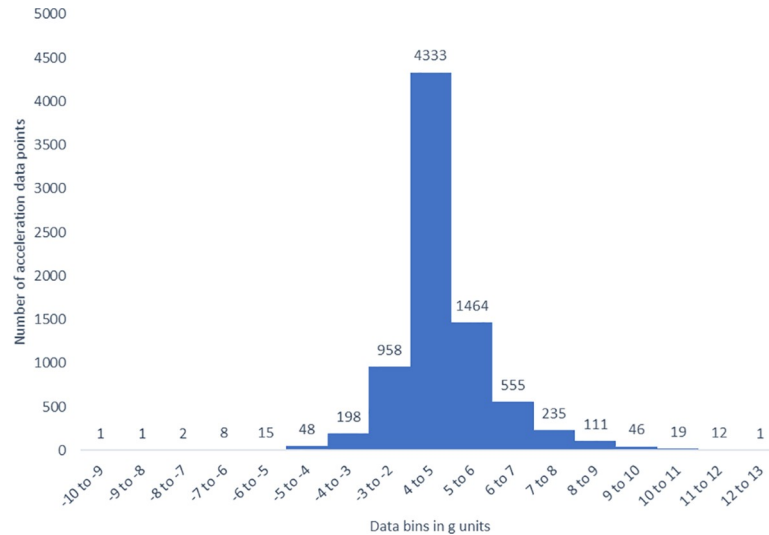
Fig 10. Binning community accelerations recorded on Hopehaven castor. Bins from -2 to 4 g values (mostly surface vibrations) were significantly taller making the high acceleration bins appear flat and hence, are not displayed.

Community accelerations were binned into histograms; for example, accelerations recorded between 8-9g range were binned into one data bin— 8 to 9 g as shown in Fig 10. A curve joining the midpoints of the histogram bins was generated for each caster model.

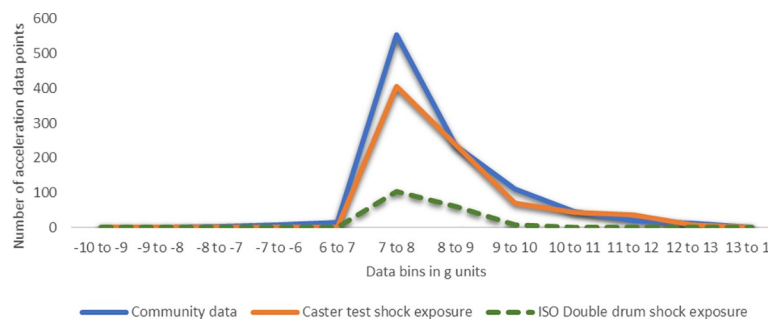
Fig 11. Correlating community and castor test exposures for Hopehaven castor.

According to the stress analysis (see [S1 File](#)), accelerations between 6-13g for Hopehaven castor and 7g-16g for Whirlwind castor contributed to fatigue and were considered for correlation between community and castor test. Accelerations recorded on the test with different obstacles and speed settings for one-minute duration were extrapolated and combined suitably to match community acceleration distribution for both models. Figs 11 and 12 show the matched community and castor test acceleration distributions. In these figures, the ISO Double drum exposure is the castor test acceleration distribution prior to this community validation experiment.

Chi-square goodness of fit testing showed that there is a significant difference between the community and validated castor test shock exposures, $\chi^2_{\text{Hopehaven}}(11, 24) = 99, p < < 0.05$, $\chi^2_{\text{Whirlwind}}(17, 36) = 128.38, p < < 0.05$, as well as between community and ISO double drum shock exposures, $\chi^2_{\text{Hopehaven}}(11, 24) = 695.78, p < < 0.05$, $\chi^2_{\text{Whirlwind}}(17, 36) = 856.47, p < < 0.05$. Following validation, the gaps between community and castor test acceleration distributions were smaller, suggesting the castor test system provides an exposure more similar to the community than the ISO test. Higher magnitude accelerations greater than 10g that contribute greater to fatigue stress in the castor’s stem bolt were matched appropriately with shock validation.

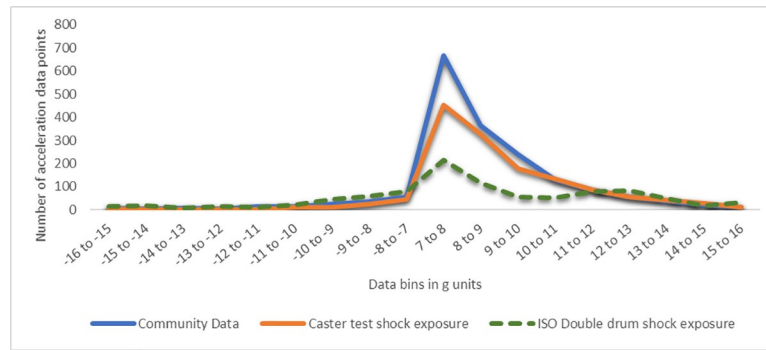
Fig 12. Correlating community and castor test exposures for Whirlwind castor.

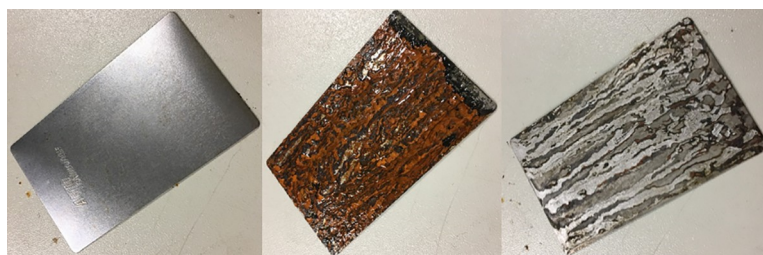
Fig 13. Mass loss test panel before corrosion (left), corroded panel after 100hrs of salt fog exposure (centre) and cleaned panel before weighing (right).

Corrosion testing in the salt fog chamber. Three test panels were cleaned and placed in the salt fog chamber for constant fog exposure at 48°C with high relative humidity (about 97%). Weight loss on test panels was evaluated on a scale at 100, 200 and 300 hours of exposure. Prior to weighing, panels were cleaned, and all rust was scraped from the panels (see Fig 13) surface using a scrubber as specified in ASTM G1 and ASTM B117.

Corrosion testing protocol. Mass loss seen with the three panels after every 100 hours of exposure ranged from 1.33–1.50 grams. Accordingly, the corrosion rate average for the three panels comes to 1.5mm/year. Comparing this result with the outdoor corrosion rates in Table 3, 100 hours of salt fog exposure can simulate corrosion equivalent to 1 year of outdoor corrosion.

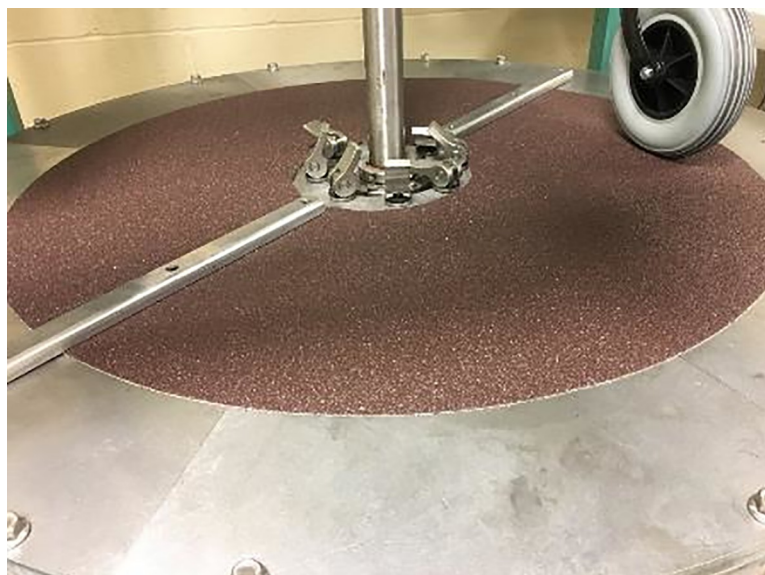
Fig 14. 36-grit sanding disc attached to the turntable to simulate abrasion.

Conducting abrasion simulation on castor test. Sandpapers of 20 and 36 grit sizes were evaluated individually by attaching them to the turntable to simulate rough surface. Obstacles were bolted through the sandpaper and the pattern was based on validated shock testing protocol for castors greater than 150mm in diameter. Fig 14 shows the test setup with the 36-grit, 0.76m wide sanding disc. Two new Hopehaven castor samples were tested. Reduction in tyre thickness was calculated following shock exposure corresponding to one year of outdoor exposure. The tested models experienced wear of 1.84 ± 0.7 mm with 36-grit sandpaper compared to 0.51 ± 0.03 mm with the 20-grit sandpaper. The 20-grit sandpaper had less number of grits per square area with a high grit profile which resulted in less material removal. Comparing the abrasion rate with that experienced in the community (Table 3), the 36-grit sandpaper was found suitable for abrasion testing.

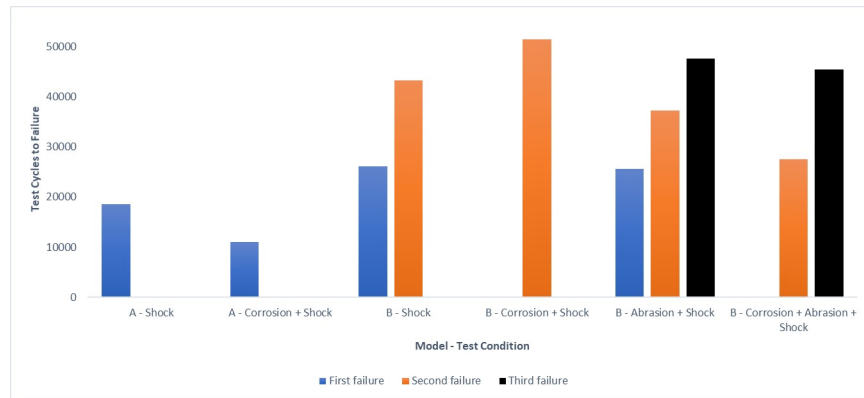
Fig 15. Test cycles to failure for small castors (less than 150mm in diameter). The number of failures for the two samples in each condition varied across models and test conditions. Corrosion tested samples of B suffered obstruction to rolling due to corrosion exposure and hence, no testing cycle is noted for their first failure.

Castor models A and B were less than 150mm in diameter and were tested with shock testing protocol I. The other models were tested with shock testing protocol II. As per the results, the castor durability and failure modes of seven out of eight models (87.5%) were affected by corrosion and abrasion. Figs 15 and 16 show the test cycles and Table 4 shows the castor failure

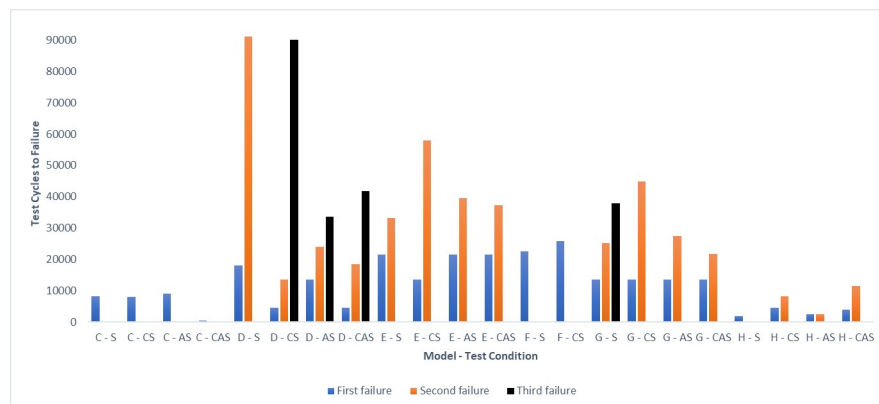
Fig 16. Test cycles to failure for larger castors (greater than or equal to 150mm in diameter). The number of failures for the two samples in each condition varied across models and test conditions. Abbreviations: S, Shock; CS, Corrosion + Shock; AS, Abrasion + Shock; CAS, Corrosion + Abrasion + Shock.

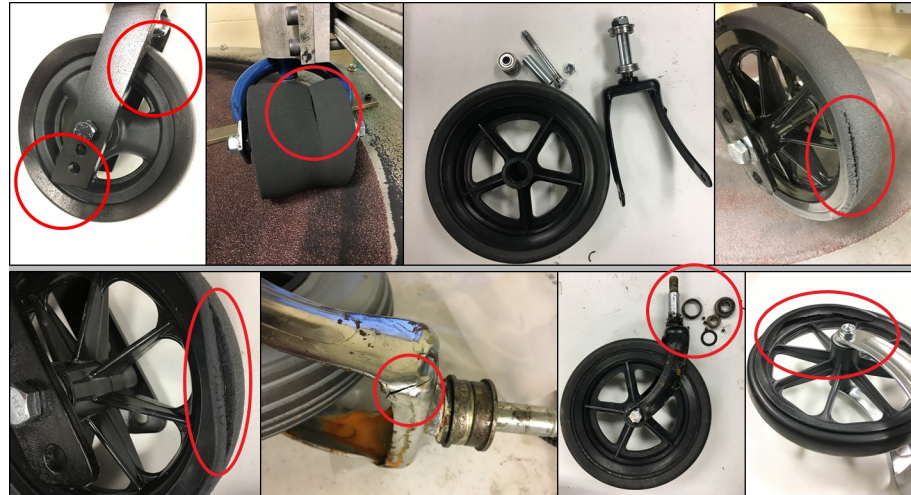
Fig 17. Model A–Delaminated tyre brushing against the fork (top-left), Model B–Tyre cracking (top-left-middle), Model C–Axle hub assembly fell apart (top-right-middle), Model D–Tyre Cracking (top-right), Model E–Tyre Cracking (bottom-left), Model F–Fork fracture (bottom-left-middle), Model G–Stem bearing fracture (bottom-right-middle) and Model H–Wheel Fracture (bottom-right).

modes. Stem bearings from corroded samples of B, D and G locked randomly during testing which led to dampening of the castor's lateral swivel. This phenomenon was associated with four corroded samples that lasted more test cycles before failure than the non-corroded samples. Among tested models, models C and H failed quite early across all four testing conditions compared to others. Fig 17 shows the example photographs of failures.

Failure modes were different across six models when tested with the environmental factors of corrosion and abrasion. For instance, failure modes for four models—B, D, E and G were altered by the presence of abrasion, and three models—B, F and H in the presence of corrosion. Two-thirds of the altered failure modes—bent bolt and fork fracture, are associated with increased risk of causing user injuries based on a castor failure checklist [68]. The forks fractured at corroded hotspots.
