A major leak from the condenser assembly of the anesthesia workstation

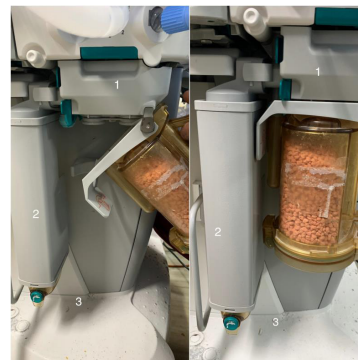
After the surgery got over, a detailed inspection of the CO₂ canister assembly was done, and the leak seemed to originate from the EZchange and condenser part of the machine (**Figure 1**). Further evaluation revealed no issue in the EZchange part. The drain button of the condenser, however, was stuck in a semi-open position due to a soda lime granule trapped under the flap valve, leading to the leakage of gases through the condenser via the water drain (**Figure 2**). Once the granule was cleaned out

Figure 1: Canister on the machine with EZchange option. Note: 1: EZchange Canister manifold; 2: condenser; 3: drain button.

The EZchange and condenser option are included in the Advanced Breathing System of the Datex Ohmeda Aespire View workstation. The EZchange option allows the user to change a canister during a case without introducing a large leak and the condenser (**Figure 1**). The condenser helps to remove moisture from the freshly scrubbed gas that comes out of the canister before going to the inspiratory flow sensors. This moisture is then drained out at the bottom of the condenser through the water drain.

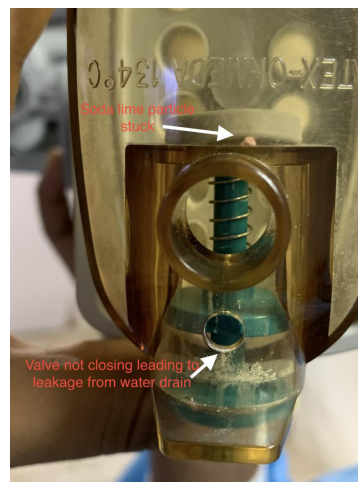
Figure 2: Leak site in the condenser assembly.

It is very difficult to explain the presence of absorbent granule in the lower part of the condenser assembly, thereby causing a circuit leak in our case. There was a high content of dust in the absorbent material used. But how it could reach the condenser assembly is difficult to explain.

from underneath the flap valve, the drain button was restored to the original position and the audible leak was eliminated, as was evident upon rechecking the machine.

over the years. A malfunction that occurred in our case might be difficult to recognize early unless the staff using anesthesia workstations is well versed with all the components of the machine and should have completed the clinical training test in the user manual. The user manual should be kept readily available at all times. After the anesthetic machine check is completed, no component (circuits, bellows, vaporizers, absorber canister) should be changed at will. If there is a requirement to do so, the machine check should be performed all over again. In machines equipped with a condenser, a visual check of the condenser and reservoir should be done daily and it should be ensured that the water drain push button is moving freely and not stuck. Alternative methods of ventilation and provision of anesthesia should always be available.
