Evaluation of the effect of different surface treatments on the bond strength of non-precious alloy–ceramic interface: An SEM study

J Dent Res Dent Clin Dent Prospect 2019; 13(3):200-207|doi: 10.15171/joddd.2019.031

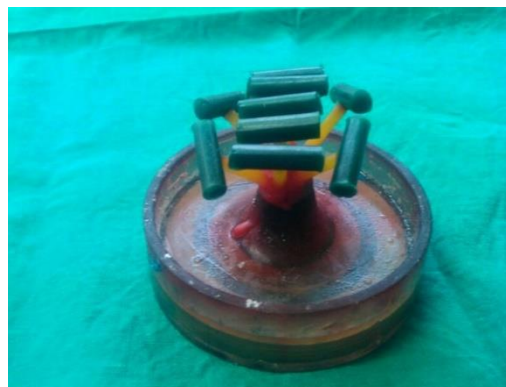
Figure 1. Spruing of the wax pattern.

Prefabricated sprue waxes, measuring 5 mm in diameter, were directly cut to a length of 15 mm for casting, which served as wax patterns. The use of sprue wax of the desired diameter prevented the possibility of error in the dimension. 2-mm diameter sprue wax was attached to the wax pattern (Figure 1) and invested.

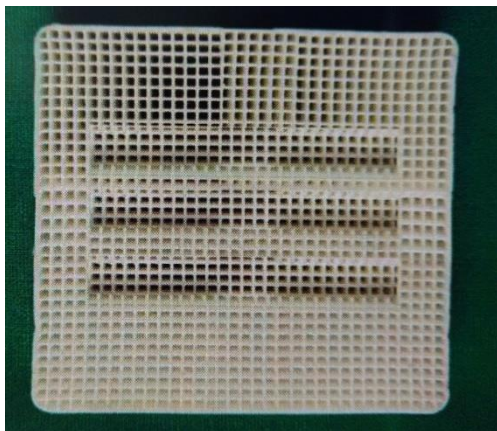
Figure 2. The customized sagger tray.

Customizing the Sagger Trays (Figure 2)

The sagger tray (firing tray) was customized to support and stabilize the test pieces. The tray was grooved along the length of the test piece to stabilize the test

pieces. Another groove was placed on the end surfaces of the test piece so that the two test pieces could be placed parallel with a gap of 2 mm between the ends for the porcelain application. This helped in the standardization of the thickness of the porcelain and also the paralleling of the samples as any bend would create a fulcrum, leading to the fracture of the samples under a slight tensile load.

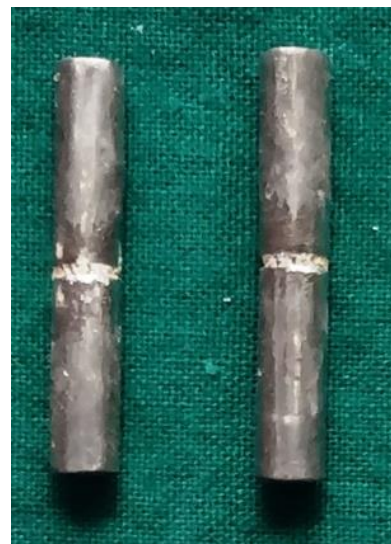
Figure 3. The fabricated samples.

The test pieces were placed on customized sagger trays facing each other, with the surfaces having undergone surface treatments; during the placement, a 2-mm gap was maintained for porcelain firing. The samples were air-dried in front of the open furnace chamber for 10 minutes; then, the opaque layer of the porcelain was applied and heated from 1250°F to 1750°F at a rate of 80°F/minute. Two test pieces formed a sample with a 2-mm-thick porcelain piece interposed between them (Figure 3).

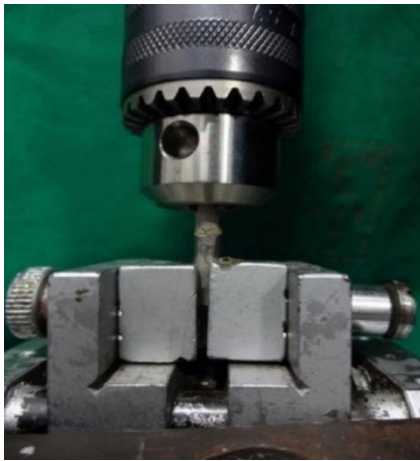
Figure 4. Holding of the sample in the fixture.

The samples of the metal block, with ceramic interposed, were placed in the fixtures of the universal testing machine (Instron, India Private Limited) and a maximum tensile load was applied at a crosshead speed of 5 mm/min (Figure 4) and the tensile bond strength for all the four groups was tabulated (Table 1).

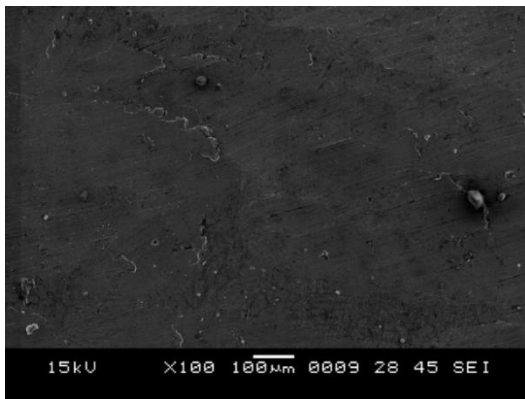
Figure 5. SEM image showing surface irregularities after surface treatment in group A.

2. The tensile bond strength was the highest in group D and the lowest in group A. Group B and C showed higher bond strength compared to Group A, with lower bond strength compared to group D.
3. Scanning electron microscope observations in group A after surface treatment showed a smooth surface with no irregularities (Figure 5), and the type of bond failure was predominately adhesive (Figure 6).
4. Group B showed surface irregularities, which were less than that in group C (Figure 7), with a mixed type of bond failure that was a combination of adhesive and cohesive failures, predominately adhesive (Figure 8).
5. Group C showed surface irregularities, which were more than those in group B (Figure 9). The type of bond failure was cohesive, but the line of demarcation was not clean (Figure 10).

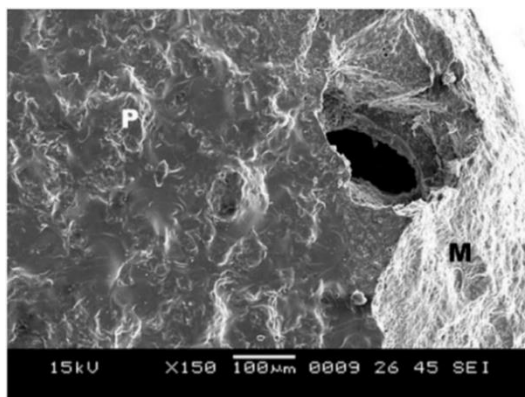
Figure 6. SEM image of the debonded surface in group A, where P is porcelain and M is metal.

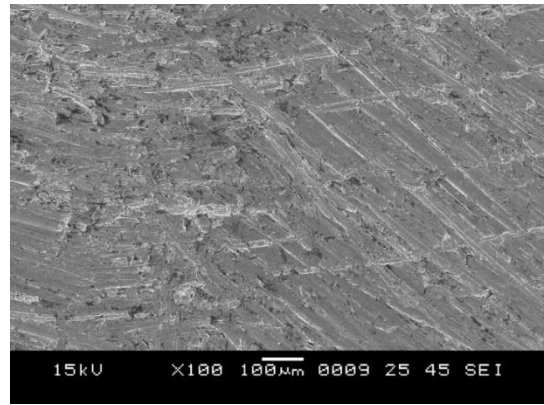
Figure 7. SEM image showing surface irregularities after surface treatment in group B.

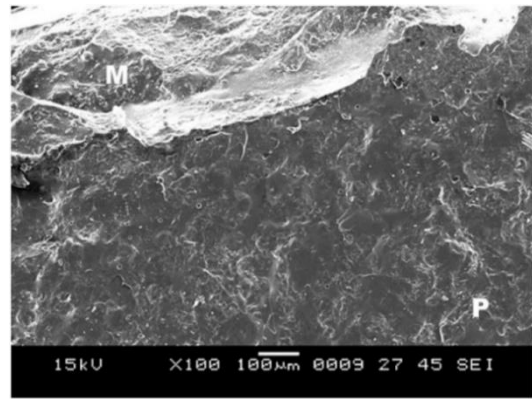
Figure 8. SEM image of the debonded surface in group B, where P is porcelain and M is metal.

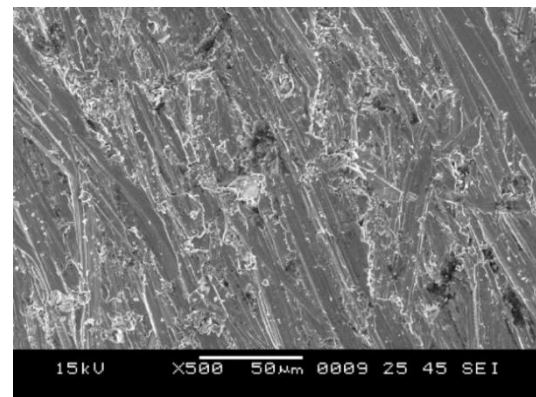
Figure 9. SEM image showing surface irregularities after surface treatment in group C.

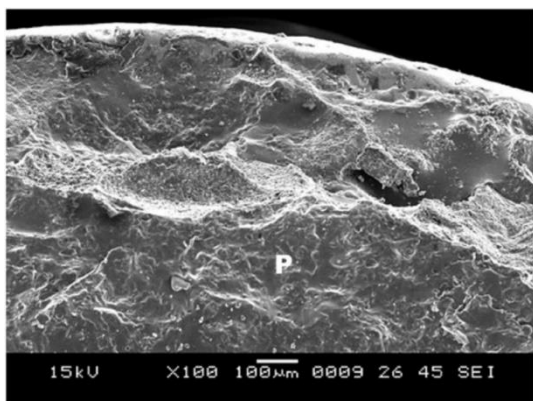
Figure 10. SEM image of the debonded surface in group C, where P is porcelain and M is metal.

Naylor¹⁷ also reported that one of the reasons for the porcelain–metal bond failure is contamination, and the best procedure to remove the impurities is ultrasonic cleaning in distilled water for 10 minutes. The absence of a clear line of demarcation in group C is

attributed to the impurities present, which were not found in group D.

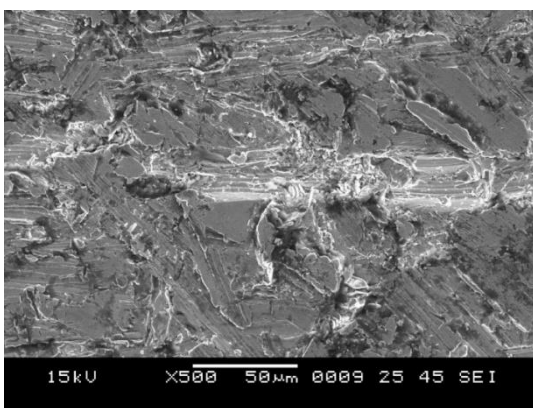
Figure 11. SEM image showing surface irregularities after surface treatment in group D.

Group D showed surface irregularities, which were more than those in all the other groups (Figure 11); this is essential for bonding between the metal and ceramic and cohesive type of bond failure with a clean line of demarcation (Figure 12).

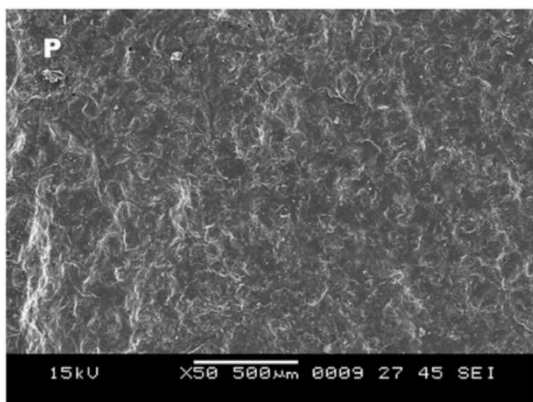
Figure 12. SEM image of the debonded surface in group D, where P is porcelain and M is metal.
