## Research Article

# Long-Term Assessment of an Innovative Mangrove Rehabilitation Project: Case Study on Carey Island, Malaysia

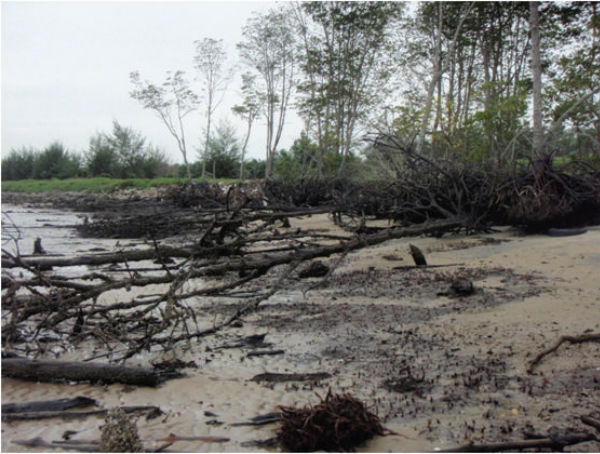
FIGURE 2: Loss of "*Rhizophora apiculata*" mangrove forests at the site before the project is carried out in early 2008.

wave energy induced by storms [20]. The environmental value of mangrove forests, however, was ignored in this era, and the negative consequence was the massive retreat of mangrove trees observed over the last two decades (Figure 2).

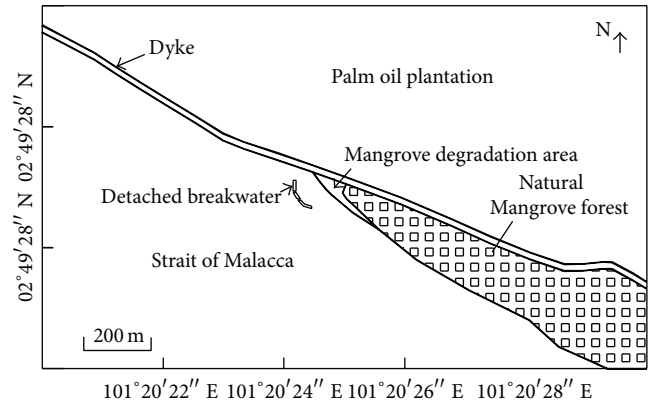
FIGURE 3: The schematic view of Carey Island after mangrove rehabilitation project in 2008.

The university directed construction of a detached breakwater system composed of a submerged breakwater with three segments separated by 2.5 m to allow for water circulation. Hashim et al. [20] reported that the average crest height of the breakwater system is 1.8 m above MSL. Furthermore, the system occupies nearly 60 m of the shore at the site. The system is approximately perpendicular to the coastline. The authors also presented detailed information on the breakwater design and described its implementation. Figure 3 illustrates the geographic position of the deforested area and the existing mangrove forest before the breakwater system was constructed in 2008. The figure also depicts the breakwater system and the dike after construction was completed.

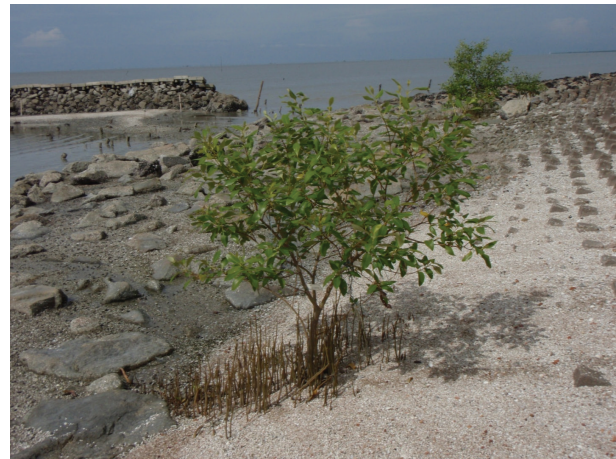
FIGURE 4: A row of natural recruits in the study site at the site near the detached breakwater (June 2014).

Our most recent observation (June 2014) revealed a few new natural recruits outside the rehabilitation site. The natural recruits are *Avicennia marina* and *Rhizophora apiculata*, which are now more than 1 m tall with well-developed spreading root systems (Figure 4). The growth of natural recruits indicates that the site is now biologically ready for further mangrove rehabilitation. Based on our findings, trying to rehabilitate the mangrove forest at the target site is worthwhile.

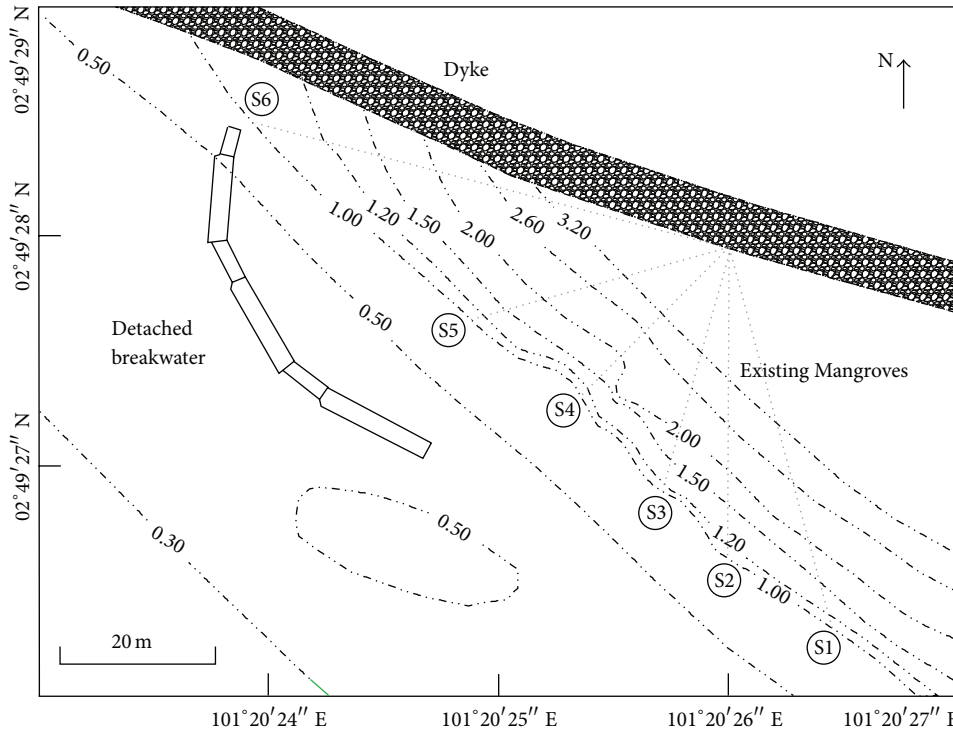
FIGURE 5: Thirty-six soil samples have been collected along S1 to S6 lines in various topographic elevations.

Sample salinity was assessed using an Atago Hand-Held Refractometer in accordance with *Standard Methods for the Examination of Water and Wastewater* (American Water Pollution Control Federation) [47]. Figure 5 shows the location of collected water samples for salinity test aligned along measurement axes S1 through S6.

*calcium, manganese, and copper.* The locations of collected water samples are depicted in Figure 5.

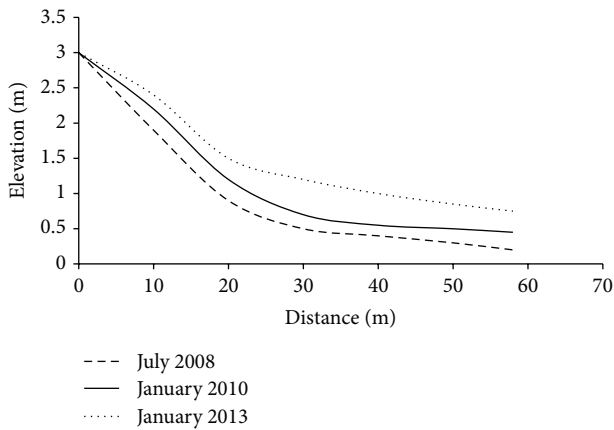
FIGURE 6: Observed elevation of sea bed level from December 2008 until January 2013 at the site.

We collected bathymetric data from Carey Island three times: in (1) December 2008 (before the detached breakwater system was constructed); (2) January 2010 (12 months after the detached breakwater system was complete); (3) January 2013 (48 months after the detached breakwater system was finished). The analysis of bathymetric data along the S5 axis in Figure 5 shows the variation of average elevation of a cross-section of the beach.

**4.2. Cross-Section Surface Profiling.** Figure 6 shows the variation of elevation from July 2008 to January 2013. About four years into the project, the elevation of a cross-section along axis S5 in Figure 5 had increased considerably. For example, one month after construction, the elevation at the toe of the breakwater system rose from 0.2 m to 0.45 m. After 12 months, it increased nearly 125%. In the same way, the data collected in 2008 indicate that the elevation of the soil stratum at a distance of 30 m from the shoreline was about 0.5 m, and as of January 2013, it had increased to 1.2 m. The elevation was about 1.9 m near the coastal dike at a distance of 10 m from the shoreline in 2008. The elevation at the same location reached 2.2 m in January 2010. Finally, in January 2013, the elevation leveled at 2.4 m. The sediment deposition trend is more noticeable near the breakwater than near the shoreline. Based on the positive trend of growth in the seabed level over time, we can conclude that the elevation of a cross section of the beach is increasing.
