C A S E R E P O R T

Rupture of the femoral component and severe metallosis of the knee 10 years after unicompartmental knee arthroplasty (UKA): a case report

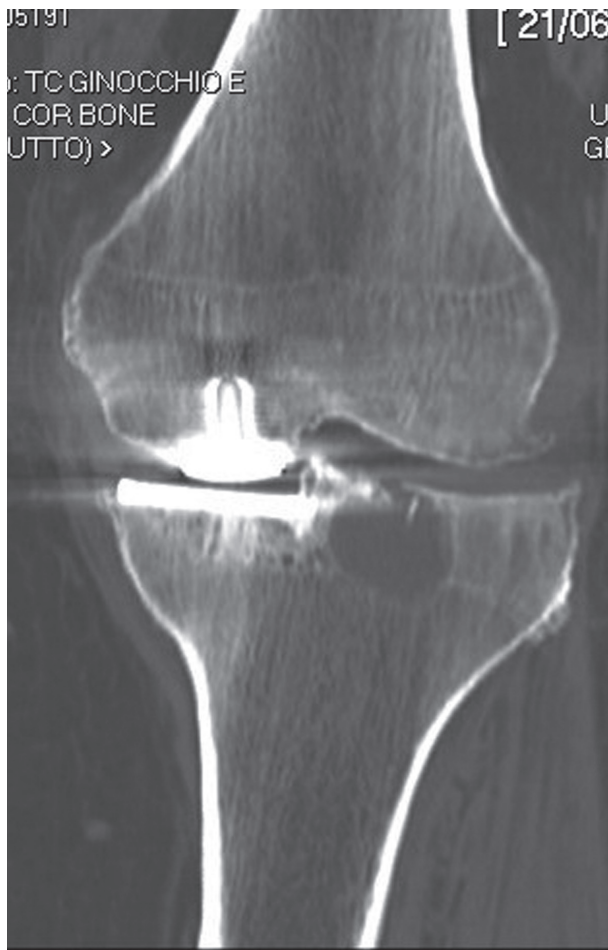
Figure 1. CT scan of the UKA

In a CT scan performed in June 2017 (Fig. 1) no signs of alteration were evident, but an X-Ray performed in January 2018 (Fig. 2) showed a rupture in the UKA femoral component.

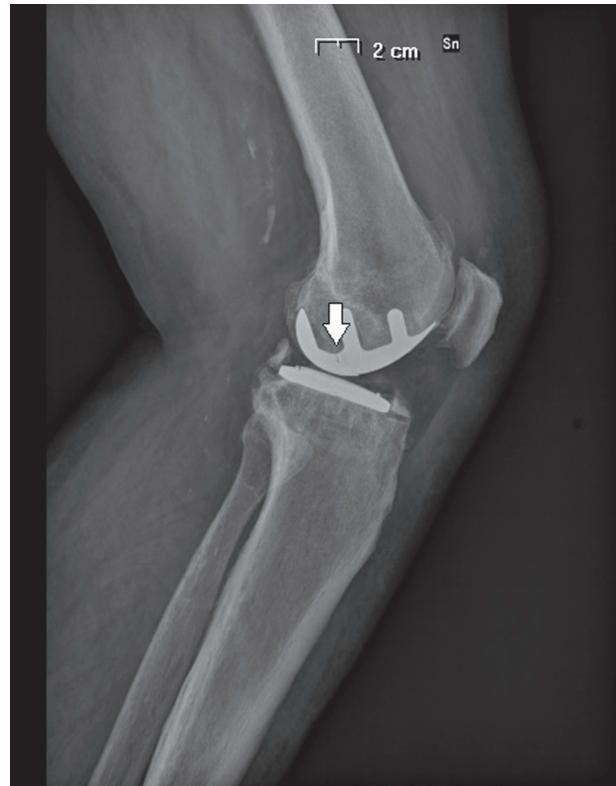
Figure 2. XR in LL projection. The white arrow indicates the rupture of the femoral component

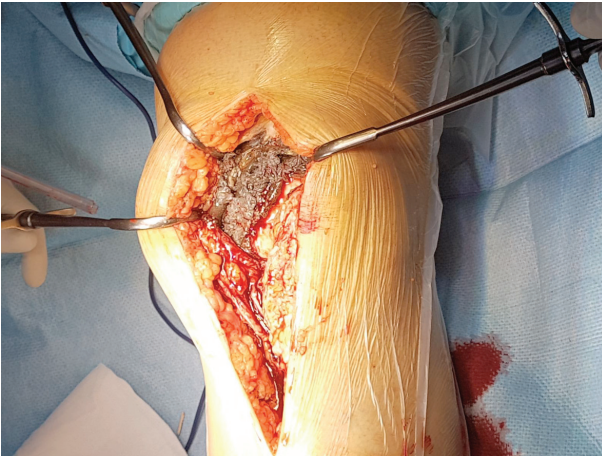
Revision surgery was performed at the end of February 2018. At the time of revision surgery, we noticed a very clear synovitis associated with a massive metallosis. The tibial component was well fixed while the femoral component was broken (Fig. 3-4).

Figure 3. At the exposure of the articular cavity the metallosis and the synovitis were clear

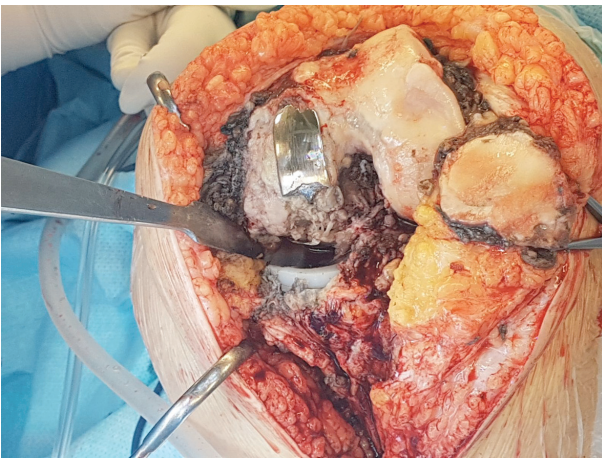
Figure 4. Intraoperative view of the broken femoral component and the wear of the polyethylene insert

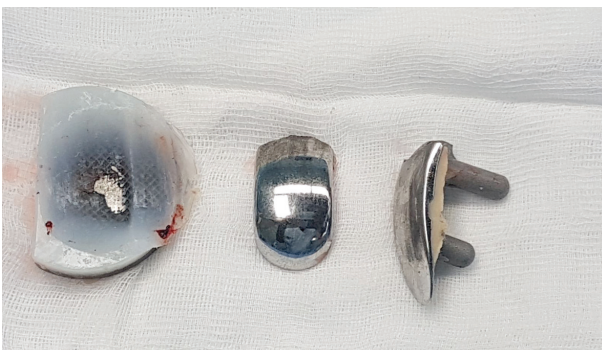
There was a severe wear of the polyethylene tibial insert (Fig. 5) that caused a minor friction between the femoral component and tibial metal surface with a huge abrasion of the metal femoral component. The periprosthetic tissue affected by the metallic debris was cleaned up and several swab samples were taken from the articular structures. Then a cemented medial pivot total knee arthroplasty was performed (revision Advance, MicroPort®) (Fig. 6).

Figure 5. Tibial and broken femoral component of the prosthesis

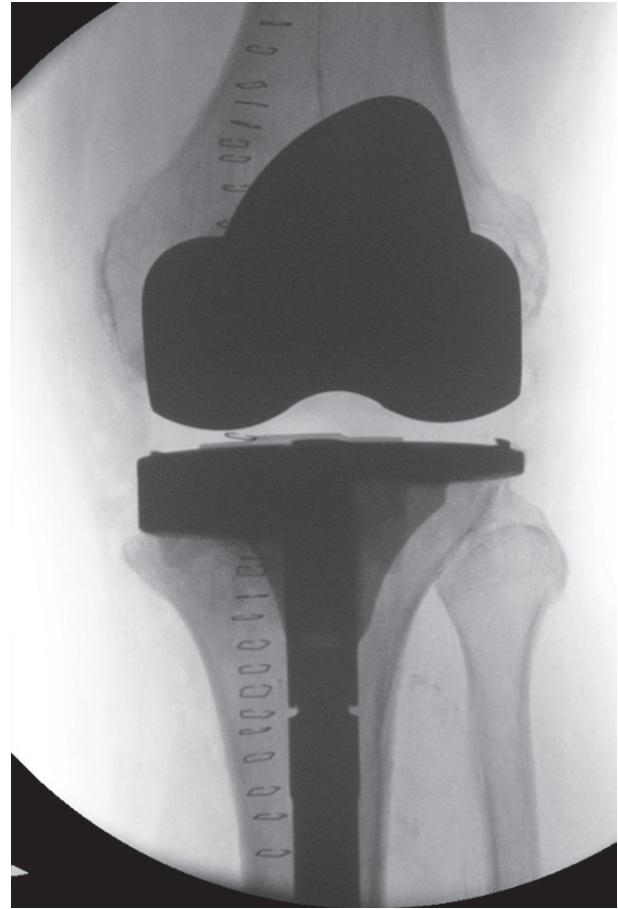
Figure 6. Fluoroscopic image of the revision total knee arthroplasty
