Case Report

Disengagement and intrapelvic migration of a dynamic helical hip screw

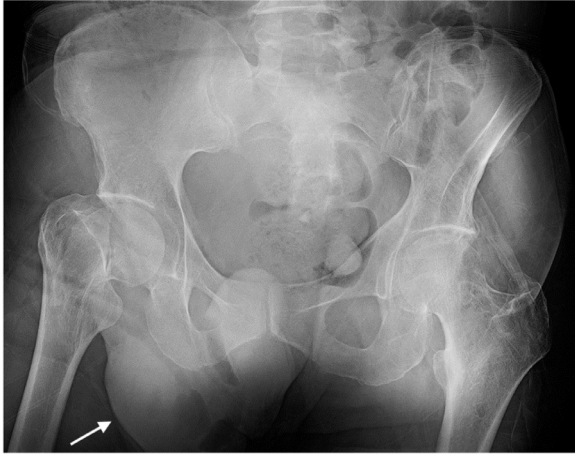
Fig. 1 – AP (anteroposterior) radiograph of the pelvis shows displaced transcervical fracture of the right femoral neck with valgus angulation, external rotation, and femoral foreshortening. There is an incidental large right inguinal hernia (arrow).

a displaced right basicervical femoral neck fracture (Fig. 1). Given the patient's social situation, medical history, and comorbidities, including hypertension, diabetes mellitus type II, and tobacco use, he was not considered a good candidate for hip arthroplasty. He gave consent for open reduction and internal fixation using the DHHS apparatus. At surgery, the fracture was found to extend vertically and distally through the medial cortex at the level of the lesser trochanter (Fig. 2). The procedure was performed without complication and the immediate postoperative course was unremarkable (Fig. 3). The patient was discharged to a supported living facility with wound care instructions and deep venous thrombosis prophylaxis. His activity instructions were weight-bearing as tolerated of the right lower extremity.

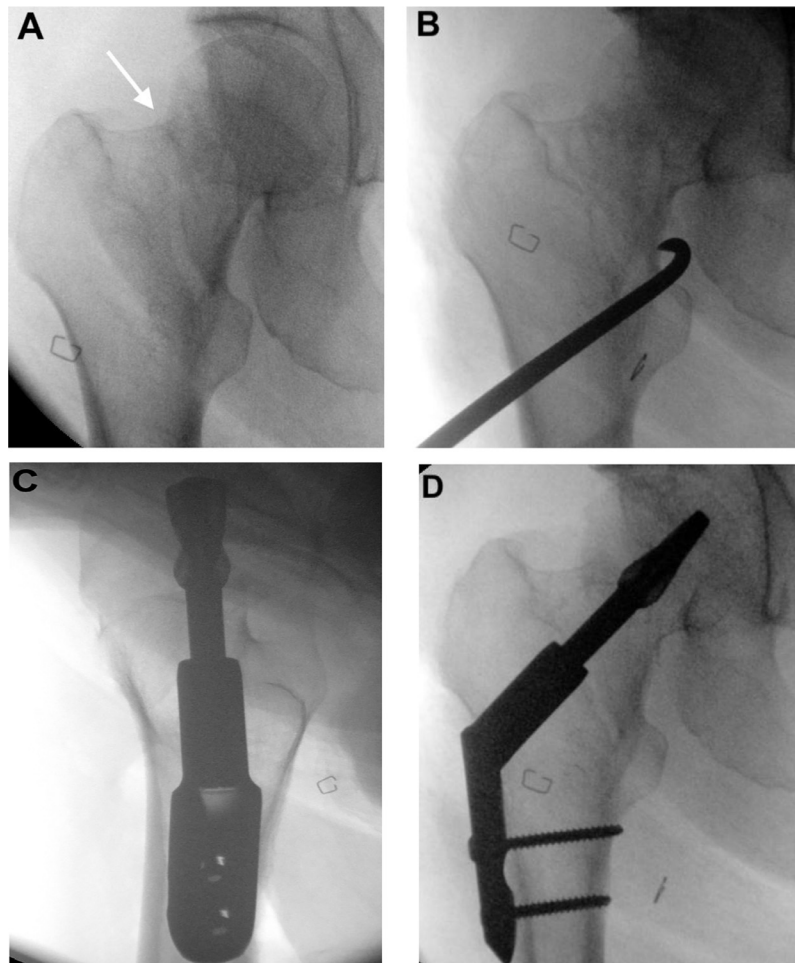
Fig. 2 – Intraoperative radiographs showing surgical treatment of the right basicervical femur fracture. Initial image shows mildly displaced vertically oriented fracture (arrow) (A). The fracture has been reduced with instruments (B). Lateral and AP images show appropriate position of the dynamic helical hip system device (C–D).

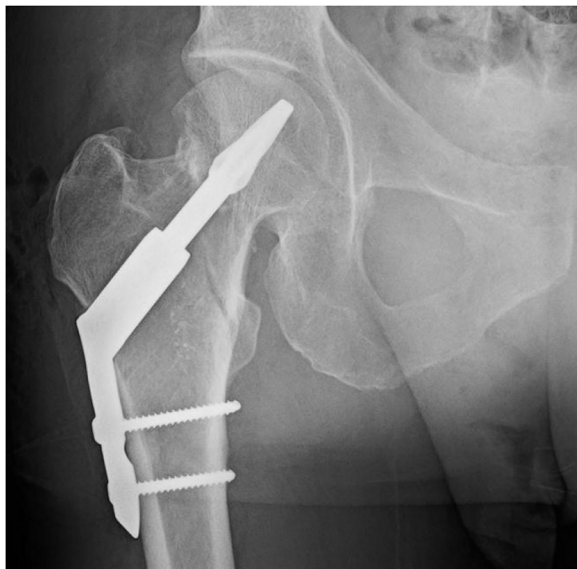
Fig. 3 – Immediate postoperative AP radiograph before weight-bearing shows anatomically reduced fracture with ideal position of hardware. Note that the hip screw has a helical blade rather than threads.

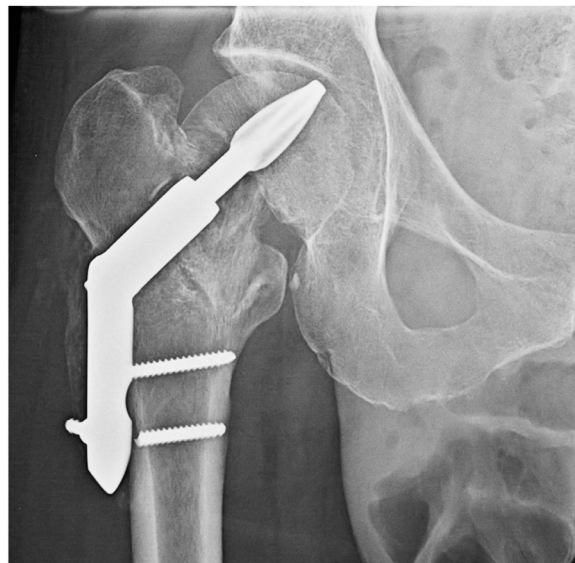
Fig. 4 – AP radiograph of the right hip 6 weeks after surgery shows subsidence of the femoral head fragment and protrusion of the tip of the hip screw through the articular surface. There is loosening of the hardware and breakage of the distal sideplate screw with migration of the head fragment into the soft tissues. There is a large right inguinal hernia.

On his postoperative visit 6 weeks later, the patient was found to have extension of the helical blade medially through the articular surface of the femoral head and a fractured side-plate screw (Fig. 4). He was initially managed conservatively with weight-bearing restrictions. After approximately 4 weeks

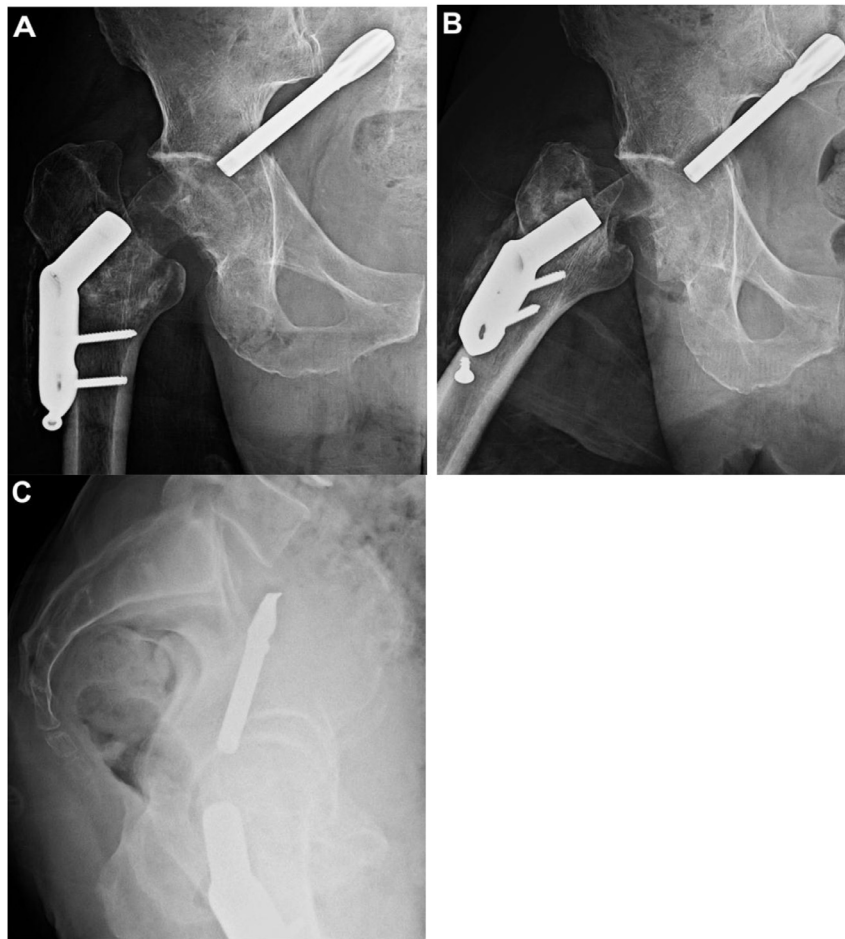
Fig. 5 – AP, frog-leg, and lateral radiographs of the right hip 10 weeks after surgery (A–C). There has been complete disengagement of the hip screw from the plate barrel and migration through the hip joint into the pelvic cavity. There is marked bone resorption at the fracture site, no evidence of healing, and proximal migration of the distal femur. Additionally there is redemonstration of the broken distal sideplate screw and right inguinal hernia.

(10 weeks postoperative), he was noted to have worsening ambulatory capacity and follow-up radiography showed complete disengagement of the helical blade from its plate barrel with intrapelvic migration (Fig. 5). Out of concern for possible vascular or visceral injury, and for surgical planning, CT angiography of the abdomen and pelvis was performed, but no injury was found (Fig. 6). The patient was returned to the operating room and the side plate and screws were removed, including the fractured distal plate screw, through a lateral incision. The helical blade was visualized under fluoroscopy, retrieved with a solid coupling screw, and removed through the existing femoral head and acetabular defect (Fig. 7). The patient remained hemodynamically stable during hardware retrieval and did not demonstrate evidence of hollow viscus injury; therefore, laparotomy was avoided. An arthroplasty was not performed because the patient was considered to be a poor surgical candidate, given his marginal pre-existing ambulatory capacity, limited functional demands, and anticipated high risk of complications and failure. His postoperative course was unremarkable. He was discharged to a skilled nursing facility for rehabilitation with weight-bearing restrictions.

In the case presented above, approximately 10 weeks postsurgery, there is complete disengagement of the construct with migration of the dynamic blade into the pelvis. As described, the patient was evaluated when there were symptoms concerning for worsening hardware complication and eventually taken to surgery. The remarkable finding in this case was the absence of intrapelvic injuries associated with the migration of the blade. Because of this finding, retrieval of the hardware was uncomplicated and the patient did not experience any other complications.

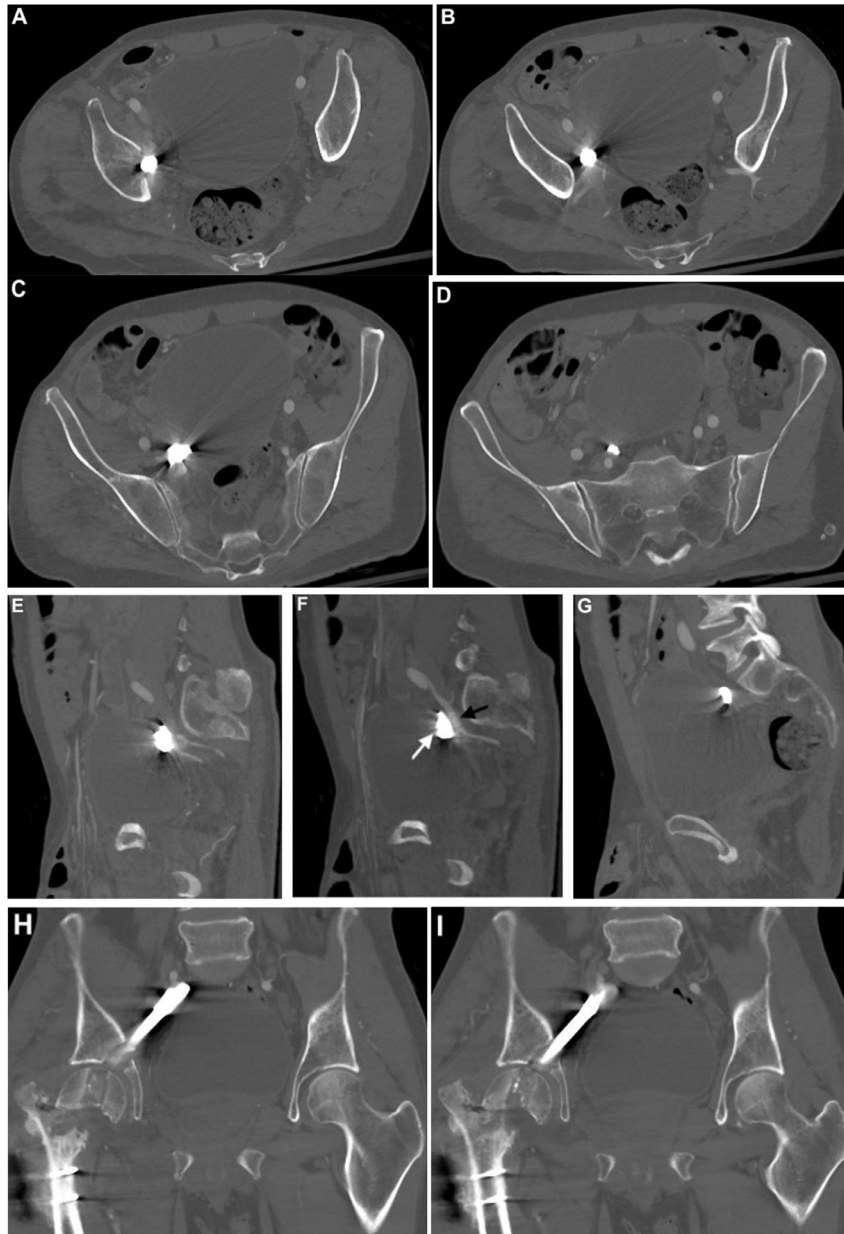
Fig. 6 – Standard axial (A–D) and sagittal maximal intensity projection (E–G) CT angiography images of the pelvis show the helical blade inside the pelvic cavity, but there is no evidence of vascular or pelvic visceral injury. The helical blade abuts the right internal iliac artery (white arrow pointing to the screw, black arrow pointing to the artery) (F). Coronal (H and I) CT angiography images show the migration path through the femoral head and acetabulum, as well as severe bone resorption at the fracture site.

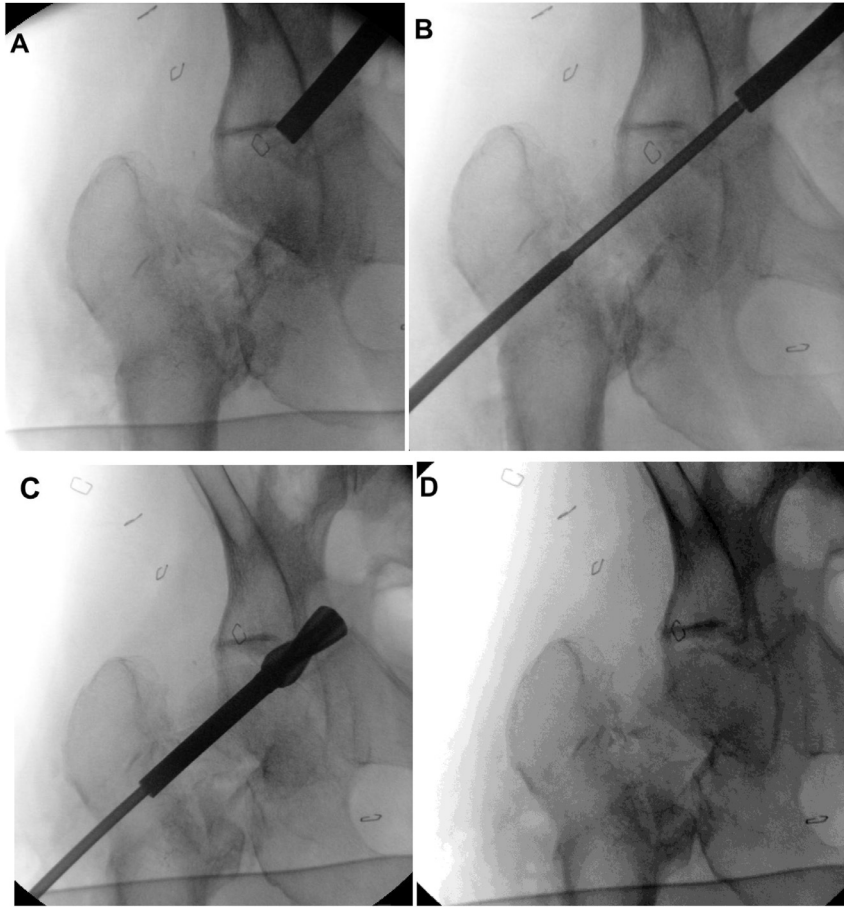
Fig. 7 – Intraoperative radiographs showing retrieval of the migrated helical blade. After removal of the side plate, the migrated helical blade could be visualized (A). The helical blade was captured by threading the solid coupling screw into the blade shaft (B). The helical blade was pulled out through the original hole (C). All of the hardware has been removed (D).

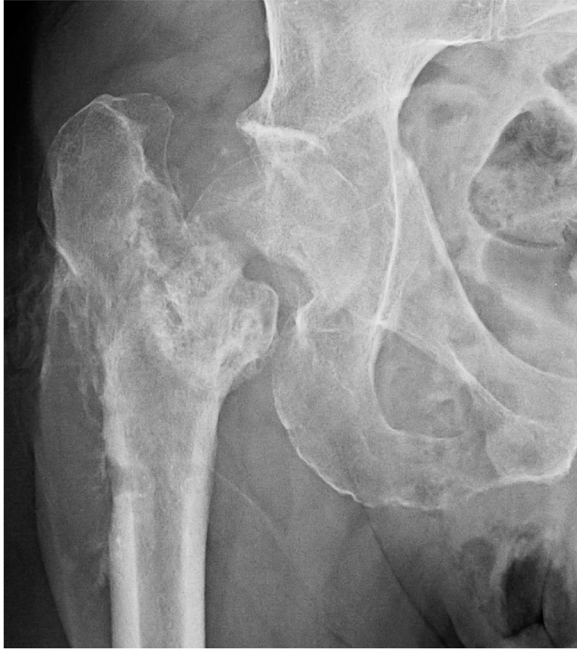
Fig. 8 – Postoperative follow-up at 4 weeks (14 weeks after original fracture fixation). AP radiograph of the right hip shows atrophic nonunion of the femoral neck fracture with proximal migration of the distal femur.

The patient was seen in clinic 4 weeks after hardware removal and reported only minor discomfort. Radiographs showed nonunion of the femoral neck fracture but no surgical complications (Fig. 8). It was decided that the patient could progress to weight-bearing activities as tolerated. Should the patient develop significant symptoms, particularly pain, a resection arthroplasty (Girdlestone procedure) would be the last resort.
