# Leadless Pacemaker Pitfalls

## Navigating Implantation and Postprocedure Challenges

**CASE SUMMARY** Our case highlights the rare occurrence of LP dislodgement into the pulmonary artery and the delayed development of a traumatic right ventricular apical pseudoaneurysm.

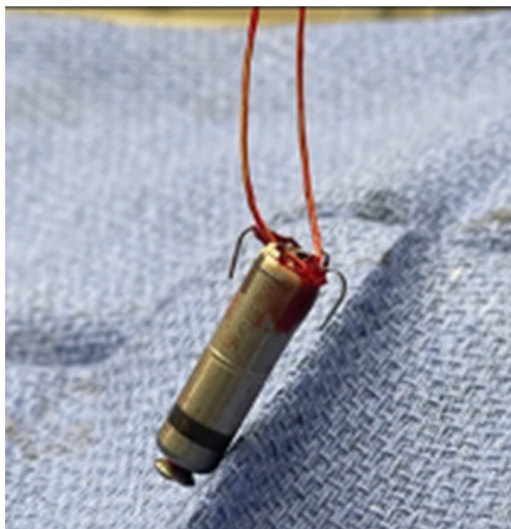
**FIGURE 4** Successful Retrieval of a Leadless Pacemaker Using a Snare at the Distal End

Successful retrieval of the device by snaring it at the distal end.

In this report, we delineate a case illustrating methods for safely retrieving an acutely embolized leadless Micra pacemaker from the right PA. In our experience, it is important to reposition the LP device in order to snare it via the distal end (nitinol tines) to avoid risking the nitinol tines getting stuck on the pulmonary valve or T formation leading to obstruction.

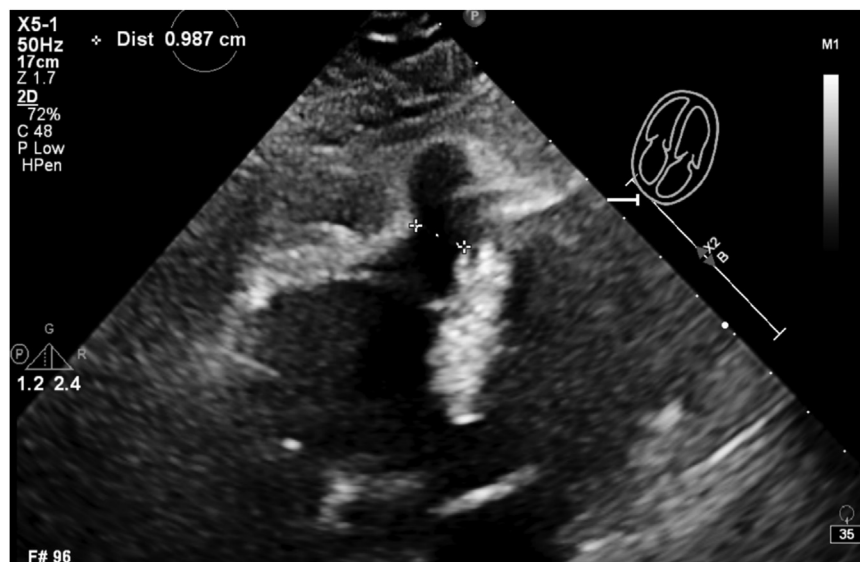
**FIGURE 5** Echocardiogram Obtained 4 Months After Initial Device Deployment

Echocardiogram showing a large echo density within the pericardial space, causing compression of the right ventricular free wall.

was readmitted 4 months after her initial presentation due to worsening edema and orthopnea concerning acute decompensated heart failure exacerbation. Repeat TTE at that time showed a large echo density within the pericardial space, causing compression of the RV free wall, raising concerns for a contained rupture (Figure 5). This was not seen on
