Research Article

Bearing-Foreign Material Deposition on Retrieved Co-Cr Femoral Heads: Composition and Morphology

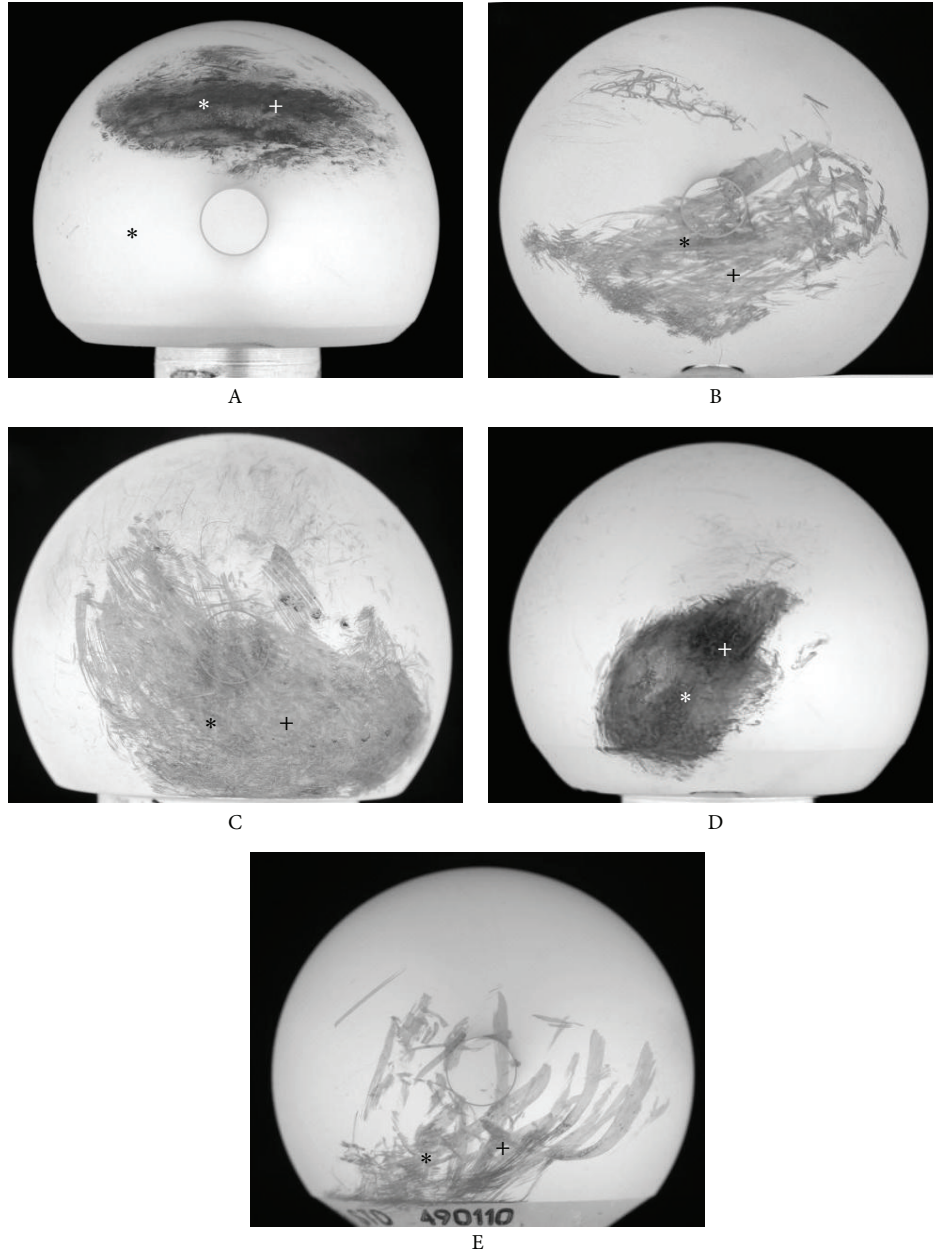
FIGURE 1: Diffused-light macroscopic images of the five femoral heads showing extensive bearing-foreign material deposits. The circles in the middle of images of heads A, B, C, and E delimit the reflection of the camera lens, which was eliminated by digital combination of photographs. The cross-mark (+) in each image identifies a corresponding site of SEM-based morphologic characterization in Figure 4, and the asterisks (*) designate the sites of EDS evaluation in Figure 5.

Each femoral head featured a large, noticeably dark region (Figure 1). Visually, head A showed a nearly featureless dark swath located close to the apex (Figure 1A). In head B, the main dark region was composed of many overlapping scrapes centered slightly below the equator (Figure 1B). Head C displayed a large dark zone also consisting of many overlapping scrapes; this region appeared much more diffuse, with individual features being difficult to discern (Figure 1C). Head D displayed a very dark region concentrated in a single discrete zone in the lower portion of the head (Figure 1D). Head E also had a dark region of overlapping scrapes (Figure 1E).

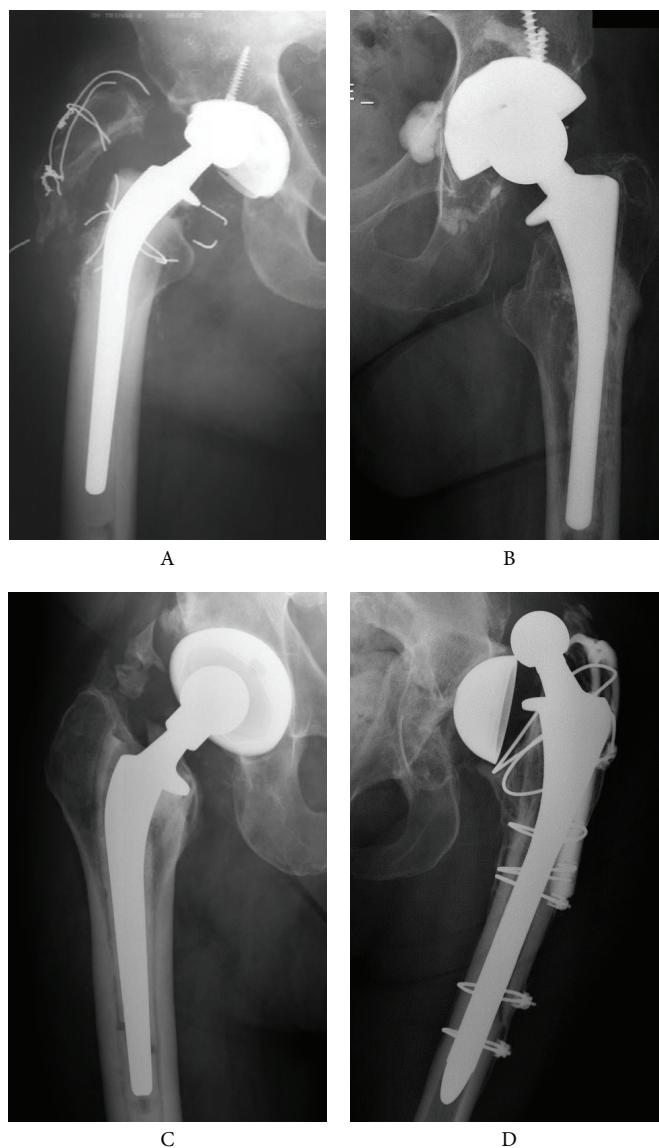
FIGURE 2: Radiographs from patients from whom heads A–D were retrieved. Radiographs of head E were not available.

Head A. A 76-year-old male presented with subluxation of his right hip 16 years after implantation (Figure 2A). He was noted to have had increasing acetabular liner wear over the preceding three years, but he had declined revision. He also had a trochanteric nonunion. After the subluxation was reduced, he elected to have revision surgery. Intraoperative findings included soft tissue metallosis. The liner was substantially worn and had undergone a rim fracture.

Head B. A 91-year-old female presented 18 months postrevision THA with a history of three dislocations of her hip within a three day interval, seven months previous to presentation. Radiographs (Figure 2B) demonstrated a loose femoral component and the stem was found to be loose at

the time of revision. The liner had embedded debris and impingement damage that was less than 1 mm deep (Grade 2, Hospital for Special Surgery (HSS) scale) [6].

Head C. An active obese 48-year-old male, a tow truck operator, was initially revised for instability one month postprimary THA. Six years later, a second revision was performed for aseptic loosening and late (5 years post op) recurrent (six times) dislocation. Radiographs (Figure 2C) demonstrated loosening of the femoral component and a stable acetabular component. The femoral component was grossly loose at the rerevision surgery. The liner had embedded debris and impingement damage that was greater than 2 mm deep (Grade 4, HSS scale).

prior she had suffered a dislocation that had been left unreduced. Radiographs demonstrated that the implant was still dislocated at the time of presentation and that there was shell loosening (Figure 2D). Intraoperative findings included a grossly loose shell with a 15° elevated acetabular liner rim. The liner had embedded debris and impingement damage that was less than 1 mm deep (Grade 2, HSS scale).

Head E. A 43-year-old male presented five years post THA with a history of one early postoperative dislocation and four recent dislocations which had occurred within a four-day interval. The liner impingement damage was less than 1 mm deep (Grade 2, HSS scale).

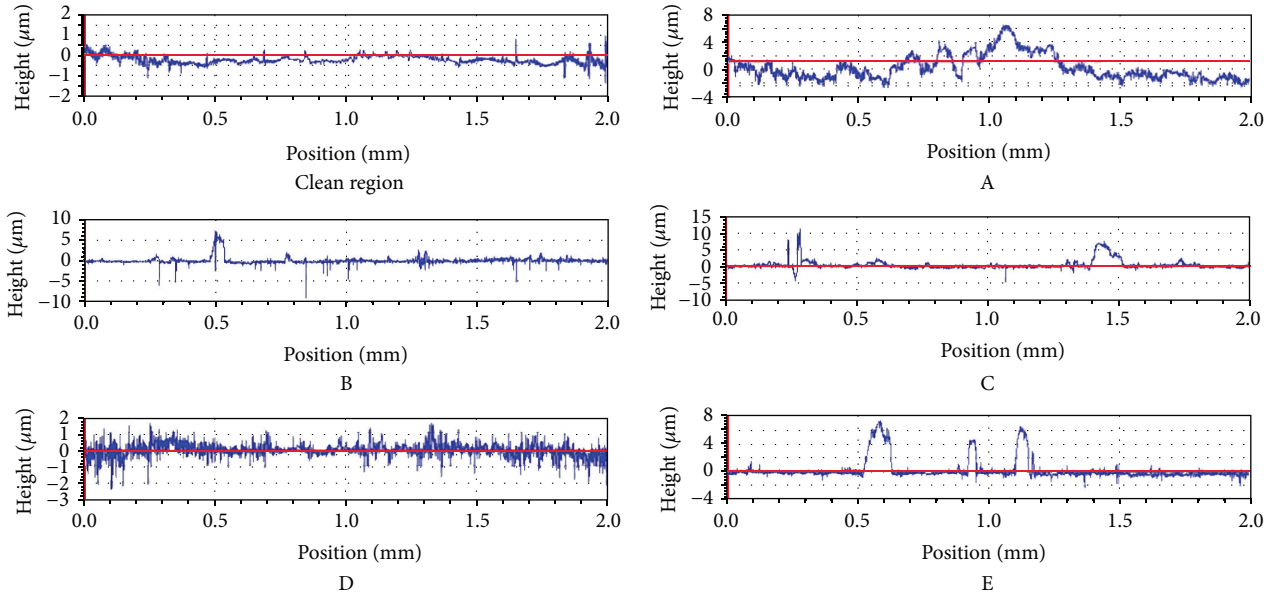
FIGURE 3: OP data from a “clean” region and from the deposit regions on retrieved femoral heads A–E.

Optical profilometry with roughness measurements illustrated the distinctions between the deposit and clean regions on the femoral heads (Figure 3). The deposit regions were associated with increased roughness (Table 1) and tended to involve many isolated peaks. Roughness increases between the clean and deposit regions on each head were 2.5–12.5, 4.0–11.7, and 5.0–10.8 for R_a , R_{rms} , and R_z , respectively.

Although individual R_a and R_{rms} values in the deposit regions were mostly at submicron levels, individual R_z values were generally more than $10\ \mu\text{m}$ for the deposit region.

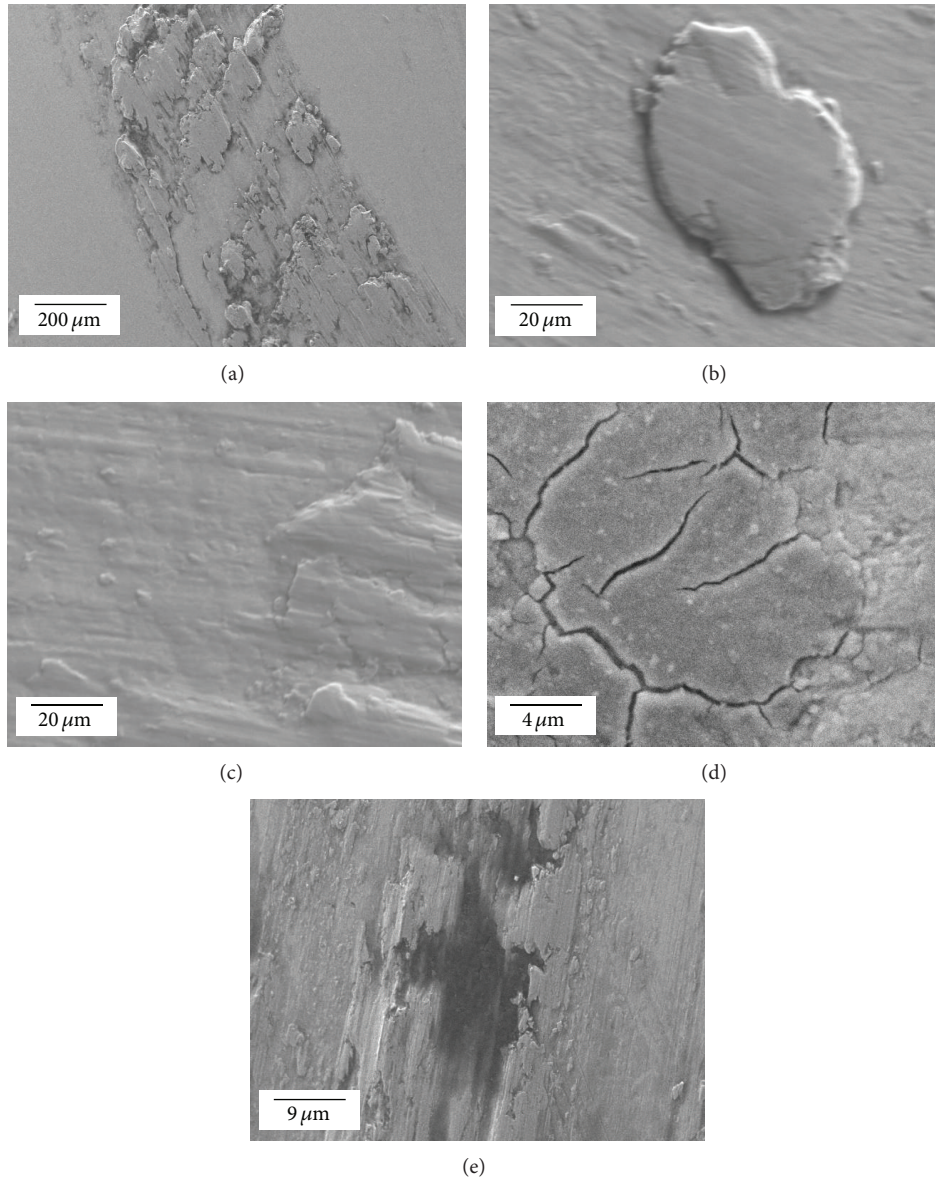
FIGURE 4: Representative microscopic morphological features observed by SEM on the deposit regions on the femoral head surfaces showing (a) pronounced scrape with deposits, (b) large, isolated deposits, (c) areas containing many small deposits $<10\ \mu\text{m}$ in diameter, (d) otherwise relatively featureless film showing some evidence of fracture, and (e) evidence of more than one compound within the deposit region. Images (a)–(e) are, respectively, from femoral heads A–E in Figure 1.

Surface irregularities observed by SEM within the dark regions of the retrieved femoral heads ranged from submicron to multimicron sizes and exhibited a range of morphologies (Figure 4). These included large areas containing pronounced scrapes with deposits (Figure 4(a)), large deposits ($>10\ \mu\text{m}$ in diameter) (Figure 4(b)), small particle deposits ($<10\ \mu\text{m}$ in diameter) (Figure 4(c)), scaly films with fractures (Figure 4(d)), and contrast differences that suggested that more than one compound existed within a deposit region (Figure 4(e)). Sites with deposits standing proud to the surrounding topography were frequently observed in the dark regions. Fine-scale scratches were widely evident, but had no consistent direction.

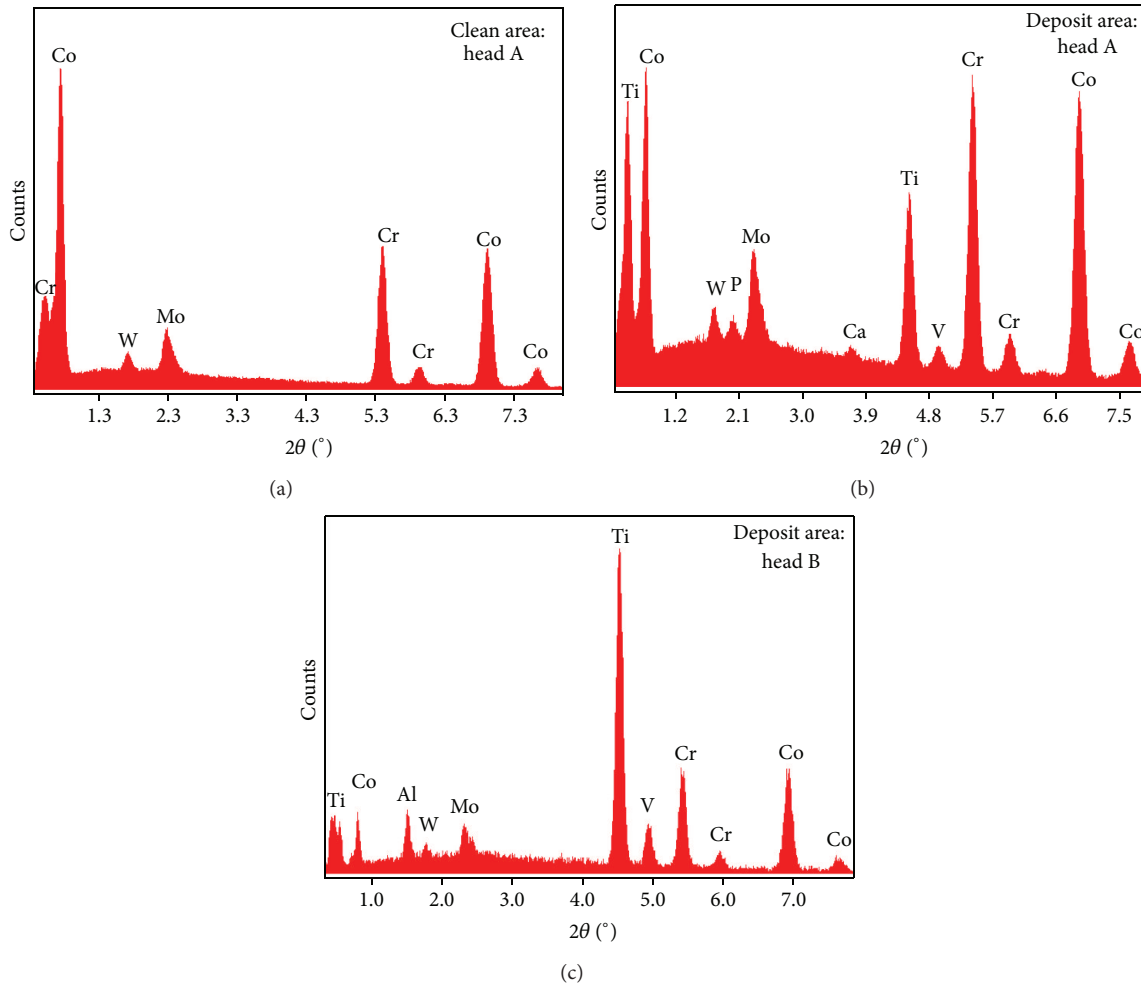
FIGURE 5: EDS data from a clean area on head A and from the deposit areas on heads A and B. The sites from which these data were collected are noted by asterisks (*) in Figure 1. Similar data were collected from deposit areas of all heads (sites marked with * in Figure 1), displaying peaks indicating the additional presence of bearing-foreign elements Ti, Al, V, Ca, and P.

The clean areas of the femoral heads had EDS peaks corresponding to Co, Cr, Mo, and W (Figure 5(a)). In the deposit areas, Ti, Al, V, Ca, and P also were found (Figures 5(b) and 5(c)). The intensity of the EDS peaks within the dark

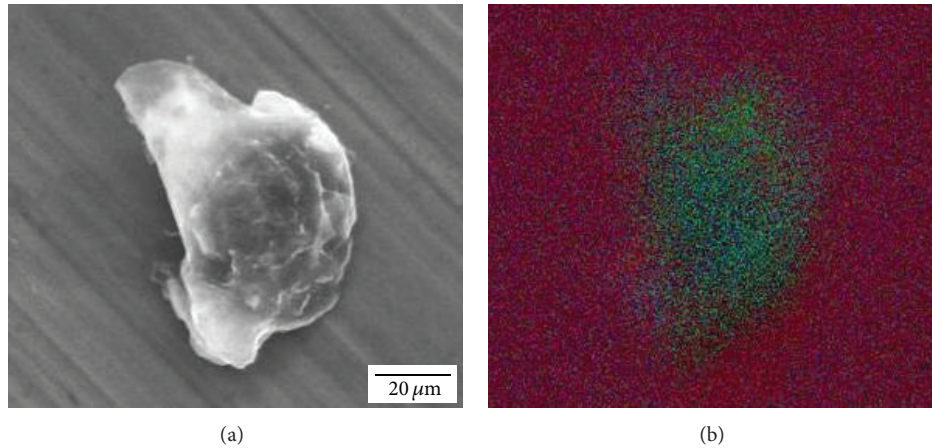
areas was highly variable. Compositionally distinct tungsten-rich particles (Figure 6) were observed on top of the deposits in all five heads. XPS performed on the deposit area on head A (Figure 7) confirmed the presence of Ca and P on the surface, with the deposit having a nominal metals basis composition of 22.2% Ti, 25.8% Ca, and 29.8% P.

FIGURE 6: (a) SEM and (b) false-color EDS map of a tungsten-rich particle on the surface of head A. The EDS mapping demonstrates that these particles were compositionally distinct from the surrounding surface.

Tungsten-rich particles were observed within the deposition areas for all five femoral heads studied. Tungsten is not a constituent of orthopaedic titanium alloy, but it is a minor constituent (0.2% maximum) of ASTM F75 cobalt-chrome alloy [29], appearing in the microstructure as tungsten carbide (WC) particles that block the motion of lattice discontinuities [30]. To our knowledge, WC particles have not been previously reported as surface contaminants of retrieved total joint replacement implants. There have, however, been similar observations of other minor constituents of cobalt chrome alloy appearing in particulate deposits on retrieval surfaces. Raimondi et al. detected silicon and manganese in spherical particles (5–10 μm diameter) found on the surface of retrieved cobalt-chrome femoral heads [31]. Silicon and manganese are also minor constituents of ASTM F75 cobalt-chrome alloy (both 1% maximum) [29]; Raimondi et al.’s disproportionately high detection of these elements in those particles was attributed to the particles having been microsegregated within the cast cobalt-chrome head and subsequently released [31]. Davidson suggested a mechanism by which particles such as carbides and nitrides could be released from the femoral head as the surface metal is worn [32]. The tungsten-rich particles detected in the present study were also likely derived from the microstructure of the femoral component. Such released particles obviously could contribute to the third-body burden.

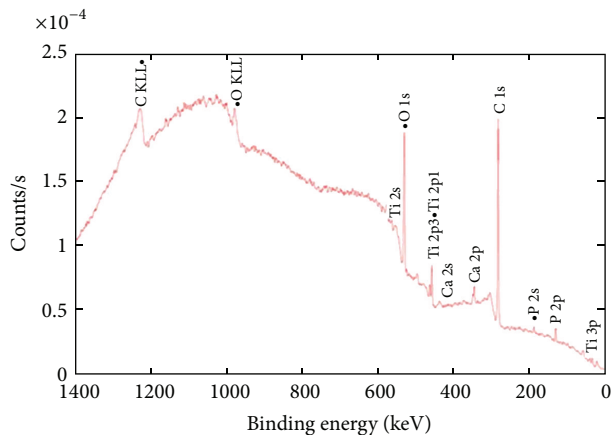
FIGURE 7: XPS data obtained from a 1×1 mm area in the deposit region on head A (site marked with an asterisk (*) in Figure 1A), showing presence of impurities corroborating the data observed in EDS. Nominal surface compositions associated with this scan are O: 68.75%, Al: 3.07%, P: 9.39%, Ca: 8.13%, Ti: 7.01%, Co: 3.68%, Cr: 0.2%, and W: 0.03%.

Calcium and phosphorus have been previously detected on retrieved heads from metal-on-metal bearings [18–21], although these elements were not associated with titanium deposition as was the case in the current study. Howie et al. suggested that the debris containing calcium, phosphorus, and oxygen that was found on the articulating surfaces and within wear tracks could be either from bone or from precipitated calcium phosphate [18]. McKellop et al. attributed surface deposits of calcium phosphate to precipitation from synovial fluid [19]. For the deposit analyzed with XPS in the current study, the apparent Ca/P ratio was close to unity, suggesting that these elements were in the form of brushite, which has been shown *in vitro* to act as a precursor to other calcium-phosphorous molecules [22, 23]. Spontaneous nucleation of calcium phosphates on titanium alloys *in vitro*

is a well-established phenomenon [24–27], culminating in the formation of carbonated hydroxyapatite. Clinically, such a mechanism could eventually result in the formation of *de novo* abrasive third bodies. EDS has limited sensitivity to the presence of calcium and phosphorous as they are relatively lighter elements [28]. That these lighter elements were detected in this study with EDS at all suggests that the thickness of these secondary deposits was appreciable. Importantly, however, calcium and phosphorous were not detected on clean (nondeposit) areas in this group of specimens; thus, there was no evidence for generalized deposition of these elements. Build-up of “secondary” deposits of calcium and phosphorous could potentially increase head roughness (and hence, exacerbate polyethylene wear) beyond that occurring by “primary” titanium alloy deposits alone.
