Article

A Full-Scale Experimental Investigation of Utility Poles Made of Glass Fibre Reinforced Polymer

Citation: Broniewicz, M.; Broniewicz, F.; Broniewicz, E. A Full-Scale Experimental Investigation of Utility Poles Made of Glass Fibre Reinforced Polymer. *Materials* **2021**, *14*, 7398. <https://doi.org/10.3390/ma14237398>

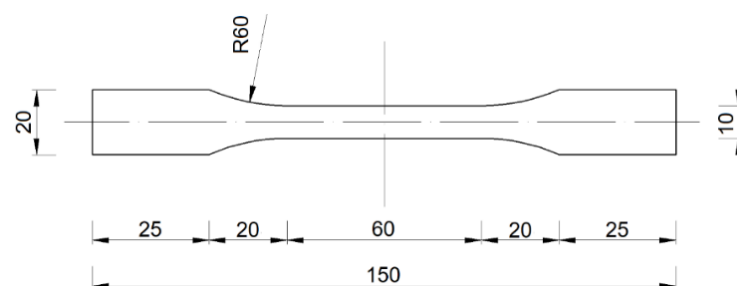
Figure 1. Tensile test specimen dimensions in mm (in accordance with [24]).

According to ISO 527-1 [25], the minimum number of test specimens was five. The values of the mechanical properties were determined with a 95% confidence interval. According to ISO 527-4 [24], the type of specimen used was 1B (Figure 1).

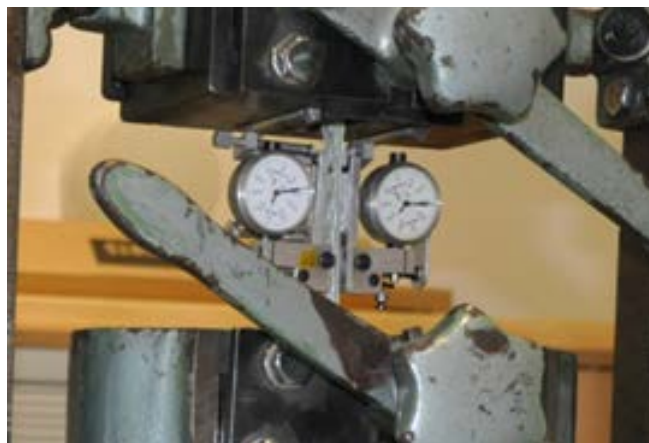
Figure 2. Specimen No. 4 during the tensile test.

The specimens were cut out from the columns' shafts to make the longitudinal axis of the specimen runs parallel to the axis of the pole. During the tests, the specimens were placed in the testing machine, ensuring that the specimen's longitudinal axis closely coincides with the longitudinal axis of the testing machine. The tensile test was performed on a Heckert ZD 10/90 static testing machine (Figure 2) manufactured by the company WMW AG, Erfurt, Germany. The tests were carried out in the range of up to 100 kN, with a minimum increment value of 200 N; the test temperature was +19 °C.

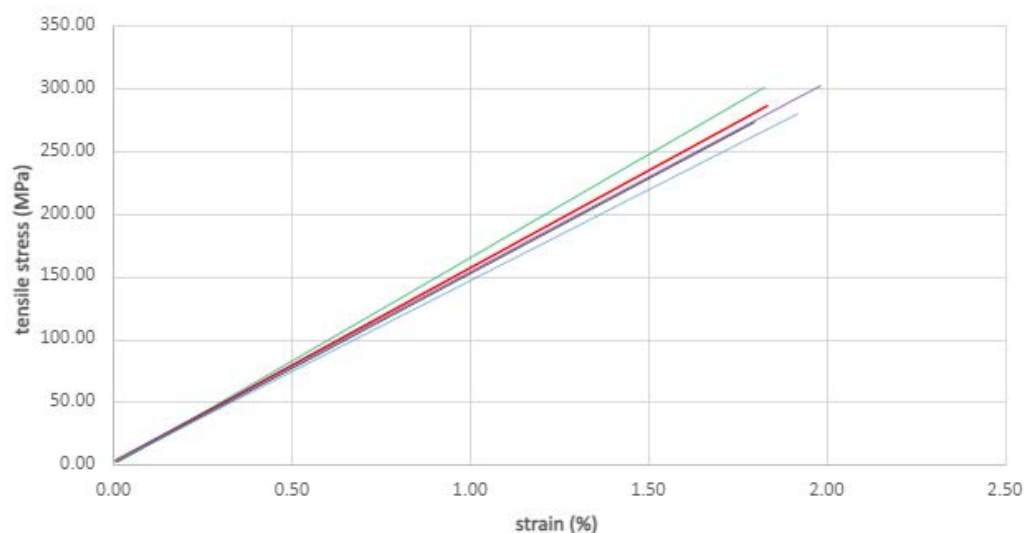
Figure 3. Coupon tensile tests: strength–strain curves.

During the tests, the specimen was loaded with tensile force along the main axis at a constant speed of 0.18 mm/s until failure. The values of the tensile force and the elongation of the measurement base of the tested specimen were recorded automatically, which allowed the stress–deformation curve characterising the tested material to be obtained (Figure 3).

A total of seven specimens were examined, five of which were accepted for further statistical processing. Two tested samples were rejected as their results were considered unreliable due to the elongation measuring device slippage on the sample surface. The values of the tested material characteristics were determined with the confidence level of 95%, required by ISO 2602 [26].

The estimated Young's modulus of elasticity in tension was obtained with linear regression of the experimental strength–strain curves corresponding to extensions ranging from 0.05 to 0.25. All specimens exhibited tensile failure in narrow gauge length (Figure 4).

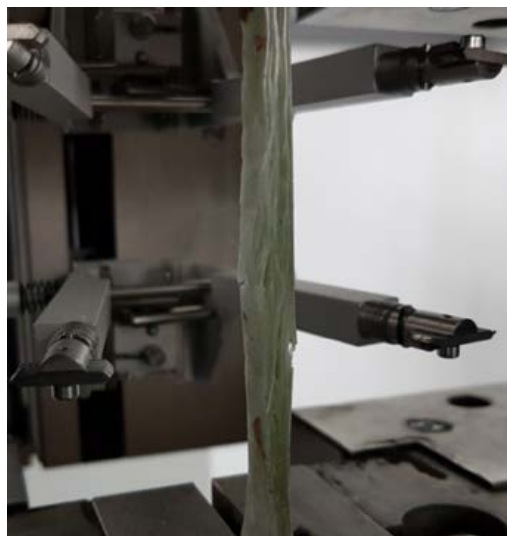
Figure 4. Ruptured specimen after static tensile test.

The brittle fracture was the failure mechanism of all tested GFRP samples. The tested GFRP specimens failed suddenly at the ultimate stress in the tensile test, and they all failed in the same manner, that is, fibre rupture. Due to surface debonding of the fibres and matrix, the failure occurred with abrupt longitudinal delamination of the laminae at the centre. As a result, as seen in Figure 5, broken fibres were divergent and fan shaped.

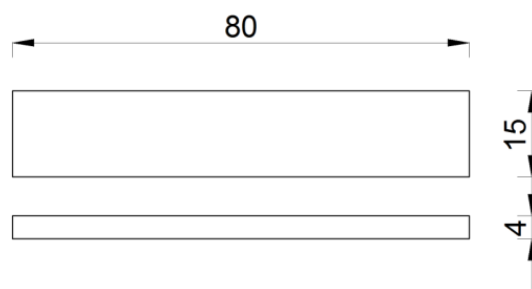
Figure 5. Flexural test specimen dimensions in mm (in accordance with [27]).

test was conducted following the requirements of PN-EN ISO 14125 [27]. The dimensions of the specimens met the requirements of ISO 14125 [27] for material class II (Figure 5).

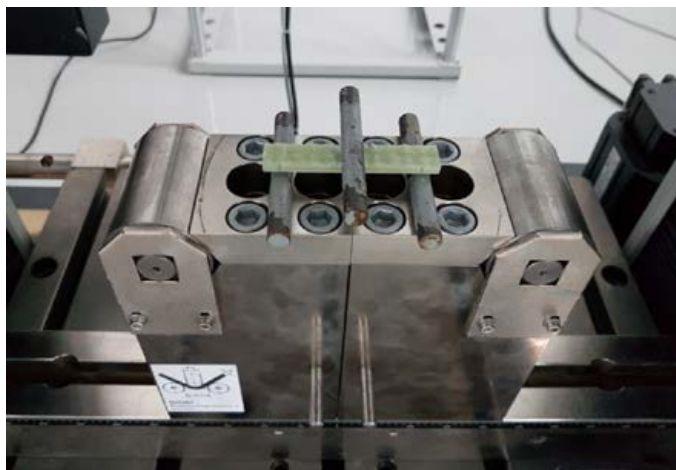
Figure 6. Specimen No. 2 during the three-point flexural test.

The test consisted of subjecting the specimens cut from the GFRP column material to three-point bending until tensile failure of the bottom fibres. The distance between the support members was $L = 64$ mm, and the loading speed was 2 mm/min. The rounding radii of the supports and central loading members were $R_1 = R_2 = 5.1$ mm. The flexural test was carried out on a ZD 10/90 static testing machine (Figure 6). Mid-span displacements were measured with dial indicators with a 0–10 mm measurement range and a resolution of 0.01 mm.

All the specimens behaved elastically during loading, up to failure. This material feature is present because undamaged glass fibres retain their linear elastic behaviour during deformation.

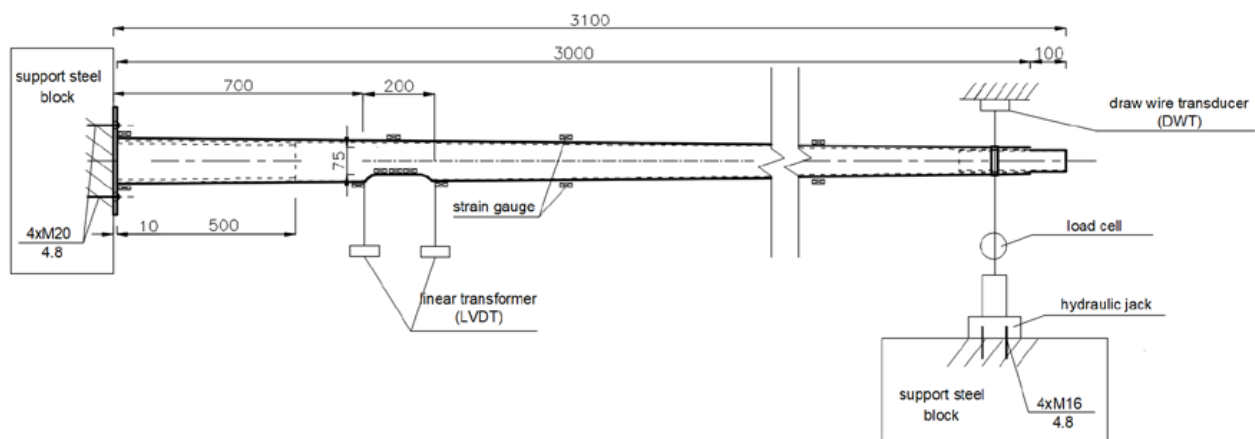
Figure 7. Schematic drawing of the full-scale test setup for 3.0 m poles (dimensions are given in mm).

A test setup was prepared according to the recommendations of EN 40-3-2 [22]. A schematic drawing of the full-scale test setup for 3 m poles is presented in Figure 7.

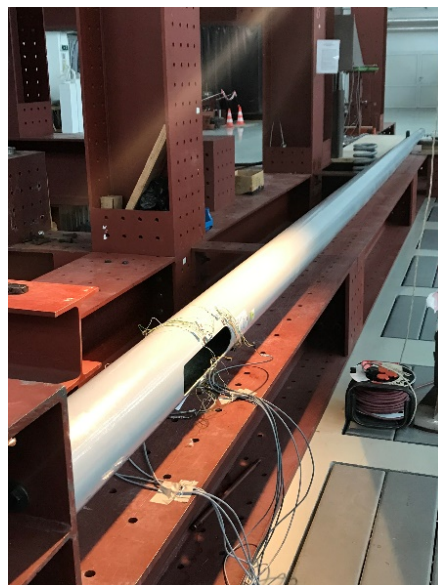
Figure 8. Pole 7b placed on the test setup.

The test setup involved a support block, approximately 600 mm wide and 800 mm high, which was used to rigidly fix the column with an anchor bolt (Figure 8). The poles were attached to the test stand with four M20 screws and supported in 2/3 of their length on a sliding support to eliminate the effect of the column's weight. The support was based on sliding bearings, which eliminated friction between the surface of the column and the support. The single tension load was applied in a slow quasi-static manner using a hydraulic jack mounted on a steel block, placed 0.5 m from the top of the poles.

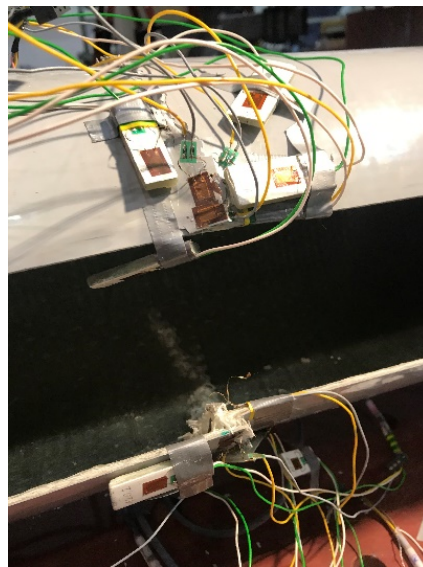
Figure 9. Total failure view of the pole in the area of the inspection hole.

In the test specimens, the inspection hole was located on the compression side of the column. All the tested elements were damaged by local buckling and finally cracking or crushing the resin or fibres in the middle area of the inspection hole (Figure 9). This failure happened suddenly after the local buckling of the walls in the vicinity of the inspection hole's edge. During the tests, no other signs of damage to the tested elements were found.

The material failure was preceded by the ovalisation of the shaft and buckling of the longer edges of the inspection hole. The buckling of the sides was caused by high normal compressive stresses parallel to the column axis. The buckling resulted in the exceedance of the compressive stress limit of the pole's inner lamina. This step can be described as a first-ply failure. The increase of load with the simultaneous reduction of load-bearing laminae resulted in the failure of the whole laminate on one side of the hole. This failure caused a redistribution of stresses, which resulted in a similar failure on the other side of the inspection hole.

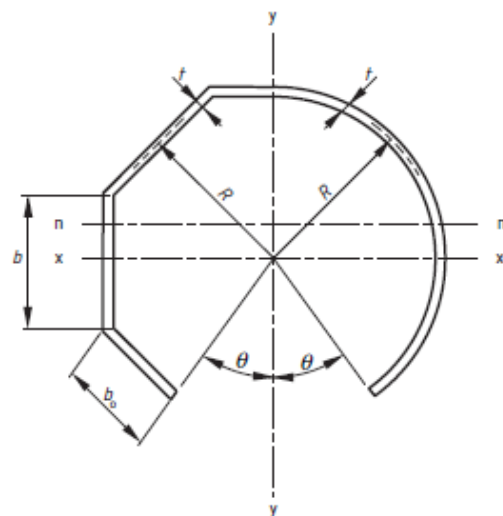
Figure 11. Cross-section of the pole at the inspection hole level.

$$Z_{pn} = 2 \cdot F \cdot R^2 \cdot t \cdot \cos\left(\frac{\theta}{2}\right) \cdot \left(1 - \sin\left(\frac{\theta}{2}\right)\right), \quad (2)$$

where F is the shape factor, R is the circular cross-section radius, t is the wall thickness, and θ is the half-angle of the door opening. Parameters used in the calculation of bending strength are presented in Table 6. The mechanical properties were obtained from coupon tests. Their values were used to apply the calculation procedure. Since all the tested columns failed near the centre of the inspection hole, the procedure was performed to calculate the bending strength (ultimate bending moment) for the cross-section at the inspection hole's centre level. Moreover, bending surrounding the axis (x - x axis in Figure 11) perpendicular to the axis passing through the hole's centre was assumed. Unfortunately, the standard PN EN 40-3-3 [23] does not consider the direction of the pole bending (i.e., whether the hole is on the compression or tension side of the cross-section).
