Accidental Puncture of a Dialysis Catheter into the Brachiocephalic Trunk

AORTA 2020;8:159–160.

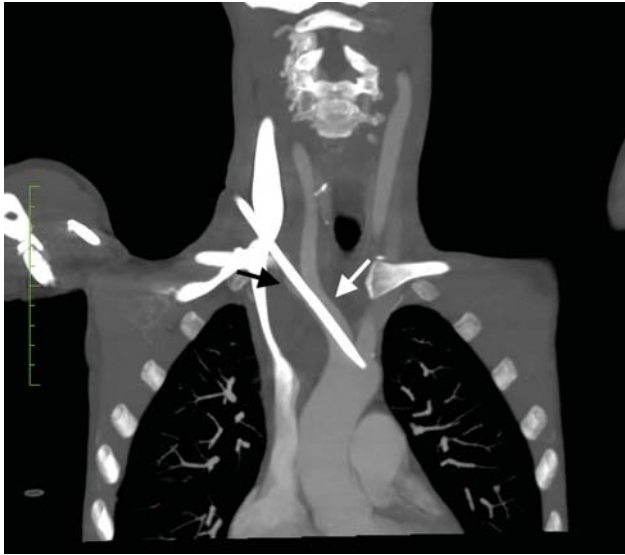
Fig. 1 Computed tomography angiography image, in coronal section, showing the course of the malpositioned dialysis catheter, after puncturing through the internal jugular vein (medial aspect). The catheter is seen to course through the right subclavian artery (black arrow), with the tip within the brachiocephalic trunk (white arrow).

An urgent computed tomography angiography (CTA) revealed the catheter puncturing through the medial aspect of the right internal jugular vein, and entering the right subclavian artery (black arrow, ▶**Fig. 1**), and passing retrograde into the brachiocephalic trunk, where the tip was seen (white arrow, ▶**Fig. 1**). Minimal hematoma was observed. A cardiothoracic surgery referral was sought.

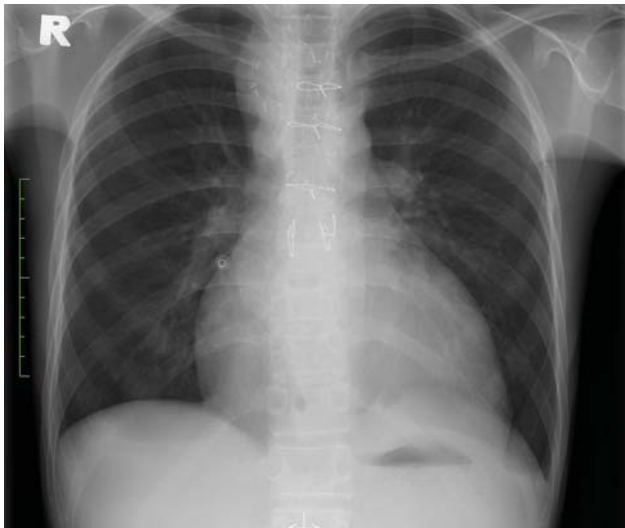
Fig. 2 Postoperative frontal chest radiograph on outpatient follow-up was normal.

The patient recovered well postoperatively and was discharged on day 3. Postoperative radiograph did not show any complications (▶**Fig. 2**).
