## Case Report

# Unexpected Complication Ten Years after Initial Treatment: Long-Term Report and Fate of a Maxillary Premolar Rehabilitation

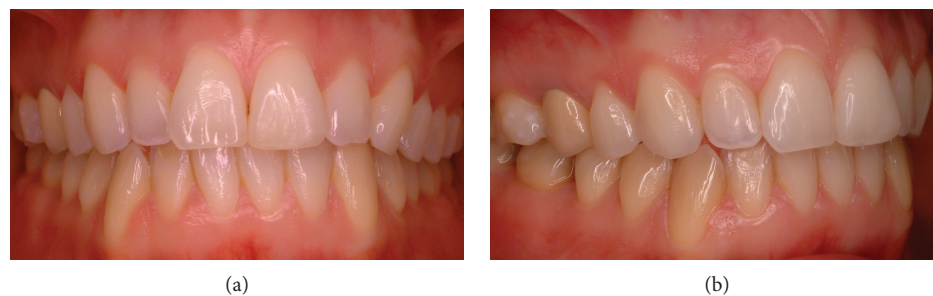
FIGURE 1: Preoperative intraoral frontal (a) and lateral (b) views showing the preexisting upper second premolar crown (tooth 1.5).

**2.2. Treatment Plan for Upper Premolar.** The previously treated abutment (>10 years ago, by other colleagues) was originally restored with a metal cast post-and-core extending up to the coronal third of the root; the intraoral periapical X-ray revealed a partially treated and/or filled root canal space, accompanied by a slight radiolucency at the mesial side of the apex (Figure 2). Periodontal clinical parameters were all within normal limits.

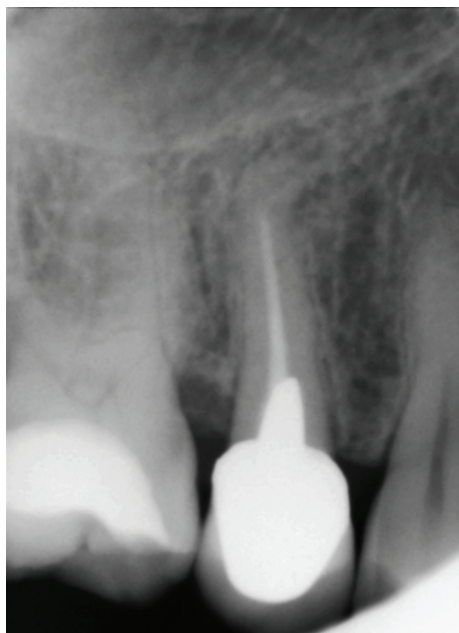
FIGURE 2: Periapical radiograph showing previous endodontic and prosthetic treatments on upper second premolar.

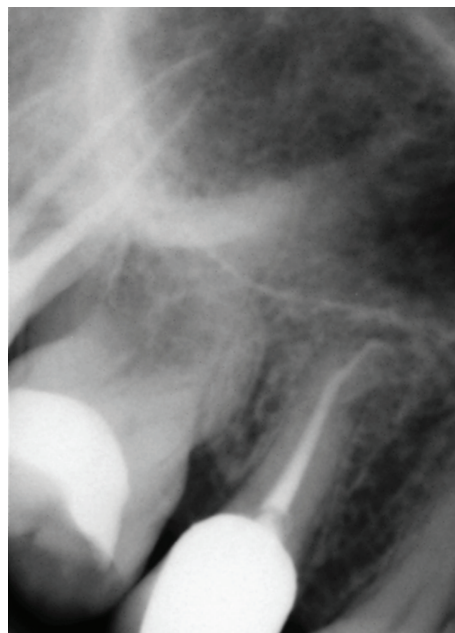
Maillefer), along with NaOCl and EDTA irrigations; the single-cone gutta-percha technique was chosen for final obturation (Figure 3) of the root canal (finishing file instrument and gutta-percha point: size *F1*, ProTaper® Universal, Dentsply Maillefer).

FIGURE 3: Periapical radiograph showing immediate outcome of nonsurgical endodontic retreatment performed at our dental office.

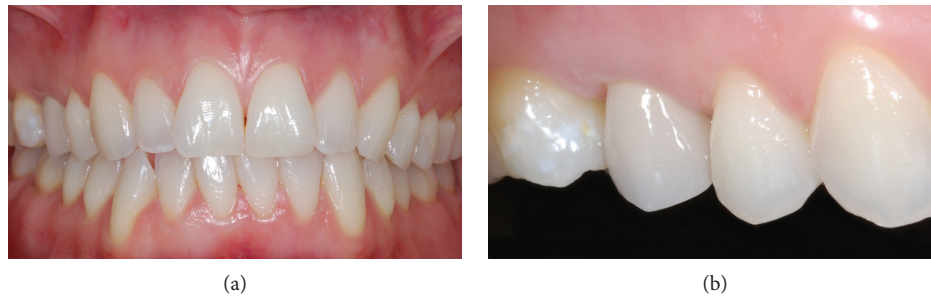
cementation (Figures 4(a) and 4(b)). After luting, the occlusion was verified to avoid both interferences during excursive (protrusive and lateral) jaw movements and prematurities at maximum intercuspation.

FIGURE 4: Postoperative intraoral frontal (a) and lateral (b) views showing good integration of the new veneered-zirconia crown on tooth 1.5.

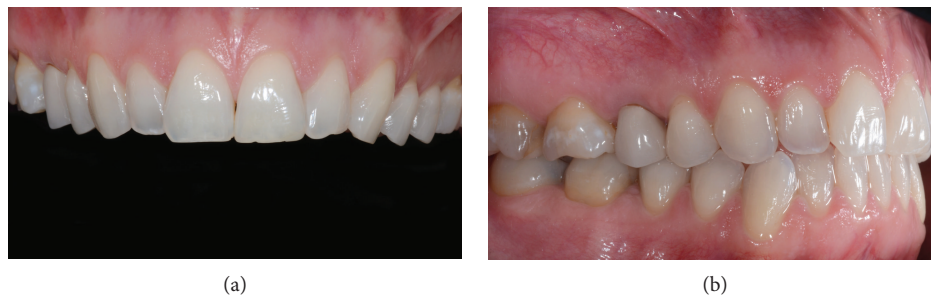
FIGURE 5: Frontal (a) and lateral (b) views 7 years after crown delivery: an overall dental deterioration is visible associated with soft tissue modifications.

**2.5. Regular Check-Ups and Development of Symptoms.** The premolar rehabilitation was completed within the same year (2008), and the tooth entirely recovered its function in the mouth; regular check-ups (approximately every 6 months) were carried out during subsequent years. Marginal integrity, signs of wear and visible cracks of the artificial crown, shade matching, and development of secondary caries at the interface with the tooth were assessed during the check-ups [26, 27]; the clinical examinations included periodontal probing and were accompanied by radiographic analyses. While the patient received other dental therapies in the meantime, no further problems or complications related to the premolar treatment were detected at follow-ups. About seven years later, in 2015, some modifications of the soft tissues were noted, as multiple gingival recession developed on upper posterior teeth: however, the margin at the premolar restoration was just slightly affected (0.5 mm recession, Figures 5(a) and 5(b)). High compliance was shown by the patient throughout the treatment, as demonstrated by strict attendance at check-ups, adequate biofilm control, and copings with discontinuous pain/symptoms during later stages.

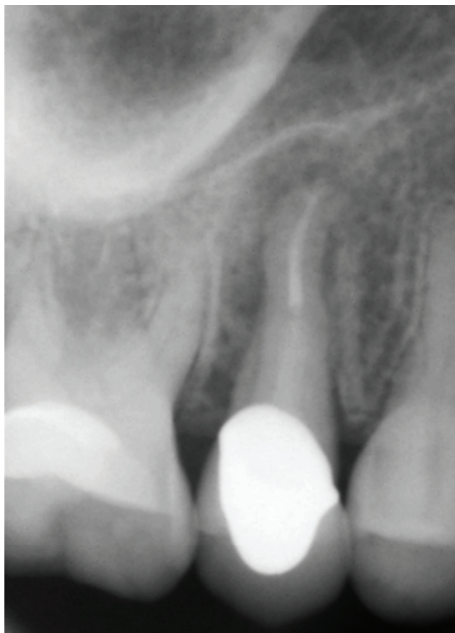
FIGURE 6: Development of clinical symptoms 9 years after crown delivery: the radiograph revealed a periapical radiolucency, with widening of periodontal ligament/lamina dura modifications.

despite the apparently well-performed root canal therapy (Figure 6). At this time point, a deep vestibular pocket was also detected by the periodontal exam (manual probing depth > 10 mm). Due to clear alterations of the attachment system, the analyses of tooth mobility and pain on biting were also carried out at subsequent examinations. The

Following a pharmacologic treatment for acute phase management and resolution of the sinus tract, a surgical intervention was planned for several reasons: (1) direct inspection of potential fracture lines that were not visible on 2D radiographic images; (2) to assess the status of periradicular tissues and bone; and (3) to investigate the presence of accessory lateral canals, especially along the body (middle third) or at the apical mesial curvature of the root (last 3-4 mm). Patient and clinician's shared efforts were all addressed towards achieving a definite diagnosis and, possibly, tooth preservation: from this perspective, the open-flap surgical intervention was well accepted by the patient.

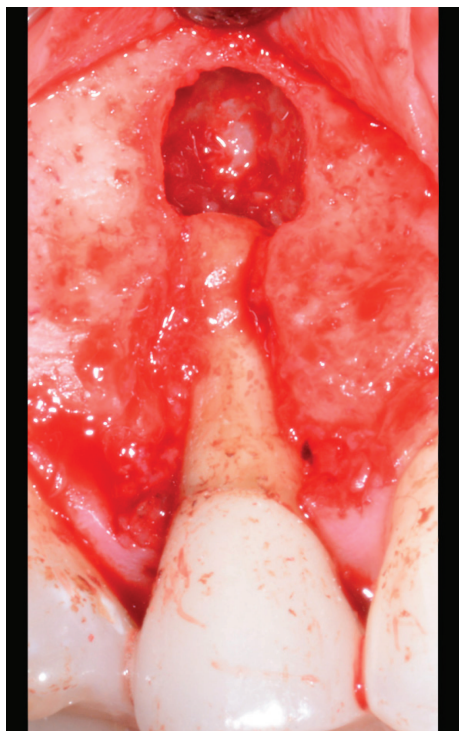
**2.6. Surgical Procedure.** During May 2017, a papilla-sparing, trapezoidal, full-thickness flap was reflected and extensive cortical bone loss was confirmed at the vestibular side of the root. Under magnification and fiber-optic illumination, however, the exposed area of the root appeared free of cracking lines. Interproximal bone peaks were still preserved. A root-end resection was performed to ensure the removal of apical ramifications and/or residual bacterial contamination as potential aetiologic factors (Figure 7). The periapical granulation tissue was carefully removed with the aid of curettes and hand excavators; the residual cleaned cavity

FIGURE 7: Apical resection of premolar root showing vertical bone resorption at the cortical vestibular side.

was finally irrigated with saline solution. The flap was repositioned and sutured.

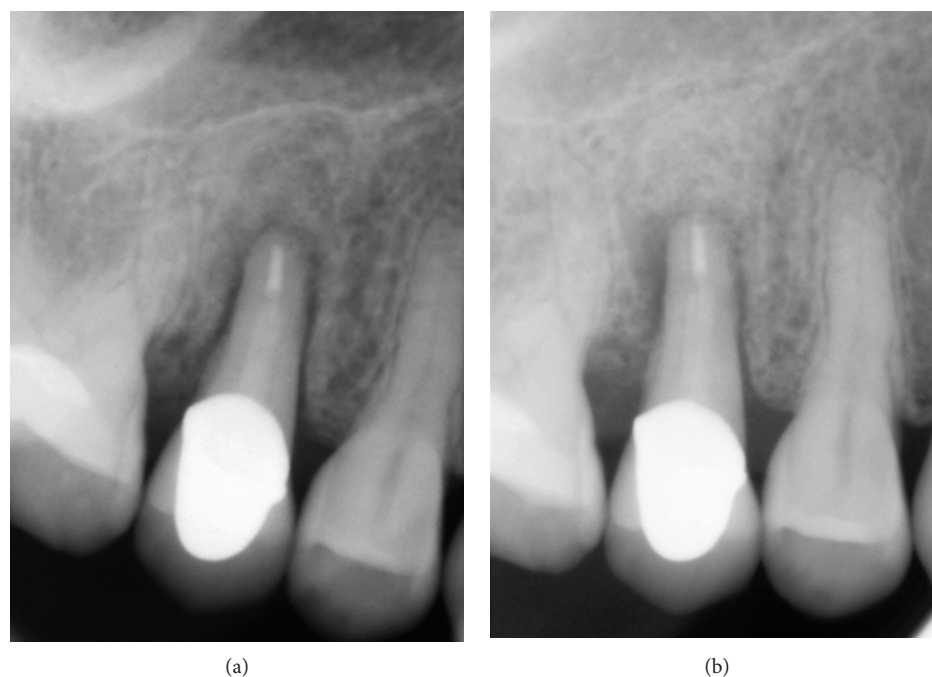
The clinical scenario did not improve after apical surgery: during subsequent months (July and September 2017), the radiographic follow-up revealed a progressive radiolucency also involving the distal areas of the tooth and proximal peaks (Figures 8(a) and 8(b)). Increased horizontal tooth mobility (Miller class II score) and pain on biting at the premolar tooth were present in September 2017.

FIGURE 8: Three (a) and five (b) months after endodontic surgery, the clinical scenario did not improve: a progressive radiolucency involved the distal areas of the tooth and proximal peaks.

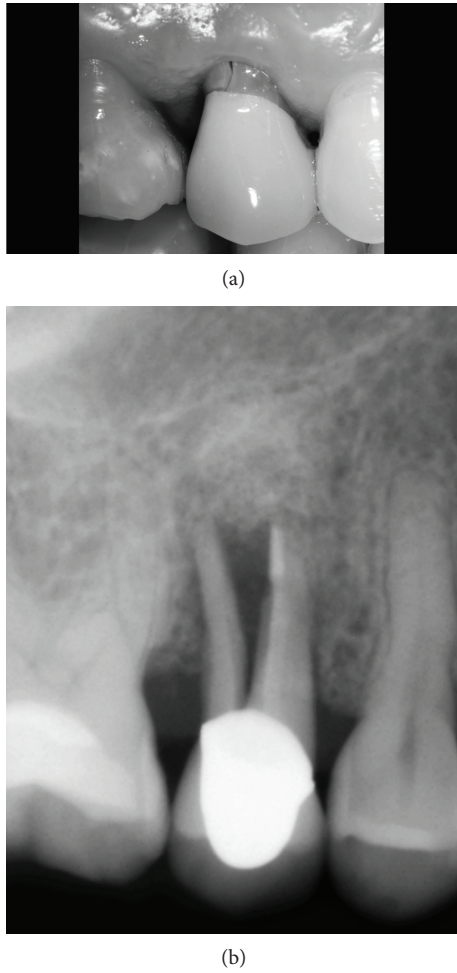
**2.7. Vertical Root Fracture.** On December 2017, a vertical fracture associated with separation of root fragments came to light both clinically and radiographically (Figures 9(a) and 9(b)). The vestibular view showed a clear, 1 mm wide gap between the two root halves, running up to gingival margin of the prosthetic crown. Considering the extensive periodontal breakdown, type of fracture, and apical splitting, the second upper premolar was scheduled for extraction. Despite some emerging treatments are available for VRF, like fragment reattachment and tooth replantation, they still need long-term validation [28]; in order to prevent further bone loss and achieve rapid resolution of symptoms, the extraction treatment was proposed and accepted by the patient. Two main tooth fragments were retrieved from the extraction procedure: a larger one, formed by the crown, post and gutta-percha obturation and a smaller slice with unoccupied root canal space, detached from all the other restorative materials (Figures 10(a) and 10(b)). The fracture was running for the entire bucco-lingual root length: it was considered “complete” in the horizontal extent or type “A” according to the classification of von Arx and Bosshardt [16], being visible

FIGURE 9: Clinical (a) and radiological (b) presentation of the vertical root fracture: splitting of the premolar root into two halves is clearly visible.

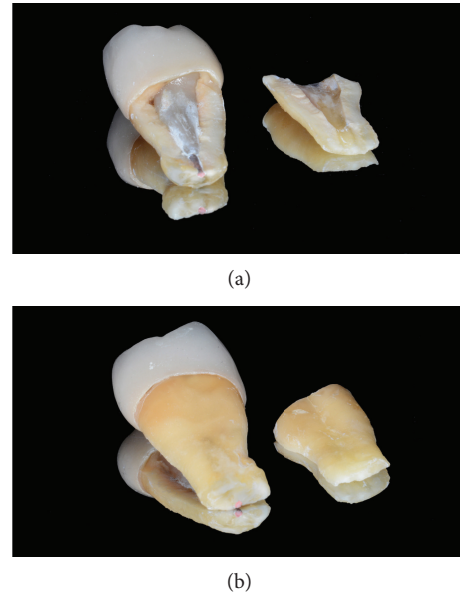
FIGURE 10: Inner (a) and outer (b) views of the two fragments produced by the longitudinal fracture, retrieved after tooth extraction.

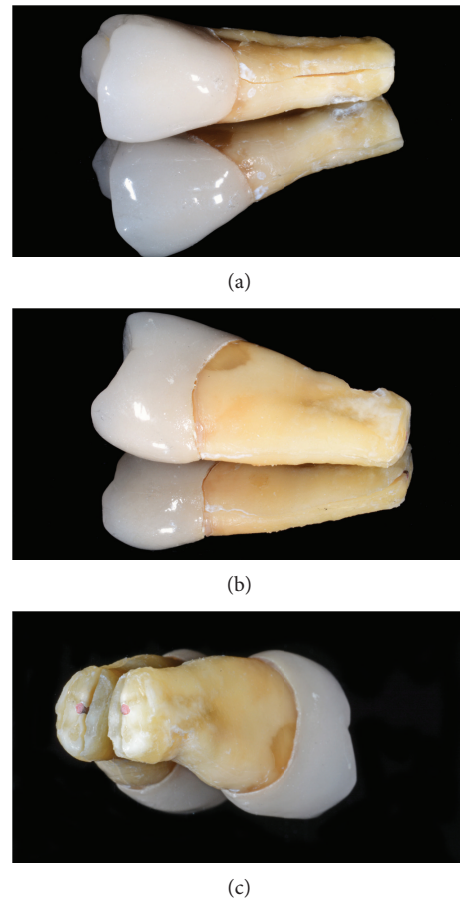
from both the vestibular and palatal sides (Figures 11(a) and 11(b)). On the longitudinal plane, the cracking line was also complete, extending from the prosthetic margin to the root-end resection. The fracture was off-centered in the axial plane (i.e., asymmetric involvement of the root), locating itself mainly outside the root canal space in the apical third (Figure 11(c)). A detailed analysis of the fragments shows a close adaptation between post/endodontic filling and the dentinal walls, which also appeared of adequate thickness; in addition, an incomplete cracking line was visible on the coronal third of the small fragment (Figure 12).

FIGURE 11: Extraoral close readaptation of fragments: the fracture runs for the entire bucco-lingual length of the tooth, as shown by separation on the vestibular (a) and palatal (b) sides. The fracture line was off-centered from the canal when observed on the axial plane (c).

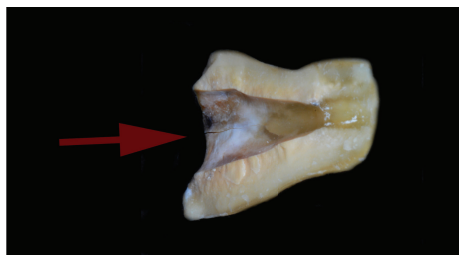
FIGURE 12: An incomplete cracking line (arrow) involved the coronal area of the small fragment.
