Corrosion behaviours of the dental magnetic keeper complexes made by different alloys and methods

International Journal of Oral Science (2016) 8, 155–163; doi:10.1038/ijos.2016.21; published online 8 July 2016

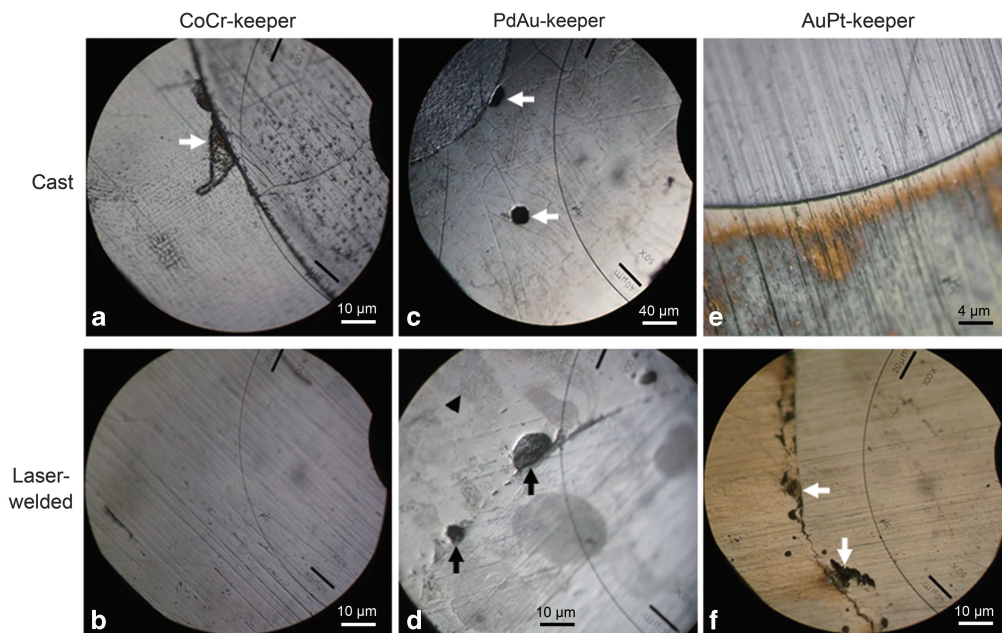
Figure 2 Observation of samples' surface morphology after oxalic acid solution etching. (a, Arrow, x200) Corrosion pits that are shallow concaves in the fusion zone. (b, x200) Only some scattered corrosion spots; sections with some outstanding features but no obvious defects existing on the keeper surface. (c, d) Corrosion holes that are deep hollows with massive defects (c, arrows, x50) and pits (d, arrows, x200) in the fusion zone and alloy area, along with flaky corrosion spots (d, arrowhead). (e, x500) A corrosion band formed in the fusion zone. (f, Arrows, x200) Corrosion pits occurred at the welding seam.

In the cast CoCr–keeper group, the keeper not only developed obvious grain boundaries but massive pitting corrosion that also occurred in the fusion zone and the alloy area only with oxydate (Figure 2a). The keeper of the laser-welded CoCr–keeper developed a few corrosion spots (Figure 2b) without visible grain boundaries, and the surface of the alloy had deep corrosion pits sedimentated with oxydate of a reticular structure.

Scattered corrosion holes and spots appeared on the keepers without grain boundaries in the cast PdAu–keeper group. In addition, the keeper surface closing of the sprue showed oxide deposition, but

the alloy area showed almost no grain boundaries or large corrosion spots except for some corrosion holes in the alloy and fusion zone (Figure 2c). The surface features of the keeper in the laser-welded PdAu–keeper were equivalent to that of cast PdAu–keeper, and the fusion zone of the former exhibited serious corrosion pits and spots (Figure 2d).

Similarly, we failed to see intergranular corrosion in the cast AuPt–keeper even though it showed some scattered corrosion holes similar to the laser-welded AuPt–keeper. The fusion region formed a corrosion band in addition to the AuPt alloy being absent of obvious corrosion pits (Figure 2e). Corrosion pits developed on the laser-welding seam instead of the AuPt alloy area in the laser-welded AuPt–keeper group (Figure 2f).

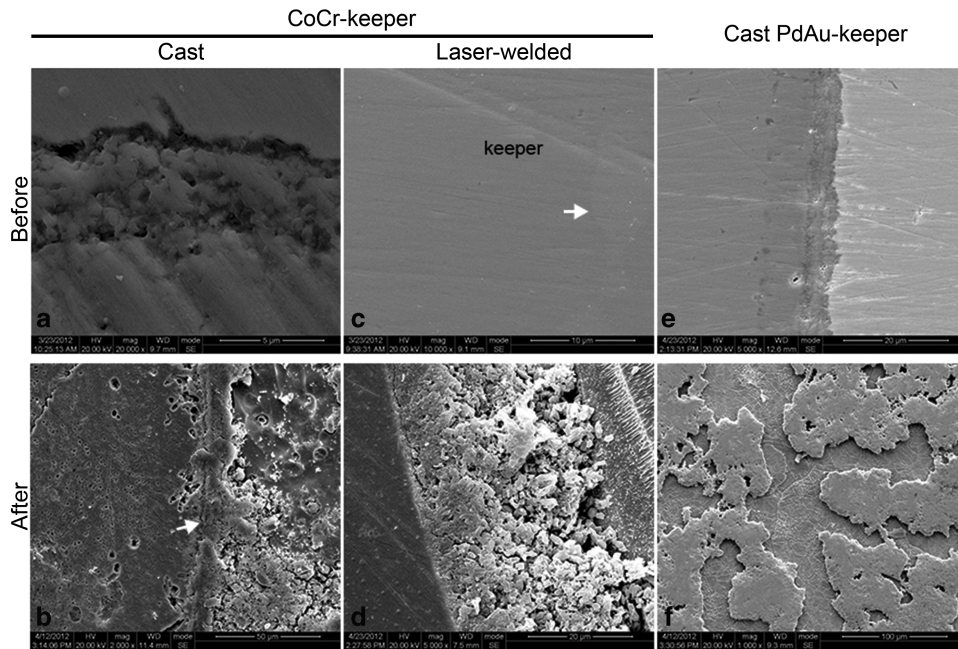
Figure 3 SEM observation before and after oxalic acid solution etching. (a, x20 000; e, x5 000) Before corrosion: the fusion area exhibited uneven surface after polishing. (b, Arrow, x2 000) After corrosion: a corrosion band appeared in fusion zone. (c, Arrow, x10 000) Before corrosion: a smooth surface in the welding area. (d, x5 000) After corrosion: the integrity of fusion zone was destroyed and a corrosion band formed. (f, x1 000) After corrosion: oxide deposition and fine grain boundaries on the keeper surface closing to the sprue. SEM, scanning electron microscope.

With distinctive surface morphology before corrosion under SEM (Figure 3a), the fusion zone of cast CoCr–keeper has been demonstrated to be a Cr-rich oxide zone with Fe and Co released mainly from this area (Figure 4a) after the chemical elements analysis. Although the keeper area exhibited coarse lattice with many corrosion holes and a fusion area with an uneven corrosion band (Figure 3b), it also released a mass of Fe and Co after corrosion (Figure 4b). Unlike the cast CoCr–keeper with an oxidation zone before corrosion, the welding area of the laser-welded CoCr–keeper presented smooth convergence (Figure 3c) and both sides of the alloy kept their original structure after burnishing. The areas of Co, Fe and Cr coexisted at 0.3–0.5-mm wide in the welding area, demonstrating that the laser-welding resulted in the re-distribution of metal elements in the fusion zone (Figure 4c). Obvious corrosion bands and attached oxide were observed in the fusion zone of the laser-welded CoCr–keeper (Figure 3d) after corrosion. Compared with the results before corrosion, chemical elements analysis revealed that Co, Fe and Cr all were seriously reduced on the alloy side of the fusion zone and

oxide was produced after corrosion, but the Fe and Cr of the keeper side remained unchanged (Figure 4d).

We next observed the surface features of the cast PdAu-keeper under SEM and analysed chemical elements changes before and after corrosion. The fusion zone showed barely any obvious oxide zone and had an uneven exterior despite polishing before corrosion (Figure 3e), and the keeper side gave rise to a none-Fe and Cr-rich band $\sim 15\text{-}\mu\text{m}$ wide (Figure 4e). After corrosion, the keeper area adjacent to the sprue deposited some oxide, and no obvious corrosion was found in the grain boundaries on the surface (Figure 3f). The distal side had no oxide or grain boundaries. Chemical elements analysis indicated that corrosion pits appeared in the Cr-rich area after corrosion (Figure 4f). However, due to the re-distribution of metal elements, the fusion zone of the laser-welded PdAu-keeper formed an area with Pd, Ag, Fe and Cr coexisting at $\sim 30\text{-}\mu\text{m}$ wide before corrosion (Figure 4g). Interestingly, no elements changed in the welding spot area despite corrosion spots that formed after corrosion (Figure 4h), but the chemical elements analysis of edges of serious local corrosion holes showed that Fe and Cr reduced significantly as compared with that before corrosion (Table 1).

A chemical elements analysis was also performed for the AuPt-keeper complex to detect the changes of distribution for various elements before and after corrosion. Similarly, a Fe-poor and Cr-rich band $\sim 3\text{--}5\text{-}\mu\text{m}$ wide was generated on the keeper side of the fusion zone of the cast AuPt-keeper before corrosion, but no oxygen element was detected (Figure 4i). After corrosion, a corrosion groove $\sim 3\text{--}5\text{-}\mu\text{m}$ wide appeared in the fusion zone with Fe obviously reduced (Figure 4j). However, a Cr-rich band had not formed on the edge of the keeper adjacent to the fusion zone of the laser-welded AuPt-keeper that had a smooth connection before corrosion (Figure 4k). The welding seam became deeper and clearer after corrosion, and the keeper side developed corrosion pits along with a significant decrease in Fe and Cr (Figure 4l).

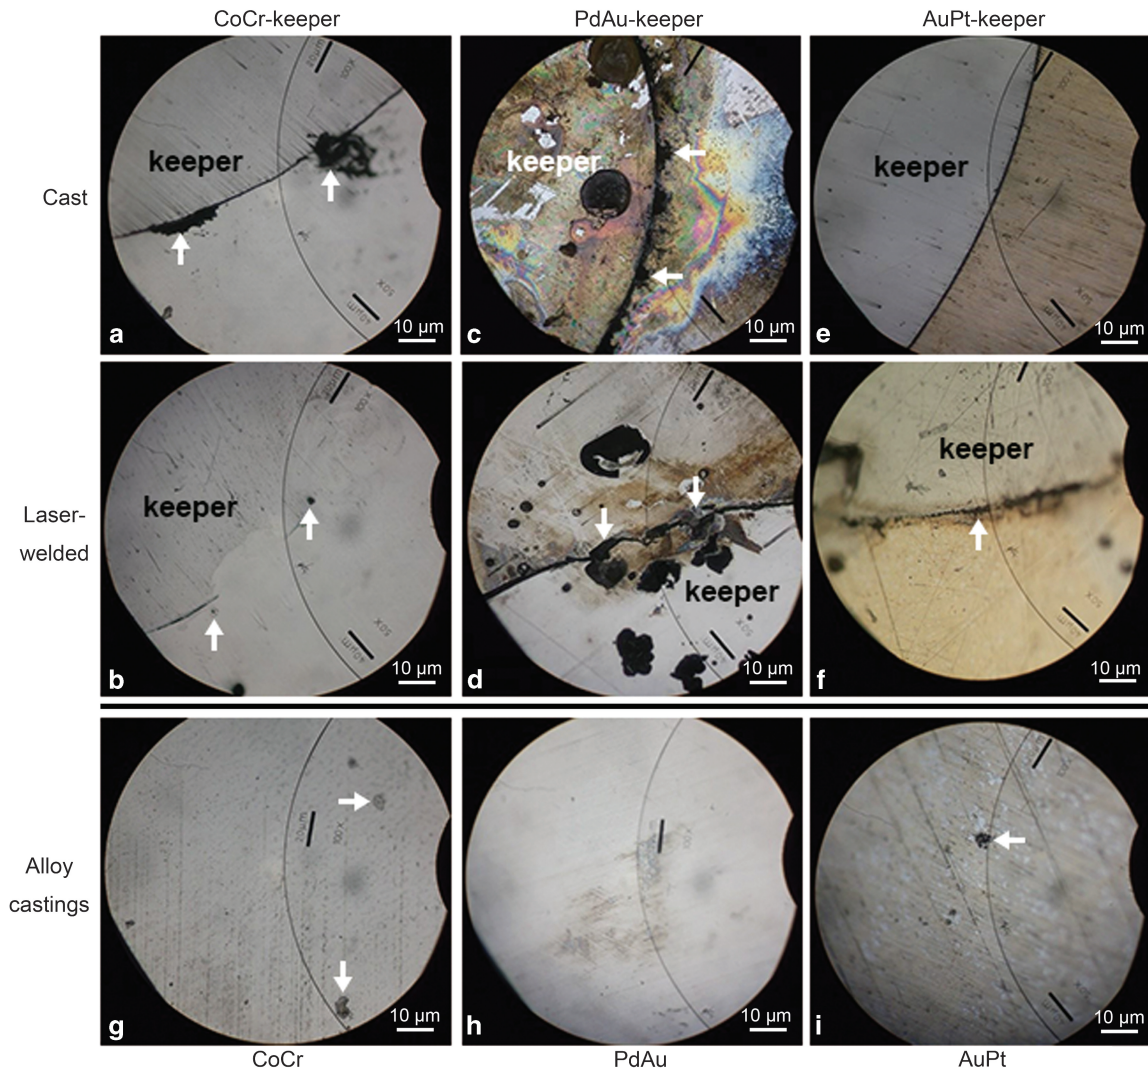
Figure 5 Observation of samples' surface morphology after electrochemical testing. (a, d, f, Arrows, x200) Corrosion pits in fusion zone. (b, x200) No obvious corrosion pits except for a few holes found (arrows) in fusion zone. (c, Arrows, x200) A corrosion band formed in fusion zone. (e, x200) The fusion zone remained smooth. (g–i, Arrows, x200) Corrosion spots on the surface of alloy castings.

Scattered corrosion spots and shallow concaves were found on the surface of CoCr castings (Figure 5g). In the cast CoCr-keeper group, each area had different surface morphology; the CoCr alloy area exhibited scattered corrosion spots and shallow concaves and the keeper produced many fine oxidation spots, but visible corrosion pits appeared in the fusion zone (Figure 5a). In contrast, no obvious corrosion pits or oxidation spots appeared in the fusion zone or keeper in the laser-welded CoCr-keeper group (Figure 5b), although scattered corrosion spots and holes existed on the CoCr alloy surface.

Only scattered corrosion spots were observed on PdAu castings after electrochemical test (Figure 5h). In the cast PdAu-keeper group, the fusion zone and its nearby keeper area showed serious corrosion banding (Figure 5c) or pits. However, the keeper central area and the edge of the PdAu alloy only exhibited corrosion spots or holes. Similarly, in the laser-welded PdAu-keeper group, obvious corrosion pits had appeared in the fusion zone (Figure 5d), and its two sides and

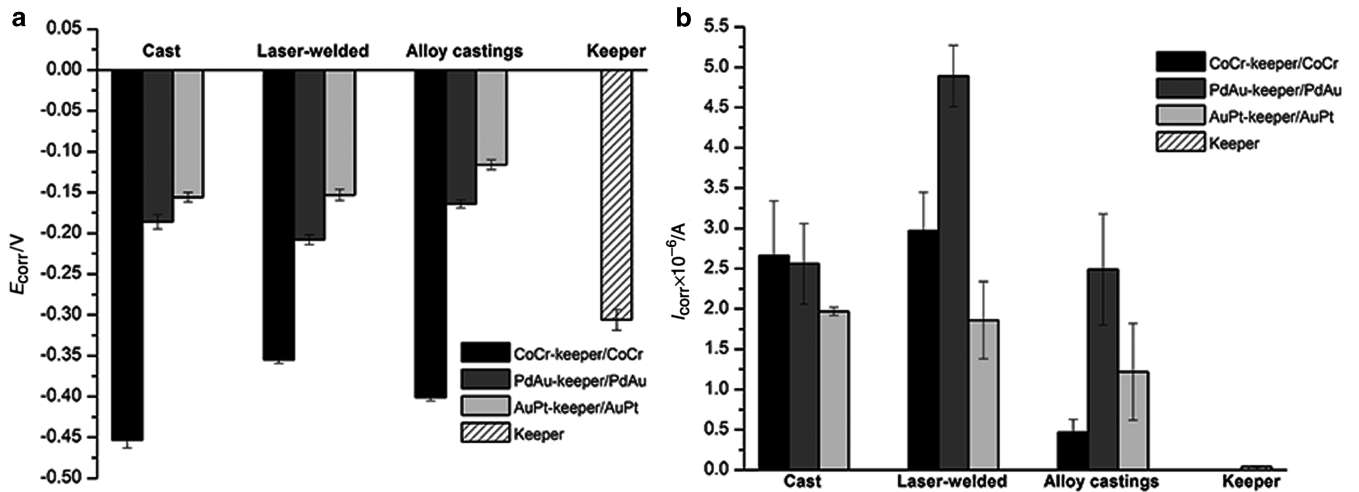
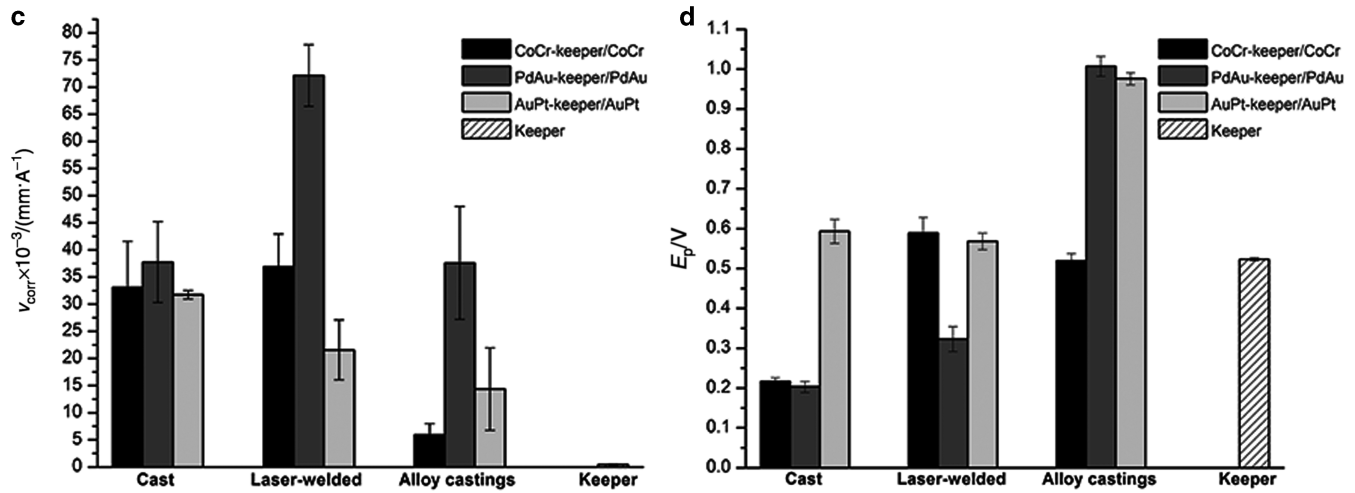
Figure 6 Results of dynamic electrochemical test of samples. Scanned potentiodynamic polarization of different samples and plotted Tafel polarization curve. (a) E_{corr} : free-corrosion potential, relative potential value when SCE acts as the reference electrode. (b) i_{corr} : free-corrosion current density. (c) v_{corr} : corrosion rate. (d) E_p : pitting potential appeared when the passivation film on the metal surface was destroyed. SCE, saturated calomel electrode.

(laser-welded PdAu-keeper) $< E_{\text{corr}}$ (cast PdAu-keeper); E_{corr} (cast AuPt-keeper) = E_{corr} (laser-welded AuPt-keeper); E_p (cast CoCr-keeper) $< E_p$ (laser-welded CoCr-keeper); E_p (cast PdAu-keeper) $< E_p$ (laser-welded PdAu-keeper); and E_p (cast AuPt-keeper) = E_p (laser-welded AuPt-keeper).

Another factor influencing the corrosion behaviour were the cast and laser-welded fabrication methods for a keeper complex. This study has demonstrated that the E_{corr} and E_p values of the laser-welded CoCr-keeper were greater than that of cast CoCr-keeper, indicating that the passivated state of the cast CoCr-keeper could easily be

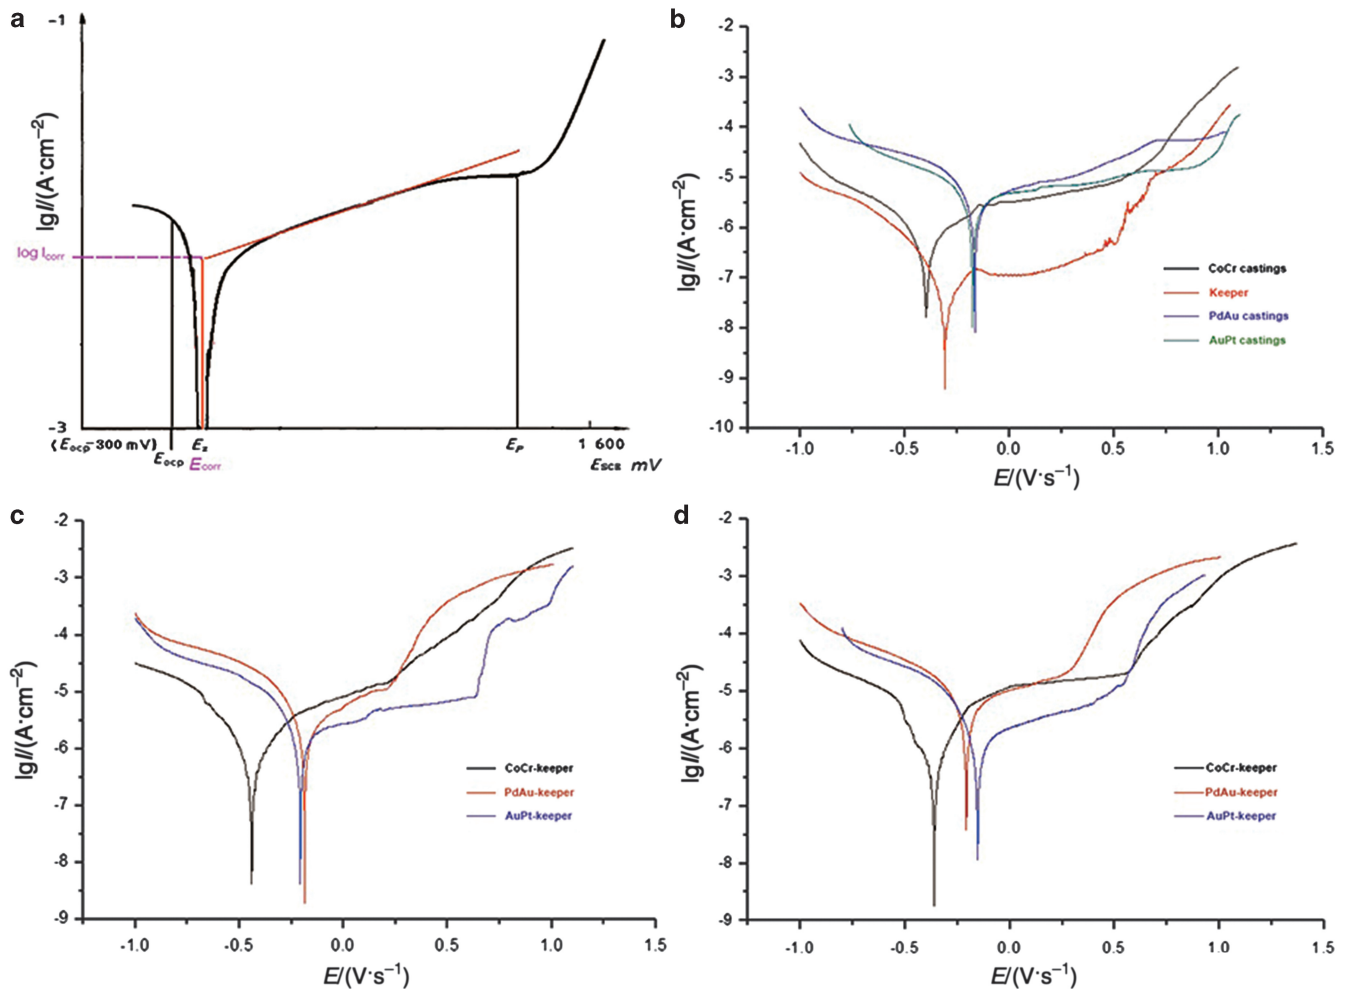
Figure 7 Tafel curves of samples during electrochemical test. (a) Typical Tafel polarization curve. (b) Tafel curves of the three alloy castings and keeper. (c) Tafel curves of cast keeper complexes. (d) Tafel curves of laser-welded keeper complexes.
