## Case Report

## Adverse Local Tissue Reaction Secondary to Corrosion at Multiple Junctions in a Modular, Segmental, Distal Femoral Replacement

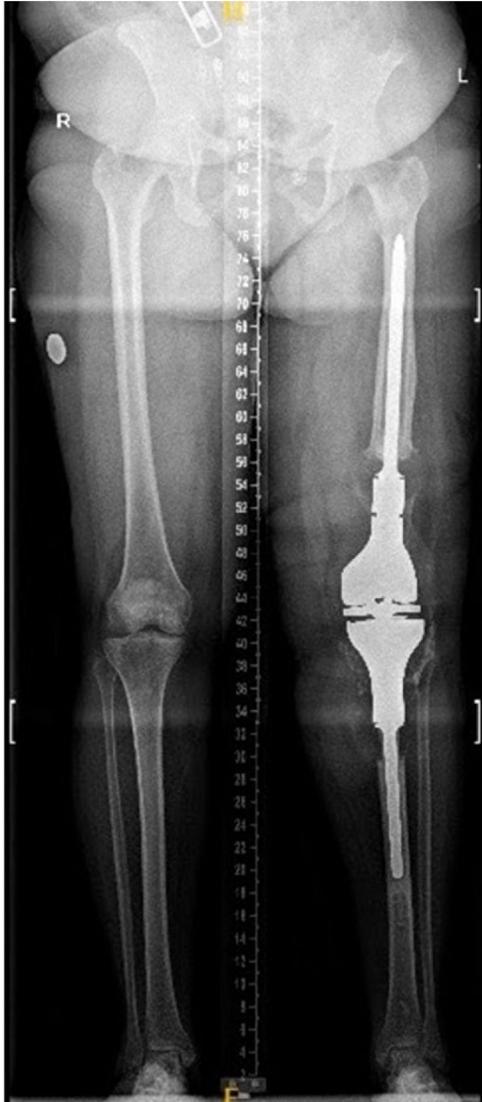
**Figure 1.** Limb length x-rays upon presentation to office demonstrating prior distal femoral and proximal tibial replacements with osteolysis. The proximal press-fit femoral stem and distal cemented tibial stem appear well-fixed.

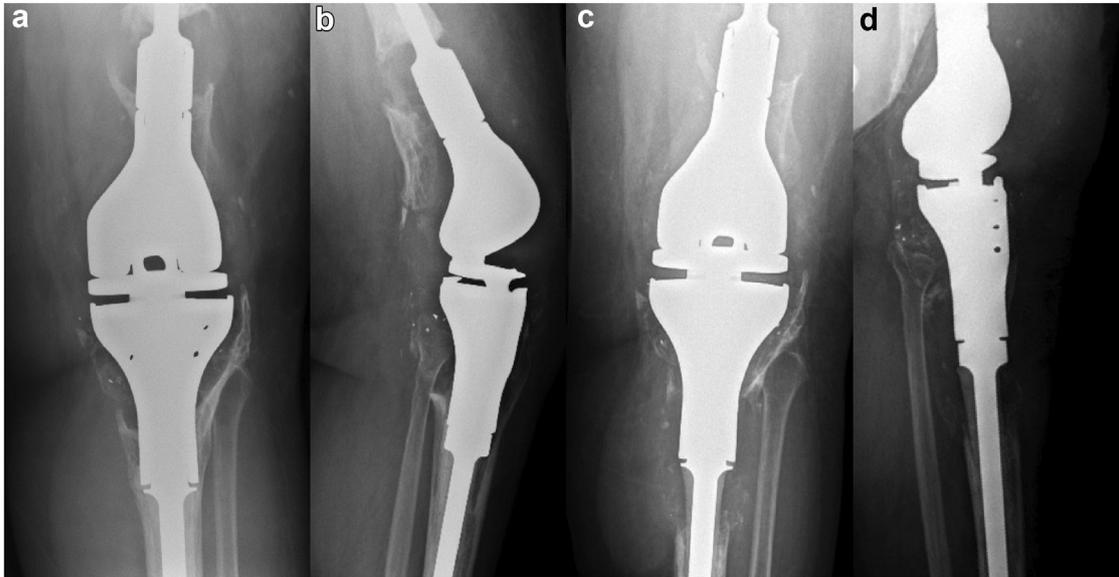
**Figure 2.** (a) Left knee anterior posterior and (b) lateral x-rays 1 year prior to presentation compared to (c) left knee anterior posterior and (d) lateral x-rays 1 year later at time of presentation demonstrating severe and progressive osteolysis of the proximal tibia.

The patient presented to the senior author's office as a new patient for evaluation of multiple months of persistent left knee swelling and pain. Her past medical history included hematuria, anemia, and obesity. Examination of the left knee revealed a well-healed midline incision. There was a moderate effusion with an area of fluctuance over the medial proximal tibia, which was tender to palpation. Range of motion testing revealed a 45-degree extensor lag, which the patient reported had been present prior to her index TKA. Limb alignment radiographs are shown in [Figure 1](#). Left knee anterior posterior and lateral radiographs from 1 year prior to presentation ([Fig. 2a](#) and [b](#)) were also compared to those obtained at the presentation to the senior author's office ([Fig. 2c](#) and [d](#)).

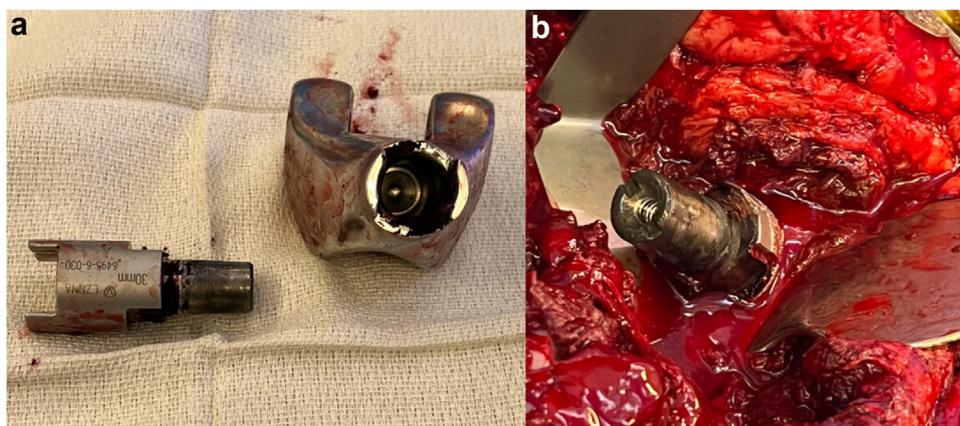
At time of surgery, there was extensive ALTR with thickening and black discoloration of the joint capsule with abundant dark brown fluid. There was also devitalized tissue, muscle necrosis, and significant bone loss of both the proximal tibia and distal femur. While there was redundant capsule from significant distension, there were no capsular or extensor mechanism defects noted. Intraoperative tissue cultures were obtained. There was no purulence or gross signs of infection. After an initial irrigation and debridement was performed, the distal femoral component was evaluated. The taper of both the femoral stem-extension piece junction and the extension piece-distal femoral component junction showed extensive corrosion (Fig. 3a and b). The femoral stem was found to be well-fixed. The femoral taper was then manually cleaned with a laparotomy pad and again analyzed to confirm its physical integrity (Fig. 4). The proximal tibia component was then disengaged from its stem. The stem's taper was in excellent condition. The tibial stem was also tested for fixation and deemed to be well fixed.

**Figure 3.** (a) Intraoperative clinic photos of extensive corrosion at the male taper of the distal femur extension piece with the female taper component of the distal femur endoprosthesis and (b) the taper of the femoral stem demonstrating corrosion.

After extensive debridement and irrigation and using a new, uncontaminated set-up, reimplantation proceeded with new modular components. The only available femoral extension piece of appropriate size was composed of CoCr alloy. The options at this point were to reimplant a new CoCr extension piece on the taper of the cleaned Ti femoral stem or remove the femoral stem and place a new CoCr stem to limit the risk of galvanic corrosion. It was again felt that the resultant bone loss associated with stem removal would be too morbid. We therefore elected to maintain the femoral stem and reimplant a new CoCr extension piece and distal femoral prosthesis. A new proximal tibial component was placed as well.

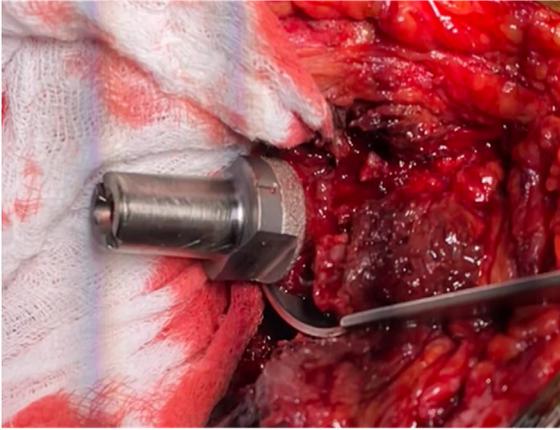
**Figure 4.** The cleaned taper of the femoral stem prior to reimplantation of a new distal femur extension piece and distal femur endoprosthesis.

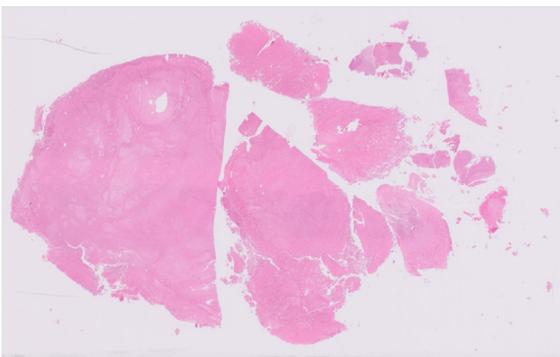
Final histopathologic evaluation of the devitalized synovium/joint capsule (Fig. 5) was performed utilizing both the Campbell and Oxford aseptic lymphocyte-dominated vasculitis-associated lesion (ALVAL) scoring systems, which resulted in a Campbell-ALVAL score of 7, indicating moderate ALVAL, and an Oxford-ALVAL semiquantitative score of 0 with no evidence of perivascular lymphocyte infiltrate but with extensive necrosis [14,15]. While there was no evidence of perivascular lymphocyte infiltration, there were dense sheets of histiocytes throughout fibrous synovial tissue.

**Figure 5.** Pathology slide of the devitalized synovium/joint capsule.

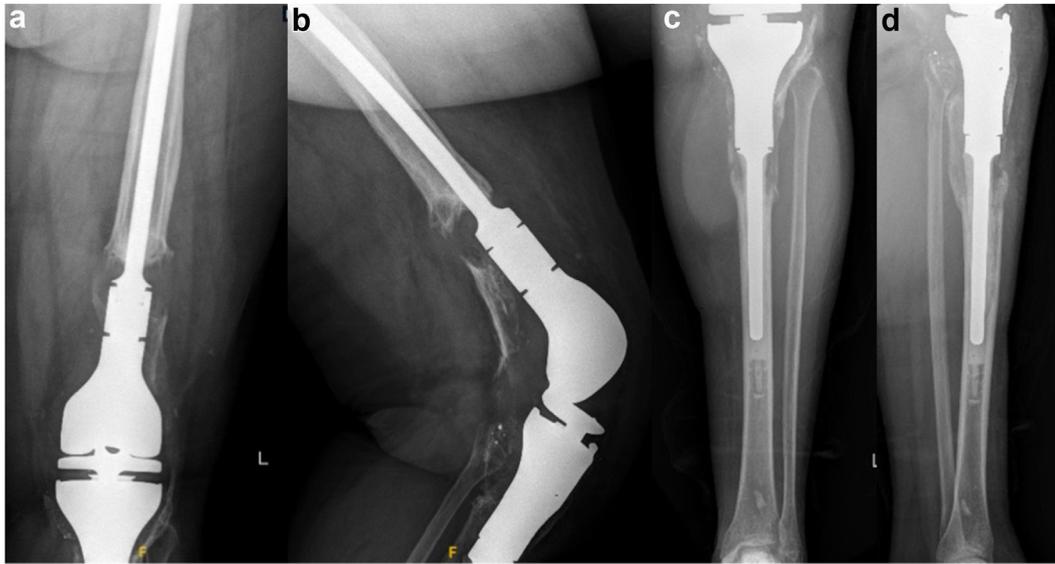
**Figure 6.** (a) Left knee anterior posterior and (b) lateral x-rays and (c) left tibia-fibula anterior posterior and (d) lateral x-rays from 5 months postsurgery demonstrating bone growth and remodeling, particularly at the proximal tibia, where most of the bone loss occurred.

The patient's postoperative course was unremarkable, and she was most recently seen in the office 15 months postoperatively. She reported continued resolution of her left preoperative knee pain and was using a cane for ambulation. Her left knee incision was noted to be well healed. She was able to straighten her leg raise but with a 20-degree extensor lag. Radiographs from the 5- and 15-month postsurgery visits demonstrate stable, well-fixed tibial and femoral components with bone growth and remodeling, primarily of the proximal tibia (Figs. 6 and 7). Follow-up surveillance will involve monitoring serial radiographs and patient symptoms.

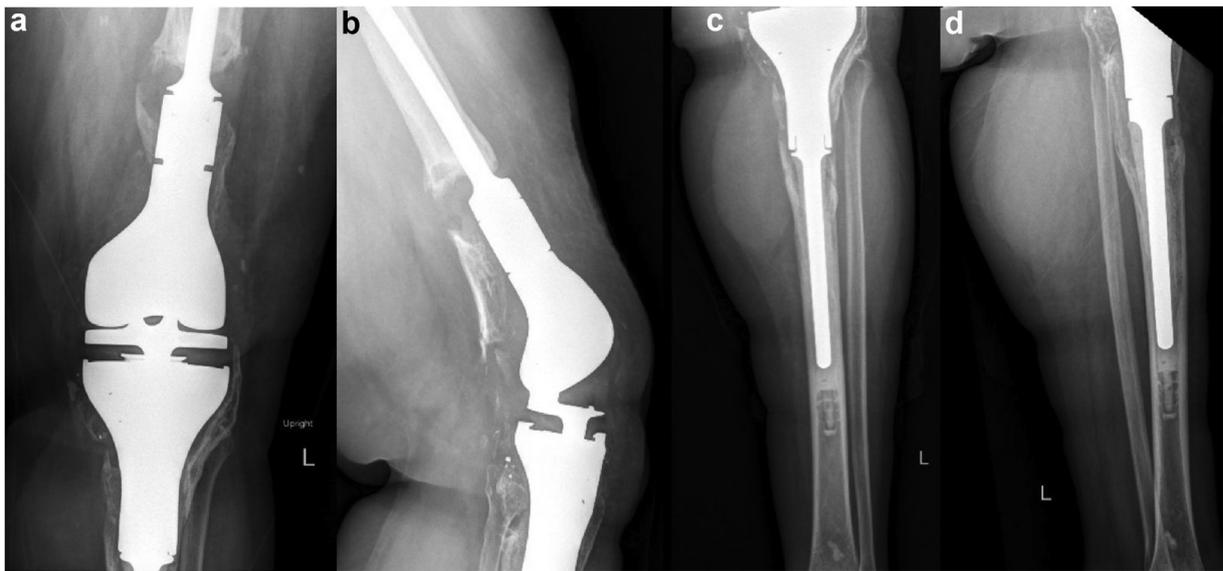
**Figure 7.** (a) Left knee anterior posterior and (b) lateral x-rays and (c) left tibia-fibula anterior posterior and (d) lateral x-rays from 15 months postsurgery demonstrating continued bone growth and remodeling.
