Restorative management using hybrid ceramic of a patient with severe tooth erosion from swimming: a clinical report

KEY WORDS: Dental erosion; Swimming; Hybrid ceramic; Vita enamic

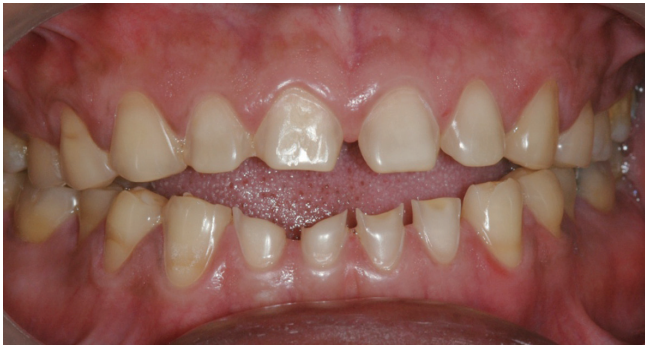
Intra-oral examination revealed loss of enamel on the labial and incisal surface of the maxillary anterior teeth. Four mandibular incisor teeth presented with loss of enamel on the facial surface and there was excessive reduction of the incisal edges. Diastemas appeared between most of the teeth, and the incisal plane was uneven (Fig. 1). The patient's esthetic appearance was affected by the irregular incisal edge position of the remaining tooth structure. Thus, he had no confidence to smile. The erosive lesion appeared with well-defined finish lines along the free gingival margins resembling veneer preparation (Fig. 2). There was no dental caries which existed and his periodontal health was fine. The pulp vitality test showed no signs of pulpal pathology. The occlusal function and vertical dimension of occlusion appeared to be normal since the patient had adequate and stable posterior stops. A significant finding in this case was the maxillary-mandibular relationship, which appeared to have anterior open bite due to the loss of tooth structure. However, the patient had no difficulty in pronouncing an "S" and "F" sound during function. During the comprehensive oral examination, the patient complained that his teeth were extremely sensitive to air blow. The diagnosis in this case was severe anterior tooth surface loss, resulting from long-term exposure to low pH in swimming pool water.

Fig. 1. Preoperative frontal view at maximum intercuspal position.

Since the remaining tooth structures were insufficient to support composite resin restorations and porcelain-laminated veneers and the optimal clinical crown height needed to be restored, complete coverage metal-free crown restorations were the treatment of choice in this case for long-term durability and esthetic satisfaction.

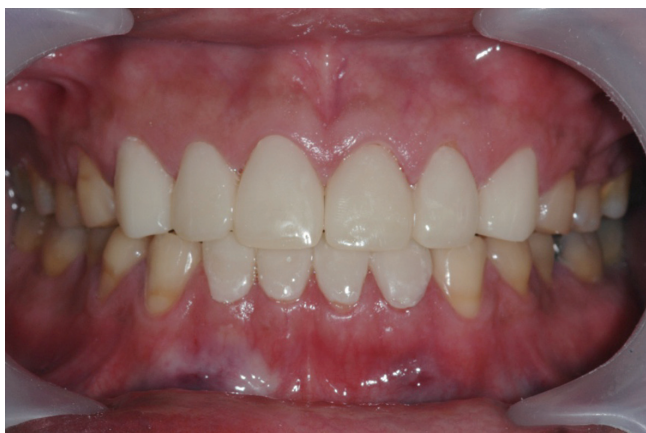
Fig. 3. Direct intra-oral mock-up made from bis-acryl provisional material.

Irreversible hydrocolloid impressions were performed for fabricating diagnostic casts. A face-bow transfer was made and the casts were mounted in maximum intercuspation on a semi-adjustable articulator (Denar Mark II, Whip Mix, Louisville, KY, USA). Diagnostic wax-up was made on the casts with the optimal tooth proportion and with 1 mm horizontal and vertical overlap. The wax-up was transferred to the patient's mouth using the direct intra-oral mock-up procedure with bis-acryl provisional material (Protemp 4, 3M ESPE, Seefeld, Germany). The mock-up (Fig. 3) was adjusted to obtain desirable esthetics, phonetics and function, and it was subsequently duplicated for using as a guideline for fabricating provisional restorations. The splinted provisional restorations were made with heat-polymerized polymethyl methacrylate (Namilon, American Tooth Industries, Oxnard, CA, USA) prior to the tooth preparation.

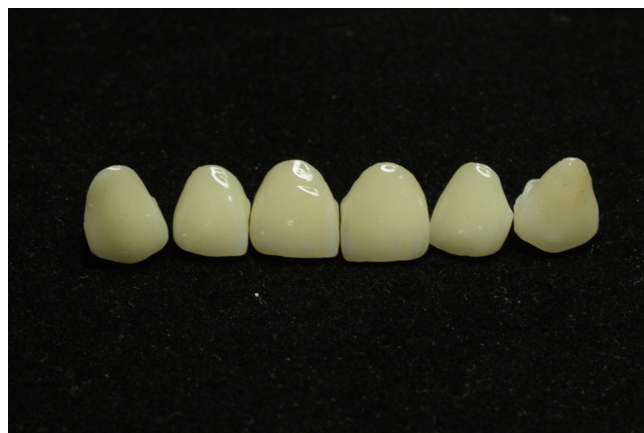
Fig. 4. Final restorations for the maxillary anterior teeth before cementation.

Shade selection was made using the Vita 3D Master System. Splinted provisional restorations were relined and temporarily cemented (Temp-Bond NE, Kerr, Orange, CA, USA). The impressions were poured in Type IV stone (Silky Rock, Whip Mix, Louisville, KY, USA) and pindexed. The pindexed casts were mounted on an articulator in maximum intercuspation. Laboratory prescription for Vita Enamic crowns were completed and sent to an outside laboratory (T Dental Lab, Bangkok, Thailand). Final restorations were received from the laboratory (Fig. 4).

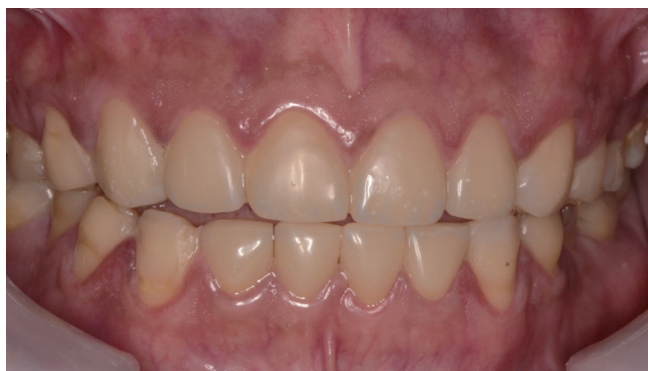
Fig. 5. Postoperative frontal view at maximum intercuspation position.

Clinical try-in and adjustment were performed prior to permanent cementation. Comprehensive esthetics, phonetics, and function were evaluated. The occlusion was assessed to eliminate occlusal interferences, especially on the maxillary and mandibular canines. The edge-to-edge occlusal relationship was established in this case to avoid excessive coronal crown height in both maxillary and mandibular anterior teeth. The intaglio surfaces of the restorations were treated with 5% hydrofluoric acid (VITA CERAMICS ETCH, Vita, Zahnfabrik, Germany) for 60 seconds according to the manufacturer's instruction. The etching gel was completely removed using water spray and the restorations were dried for 20 seconds. Silane was applied to the intaglio surfaces of the crowns and dried completely. Self-adhesive resin cement (Rely X Unicem, 3M ESPE, Seefeld, Germany) was used to cement restoration following the manufacturer's recommendations. Excess cement was removed completely and the special care instructions for ceramic restorations were given to the patient (Fig. 5). After completion, the patient's discomfort and tooth sensitivity disappeared.

The patient has been back to swim in a swimming pool with proper chlorination. Esthetics, phonetics, and function were satisfactorily restored. After 6-months follow-up, the restorations were in place with no complications. The periodontal health appeared to be normal. The patient has been maintaining good oral hygiene care of his teeth. Post-treatment monitoring will be followed in every 6 months. Since there have been insufficient clinical report regarding using hybrid ceramic in this type of case, long-term follow-up will be performed for at least 3 years. Further long-term clinical performance will be provided.
