# Failure of Less-Invasive Stabilization System (LISS) plating for periprosthetic distal femur fractures

## Three case reports

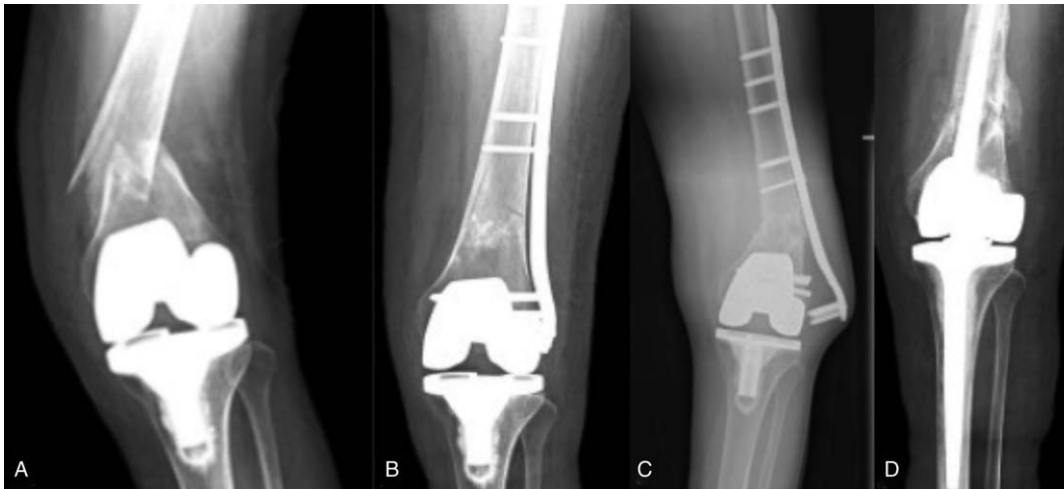
**Figure 1.** Anteroposterior radiographs of case 1, sustained a left Rorabeck type II closed distal femoral fracture (A), internal fixation of LISS plate was performed immediately (B). 7 months later, screws of LISS plate were broken and fracture displacement occurred again (C), underwent total knee arthroplasty revision surgery with rotating hinged knee prosthesis finally (D).

Case 1 was a 73-year-old female (Table 1) who had sustained a left Rorabeck type II closed distal femoral fracture after a fall from the stairs (Fig. 1A). Due to severe osteoarthritis of both knees, she underwent bilateral total knee arthroplasty surgeries 5 months prior. She was taken urgently to the operating room for periprosthetic fracture with a 9-hole LISS plate (Fig. 1B). Six screws the femoral condyle, and 4 screws were screwed in the proximal femur. Progressive weight bearing was not allowed until a significant callus was seen. Subsequently, she came to the hospital for anti-osteoporosis treatment and follow-up was performed monthly. Seven months later, 3 distal and 1 proximal

screw of her LISS plate had broken; the side of the distal plate separated from the femoral condyle and could be seen clearly on X-ray (Fig. 1C). She underwent total knee arthroplasty revision surgery with rotating hinged knee prosthesis (Fig. 1D). Subcutaneous hematoma formed around the drainage tube 2 days later. Debridement was performed immediately under local anesthesia. Six months later, her fracture united, ambulated with 1 crutch, free of pain, with a knee range of motion (ROM) of 0° to 100°.

In Case 1, due to the breakage of plate screws, the LISS plate missed the solid fixation, resulting in fracture displacement again. Although full weight-bearing was allowed at least 4 months after this procedure, she admitted that it was early. The literature on LISS plates is not specific concerning when weight bearing should be allowed, initial non-weight-bearing was required for between 8 and 12 weeks; toe-touch weight-bearing was stipulated for the first 4 to 6 weeks; partial weight bearing was initially required for the first 8 to 12 weeks following surgery.<sup>[8]</sup> Fankhauser et al<sup>[9]</sup> suggested that weight-bearing was determined on a case-by-case basis. Liu et al<sup>[7]</sup> recommended that weight-bearing should be deferred if the position of LISS plate was abnormal. Three distal and 1 proximal screws of the LISS plate were broken; a disadvantage of the LISS plating system is that the unicortical screws can result in pullout of the screw plate construct, especially in the thin cortex of osteoporotic bone, as a result of decreasing the working length of the locking screws.<sup>[10]</sup> After the review of the present cases, we suggest the concept that the screw or plate could break because of the stress concentration effect at the plate end; the stress increases with adding distance from the fracture site, which generated by interaction between the LISS plate and screw. Further discussion will be pertained to the third case.

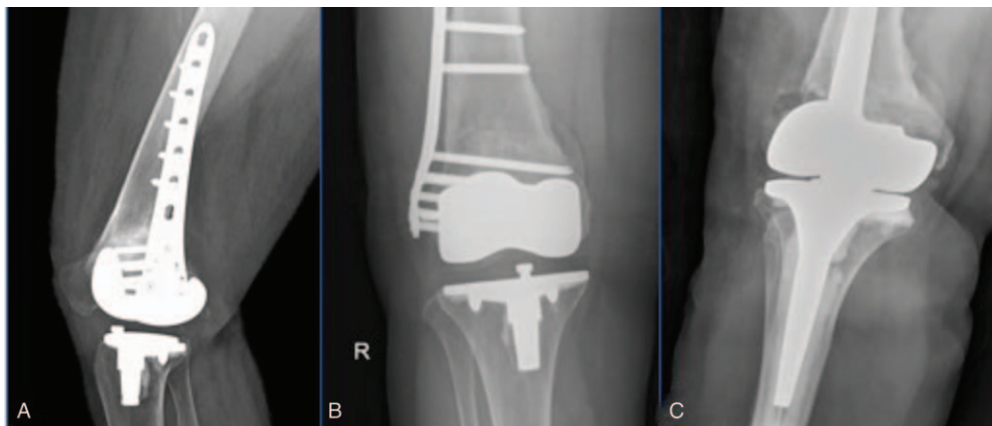
**Figure 2.** Anteroposterior and lateral radiographs of patient 2, the LISS plate was not centered on the femoral shaft (A), the gap of the lateral compartment was wider under varus stress (B), placement of the prosthesis was appropriate (C).

The second case referred from an outside institution was a 65-year-old female with a right Rorabeck type II fracture after a fall. She had a history of total knee arthroplasty surgery in both knees, as in Case 1. She underwent LISS plate fixation and significant callus formation was noted 6 months later (Fig. 2A). She was referred to our institution twice because of lateral knee pain after her internal fixation procedure, physiotherapy, and pharmacotherapy did not relieve her pain sufficiently. During the follow-up, her fracture was united, but the gap of the lateral compartment was wider than before on the postoperative x-rays, potentially generated potentially by partial or total injury of the lateral collateral ligament (Fig. 2B). She underwent LISS plate removal with replacement of the total knee arthroplasty (Fig. 2C). Six months after this procedure, she could walk unaided, without pain, but with partial numbness around the surgical incision.

Case 2 was a case of postoperative pain after LISS plate fixation. A series of treatments did not work well. We found that the gap of the lateral compartment was wider on the x-ray, suggesting that her lateral collateral ligament of knee was injured. It was almost certainly due to incorrect plate placement. The LISS plate was not centered on the femoral shaft, according to the postoperative radiographs; the proximal end was placed anteriorly. Therefore, we suggested that fluoroscopic imaging during surgery is of paramount importance for assessing the position of the implant, and avoiding the LISS complications. The position of the implant was assessed by observing the shape of the holes in the implant, the direction of the locking head screws as well as relative position between the bone and the implant. Furthermore, the postoperative x-rays indicated that the gap of the lateral compartment was wider than before under varus stress, and slight internal rotation of the femoral component occurred. As the LISS is implanted through a small lateral approach without direct visualization of the LCL, the question has emerged as to whether damage to the LCL during LISS implantation might also be a possible cause for lateral knee pain.<sup>[11]</sup> In a cadaver study, Freimoser et al reported that if the origin of the LCL was close to the implant, the LCL might be harmed by the locking screws of the plate; therefore, lateral knee pain, or lateral instability after implantation should be assessed in further treatment.<sup>[12]</sup> Finally, it may affect the survival of the prosthesis. Consequently, intraoperative fluoroscopy should be used at each stage of the surgical procedure. Therefore, LCL injury should be considered as a potential cause, if a patient suffers from lateral knee pain or lateral knee instability after LISS procedure.

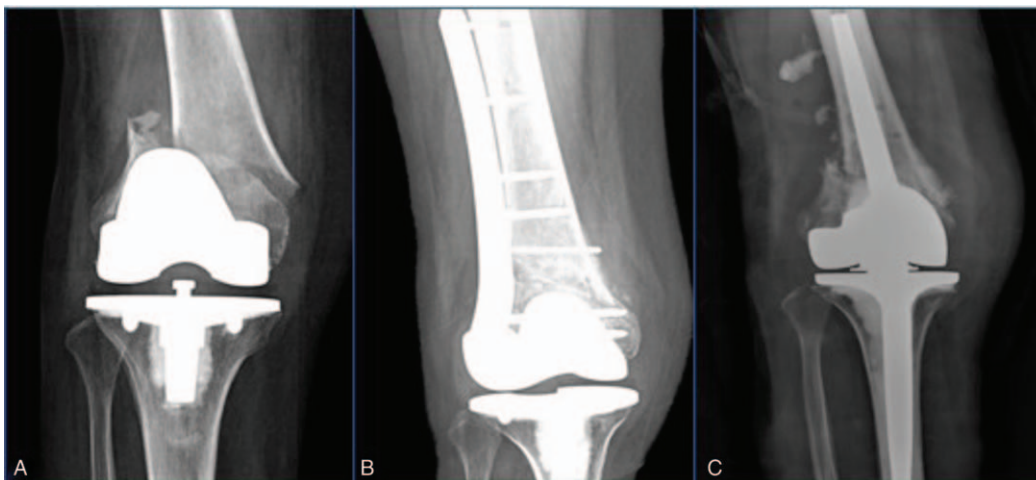
**Figure 3.** In case 3, the patient sustained a Rorabeck type II distal femoral fracture (A), bony callus was noted at the fracture site (B), total knee arthroplasty revision was beneficial for fracture healing.

The third case of plate failure occurred in a 67-year-old woman. Three distal screws were broken. Dislocation of the broken end was noted on her x-rays after a fall (Fig. 3). Just as with the other 2 patients, she underwent total knee replacement on account of the right knee osteoarthritis and sustained a Rorabeck type II distal femoral fracture in a non-motor vehicle accident. She was not noted to have a solid union after LISS plate fixation. Total knee arthroplasty revision surgery was performed the third day after the injury. At the last follow-up, she had no pain or limitations to activities of daily living activities. No further treatment was required. Final union was confirmed at 1 year after surgery for both case 1 and case 3.

The third and first cases had several similarities. Bony callus was noted at the fracture site 4 months later. In both cases, the LISS plate screws of distal end were broken, confirmed during the final total knee arthroplasty revision surgery. The LISS failure in the Case 3 was almost certainly due to obesity and early, unsupervised weight-bearing. The body mass index (BMI) of the third patient was 32. Obesity is a prognostic risk factor of nonunion in distal femoral fractures treated with LLP or LISS, reported in a retrospective multicenter case-control study of 283
