Research article

Assessment of stability of a Himalayan road cut slope with varying degrees of weathering: A finite-element-model-based approach

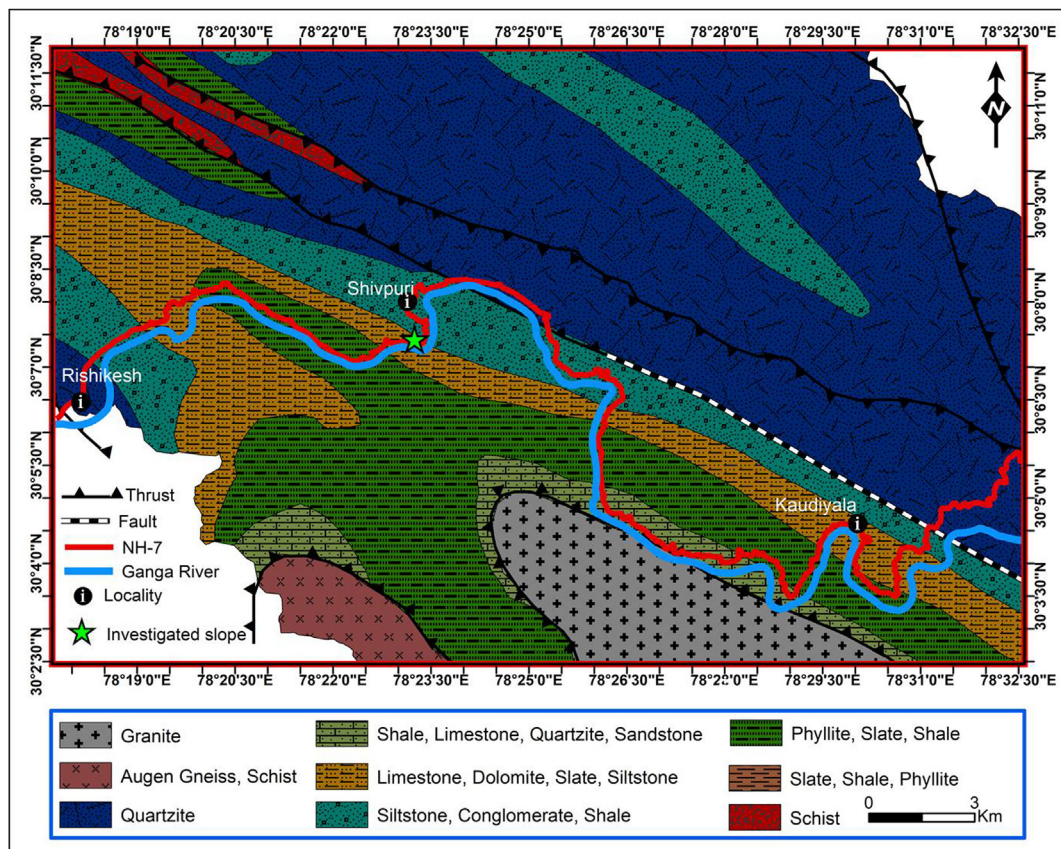
Figure 1. Location of the investigated slope on the geological map of the study area ([Valdiya, 1980](#); modified by [Siddique and Pradhan, 2018](#)).

The study area is located in the Lesser Himalayan region, along NH-7, formerly named NH-58. The road is quasi-parallel to the Ganga River in the Garhwal syncline of the outer Lesser Himalayan region ([Figure 1](#)). The Lesser Himalayan region is sealed by the main boundary thrust in the south and the main central thrust in the north ([Valdiya, 1980, 1983](#)) ([Figure 1](#)). Metasedimentary formations are encountered in the Lesser Himalayan ([Le Fort, 1975](#); [Pradhan and Siddique, 2020](#); [Valdiya, 1980, 1983](#)). Outcrops of carbonaceous rock bearing limestone, with defined levels of sandstone, quartzite, shale, and phyllitic formations have been reported and identified during the field investigation. These rocks, moderately to completely weathered, lead to the formation of the debris

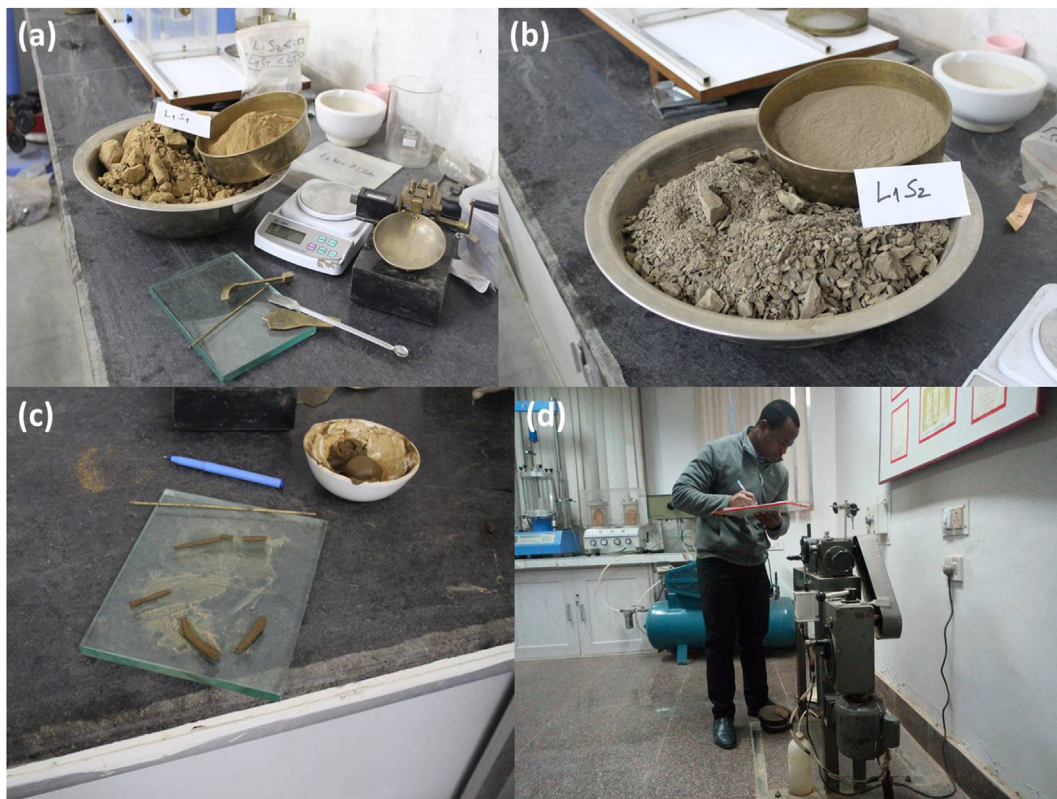
Figure 2. Debris geotechnical properties; (a) debris L1S1 with Atterberg limits test apparatus, (b) debris L1S2, (c) Atterberg limits testing, (d) direct shear strength testing.

shear testing on the specimens (Figure 2 a, b and d) following ASTM standard (ASTM D6528, 2017). The test was conducted under four different normal loads of 0.25 kg/cm², 0.5 kg/cm², 0.75 kg/cm², and 1 kg/cm² and the applied normal stresses ranged from 24.51 kN/m², to 98.06 kPa with a shearing rate of 0.01. The dial gauge reading and shear displacement were recorded for each normal load applied. Then, the shear stress at failure was determined and plotted against the normal stress for each test (Figure 3). Using the generated graph, the cohesion (C) and the angle of internal friction (φ) of the debris was calculated based on the Coulomb failure criterion (Eq. 4)

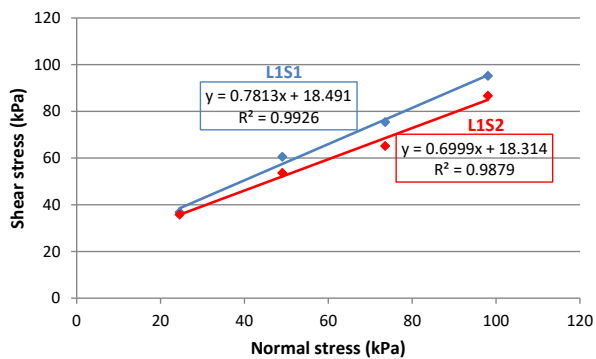
Figure 3. Determination of the shear strength parameters of the debris using the results of direct shear tests.

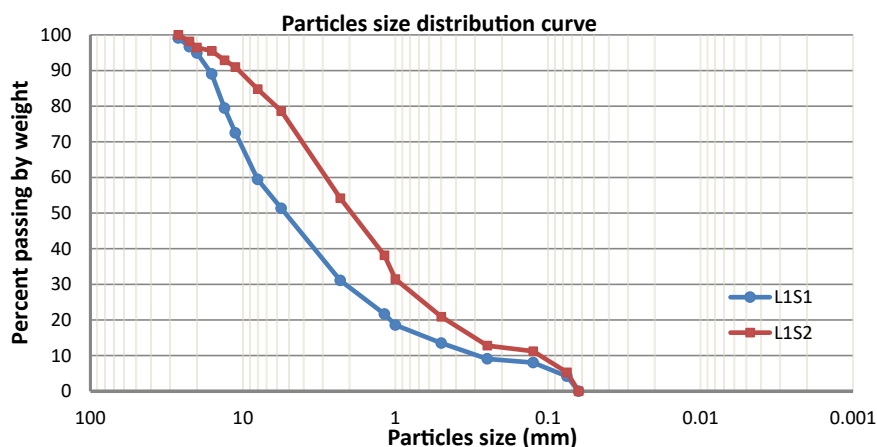
Figure 4. Particle-size distribution curve of the debris materials.

The result of the sieve analysis is presented in Figure 4. The gradation parameters of the soil, namely, the uniformity coefficient (C_u) and the coefficient of curvature (C_c), are tabulated and reported in Table 2. For both samples, the fraction of fines is less than 5%, the uniformity coefficient (C_u) > 6, and the coefficient of curvature lies between $1 < C_c < 3$, classifying both debris samples as SW, i.e., well-graded sands, gravelly sands, with little or no fines (Selig and Howard, 1984).

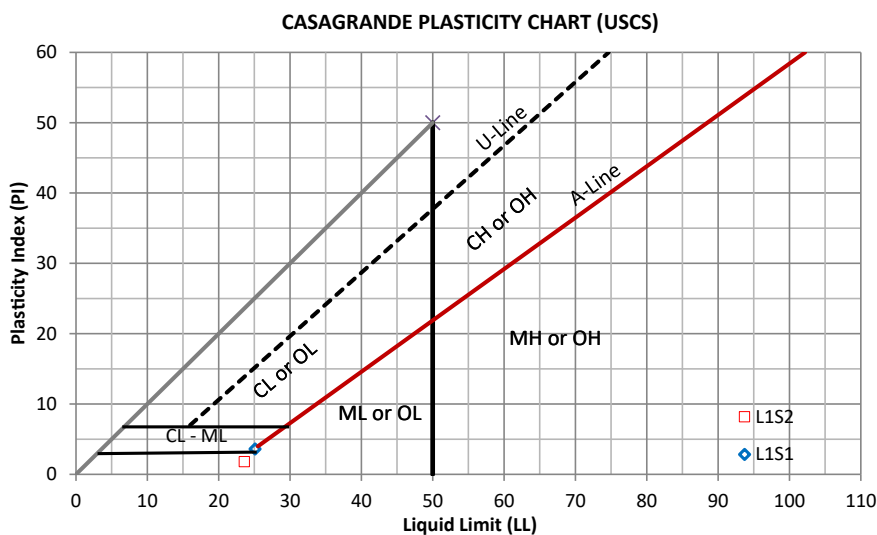
Figure 5. Plot of the debris samples in the Casagrande plasticity chart.

The liquid limit (LL) and plasticity index (PI) of the samples were found to be 25.10% and 3.61% for sample (L1S1) and 23.60% and 1.81% for sample (L1S2), respectively; from the Casagrande plasticity chart presented in Figure 5, both debris are graded silt of low plasticity (ML).

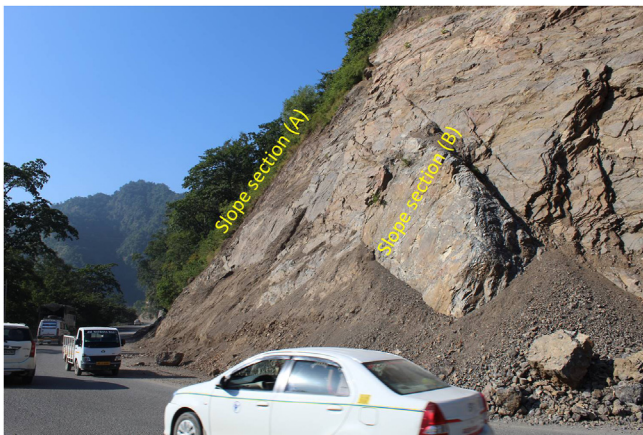
Figure 6. General overview of the investigated slope.

A general overview of the studied slope is presented in Figure 6. The slope height was found to be 28 m with a slope angle ranging from 37° to 55° at section (A) (Figure 7) and 50° – 75° at section (B) (Figure 8). The slope profile in section (A) is completely weathered (grade V) along with a cap of weathered materials (L1S1) overlying the slope surface (Figure 7) and the slope profile in section (B) belong to a moderately (grade III) to highly (grade IV) weathered rock mass characterised by the absence of debris on the slope surface (Figure 8). The numerical models of the slope at both sections A and B are presented in Figures 9 and 10 respectively. The presence of weathering materials overlying the slope at section (A) (Figure 7) is an indicator of instability problems. The shear strain dispersion within the simulated slope at section (A) and section (B) can be observed in Figures 11 and 12 respectively. The maximum shear strain contour in section (A) (Figure 11) clearly revealed the region of the slope where the sliding may occur. Such a slip surface observed at section (A), highlighted with a red dashed line, seems to be the consequence of the debris materials overlying the slope, as the shear strain is concentrated along with the interface between the rock mass and debris, representing the least resistant surface. It has been reported that weathering is one of the factors that lead to the reduction in the inherent shear strength of the rock mass, which represents the maximum shear stress that the geological formation can withstand under slope (Biondino et al., 2020; Conforti and Buttafuoco, 2017; Tran et al., 2019). Therefore, the presence of weathered materials above the slope profile section (A) indicates that there has been an alteration in the strength parameters of the slope material, such that failure is more likely in section (A). The critical SRFs of both sections (A) and (B) were found to be 1.25 and 2.53, respectively. As can be seen, the SRF was reduced by approximately 50%. Presumably, the higher SRF observed in section (B) is due to the fact that this section does not exhibit significant debris material on the slope surface (Figure 8). This result is in agreement with the case study conducted by Seyed-Kolbadi et al. (2019), which concluded that the FoS of a non-homogeneous slope covered by a weak layer is less than that of the homogenous one. The weak material on the slope surface at section (A) may be due to its geometry along with a lower overall slope angle unfavourable to surface drainage, which favours its degradation by mineral dissolution. Another factor may be the formation of secondary minerals that tend to alter the inherent shear strength of the slope-forming material (Che et al., 2012; Regmi et al., 2014; Tran et al., 2019), weakening its critical SRF. An SRF of 1.25 at the slope profile section (A) indicates that the slope is marginally stable and may fall under the influence of triggering events, such as heavy rainfall or long-lasting rainfall and seismic activity. For example, weathered products may reduce the down-water infiltration and retain the fluid, which increases the shear stress through the increase in the pore-water pressure, thereby resulting in slope instability (Nguyen et al., 2020). Migoñ (2013) studied the weathering and hillslope development and highlighted that the steep slope surface that sheds

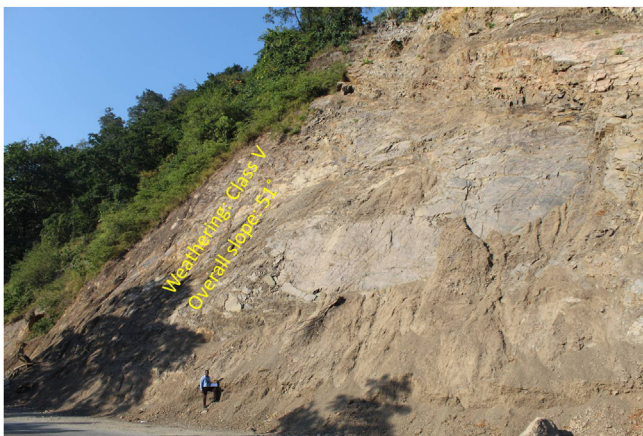
Figure 7. Slope profile section (A) showing the overall slope angle and the weathering grade.

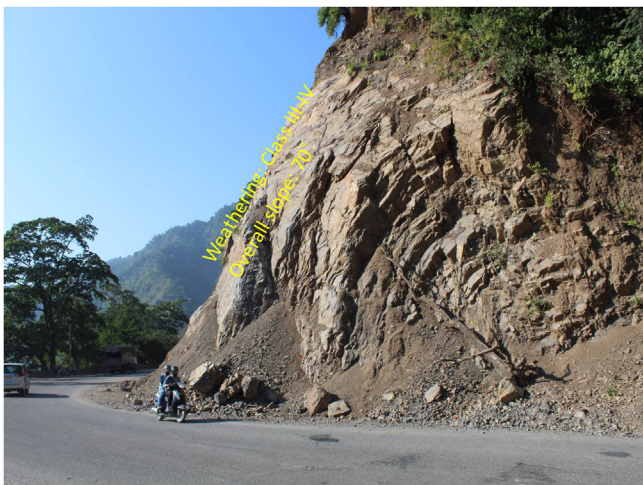
Figure 8. Slope profile section (B) showing the overall slope angle and the weathering grade.

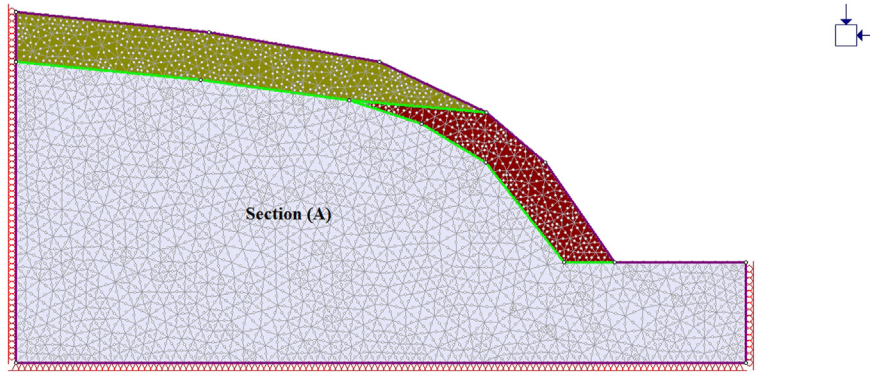
Figure 9. Geometry of the simulated slope along with the debris at section A.

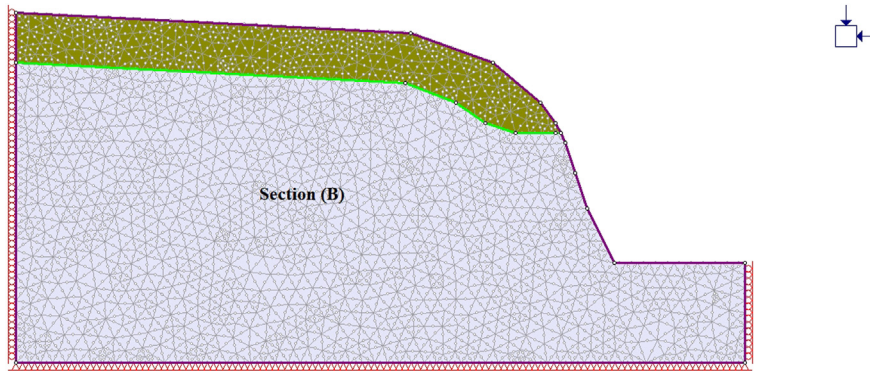
Figure 10. Geometry of the simulated slope along with the debris at section B.

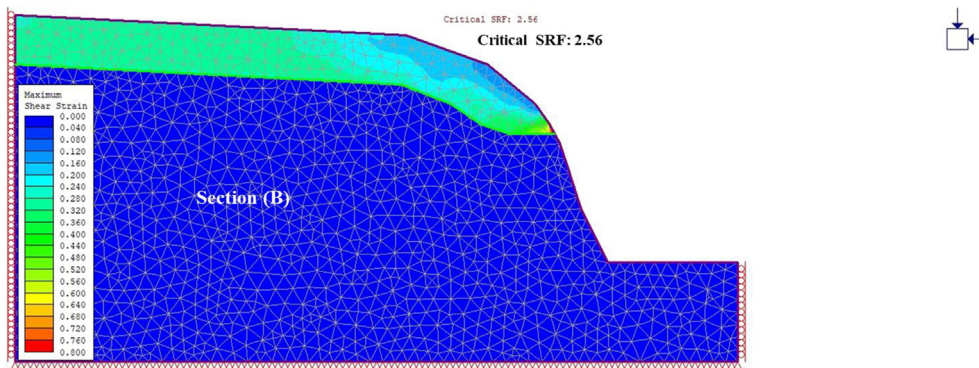
Figure 12. Shear strain dispersion at section B.

water may be more resistant to weathering and failure, as the weathering processes are enhanced by the availability of water, which is detrimental to the shear strength reduction of the geomaterial (Pei et al., 2020). Furthermore, letto et al. (2018) reported a strong correlation between the degree of weathering and the slope gradient and indicated that gentle slopes are more vulnerable to weathering. This is in agreement with the slope profile section (B) (Figure 8), where the greater overall slope angle enhances the surface runoff (Pei et al., 2020) and may have contributed to the reduction in the alterability of the rock mass/strength factor, making it more stable than that in section (A) (Figure 7). The simulated total displacement obtained at section (A) (Figure 13) is 4.73 cm, which is approximately a factor of 10 higher than that obtained in section (B) (Figure 14), equal to 0.46 cm, which shows the extent of the probable zone of failure in section (A) as compared with that in section (B).

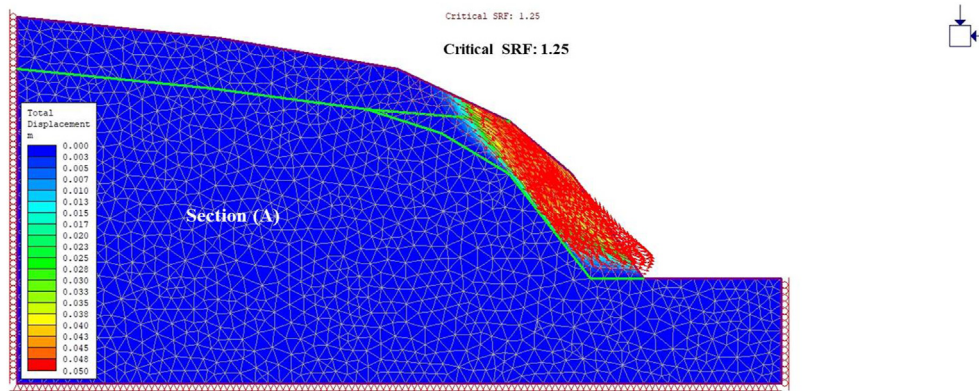
Figure 13. Contour of total displacement at section A.

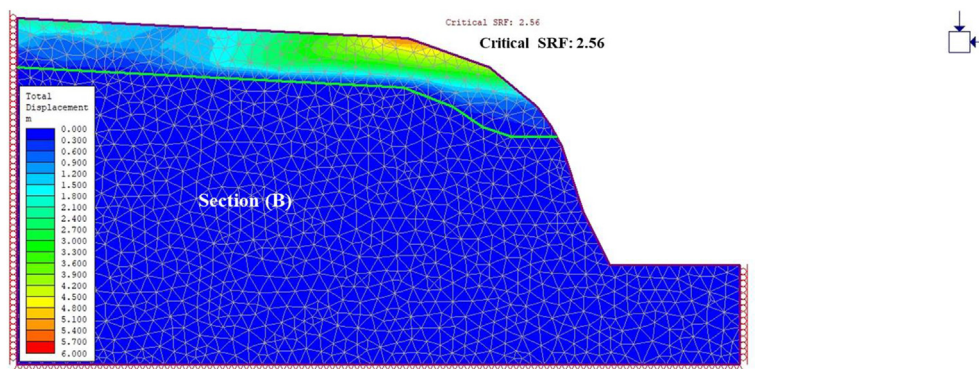
Figure 14. Contour of total displacement at section B.
