CASE REPORT

# On-X mitral valve leaflet embolization presenting as acute pulmonary oedema

**Case presentation:** We report a case of a 21-year-old male patient who presented with acute pulmonary oedema due to fracture and embolization of a leaflet of an On-X mitral valve four years post-implant. He underwent an emergency redo mitral valve replacement with a good outcome.

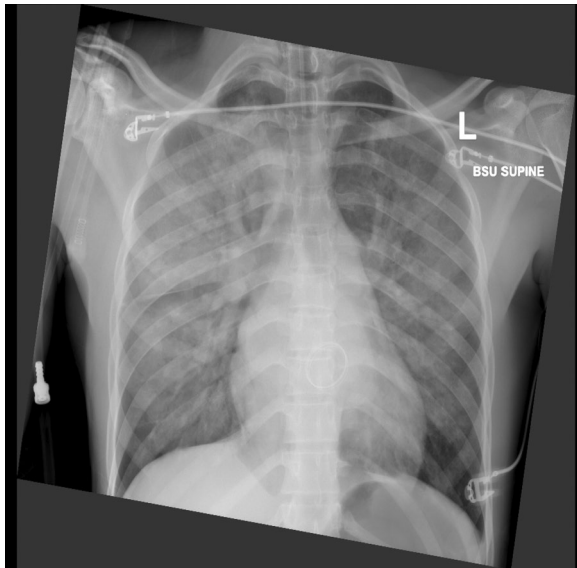
**Fig. 1** Chest radiograph showing pulmonary oedema

Once stabilized for transport, he was transferred by air to our centre (300kms) with suspected mechanical valve dysfunction. The laboratory findings were unremarkable except for an INR of 1.73. His chest radiograph showed fulminant pulmonary oedema (Fig. 1).

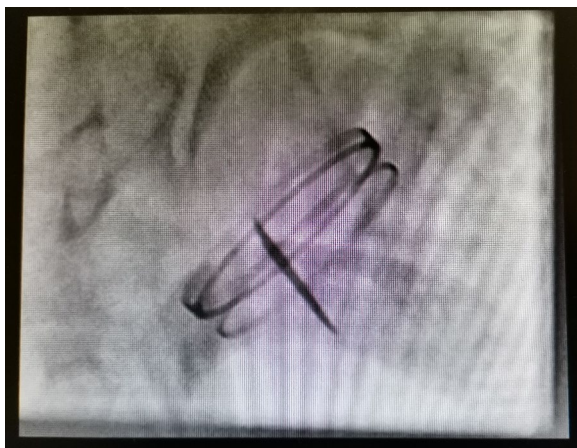
**Fig. 2** Fluoroscopy valve screen showing a single leaflet of the mechanical mitral valve

A two-dimensional echocardiogram (2D echo) and fluoroscopy screening were done (Fig. 2). Both showed

a single leaflet with normal mobility. The second leaflet was not visualized, and a working diagnosis of a stuck mitral valve prosthesis in a closed position was made. The patient underwent emergency redo mitral valve replacement. Intraoperatively on exploring the mitral valve prosthesis, a single leaflet was noted, and there was no pannus or clot formation (Fig. 3). The second leaflet was missing. The missing leaflet was not found inside the heart nor in the chest on an intraoperative transoesophageal echocardiogram. The valve was excised, and a size 25 mm On-X was implanted. We decided to reimplant the On-X valve because we could not find the literature

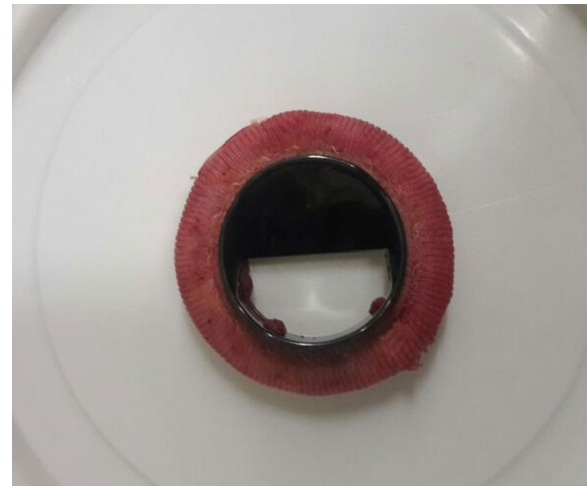
**Fig. 3** The explanted mechanical mitral valve prosthesis On-X with a single leaflet

on previous On-X valve leaflet fracture cases at the time of surgery. We assumed it was an isolated case of a possible manufacturing defect. Off bypass, all the patient's peripheral pulses were present. He had no ischemic limb, organ or cerebrovascular accident /transient ischaemic attack at any stage. We elected to locate and remove the leaflet once he was out of the intensive care unit.

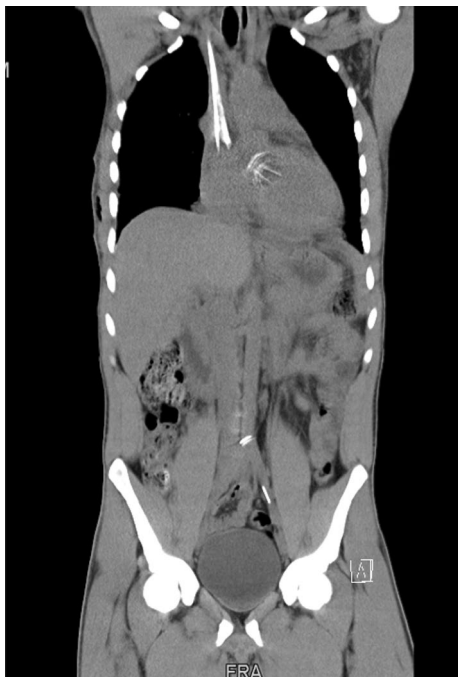
**Fig. 4** Computed tomography of the whole body showing the mechanical mitral valve leaflet at the abdominal aortic bifurcation and left external iliac artery

Post-operatively an unenhanced computer tomography (CT) of the whole body was done, which showed the leaflet had embolized to the aortic bifurcation and another fragment to the proximal left external iliac artery (Fig. 4). The patient underwent a successful open removal of the fractured leaflet via midline laparotomy on day 13 post-cardiac surgery (Fig. 5). His post-operative course was uneventful, and an echocardiogram showed normal functioning mitral valve prosthesis with a good ventricular function. He was discharged, and his follow-up at the outpatients department continues. The valve was sent to On-X for examination. The valve report stated that the mechanism of valve failure was noted to be cavitation. There was no definitive root cause found, and it was not possible to conclusively eliminate iatrogenic damage and patient factors, but no manufacturing defects were found.

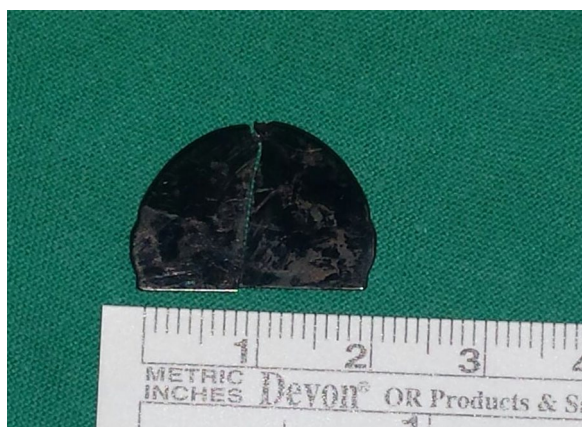
**Fig. 5** The fractured and embolized leaflet extracted from the aorta and external iliac artery

an initial diagnosis. We suspect that the valve fractured first and then embolized as it was in 2 pieces. However, the report did not conclusively support this theory. Gobel et al. reported the first fatal case of leaflet escape with the On-X valve in the aortic position. Kayegama et al. and Amoros Riviera et al. reported two cases of On-X mechanical mitral valve leaflet fracture and embolization [3, 4, 6]. The site of embolization reported was the

There is no consensus regarding removing the embolized leaflets if there is no threatened limb or ischemic complications. We decided to remove the fractured leaflets as we feared the risk of the fragments lacerating the aorta or eroding into the vessel wall. Catheter removal was considered but not undertaken due to the possible risk of the fractured ends of the leaflets lacerating the vessel. We removed the embolized leaflets surgically.
