Unique Procedure to Remove Pedicle Screw without Compatible Instrumentation: Case Report and Review of Literature

Case Report: A 55-year-old patient previously operated for D12 fracture presented to us with implant failure due to backing out of pedicle screws. Compatible instrumentation to remove the implant was not available as even the cap screw could not be removed due to screwdriver mismatch. Hence, we had to design our own method to address the problem which we did successfully. At present, the patient is on our regular follow-up, is pain free, is able to walk without support, and has not reported any new complaints.

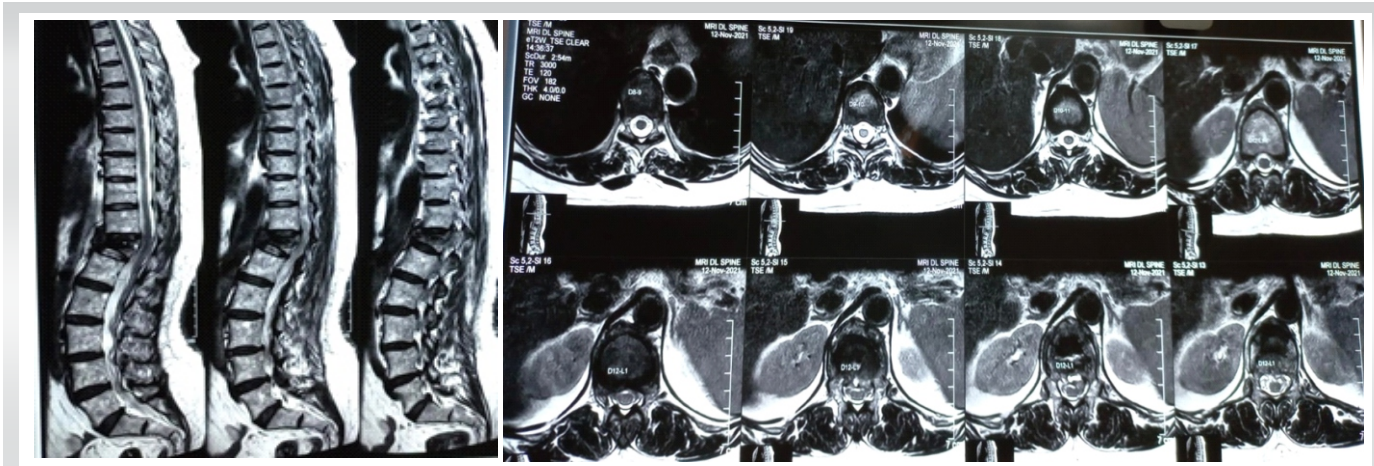
Figure 1: MRI Image before the first surgery showing D12 fracture.

A 55-year-old female came to us on wheelchair with back pain radiating to bilateral lower limbs for 6 months and being able to walk few steps inside house only to attend her basic daily toilet routine. The patient was operated elsewhere for D12 fracture 6 months back in which pedicle screw fixation was done, 2 each in D11 and L1 vertebra. The patient only had pre-operative MRI

(Fig. 1) when she came to us in OPD.

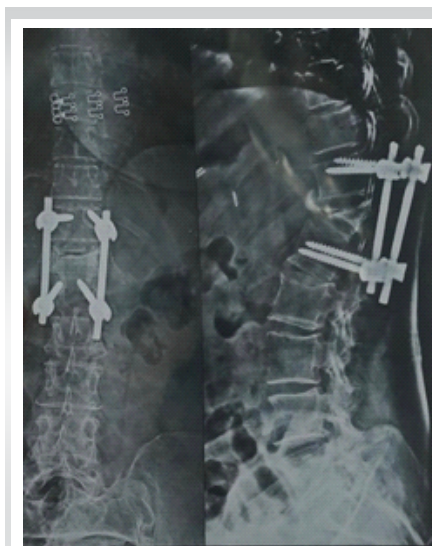
According to the patient, pain persisted even after the surgery. On examination, there was no sensory or motor deficit in lower limbs. In X-ray, it was seen that one pedicle screw in D11 vertebra had backed out and there was localized kyphosis at D12 vertebra (Fig. 2).

Figure 2: Image showing implant failure due to backing out of pedicle screw from D11 vertebra.

The patient was planned for surgery. Instrumentation was not known. Hence, we had kept all possible instrumentation including Allen key. Removal of pedicle screw requires the removal of cap screw first followed by rod and pedicle screw. In our case, cap screw was of 4.5-mm size, however, size of screwdriver available was of 6.5 mm. We also tried locking screw driver which did not work. We then tried different 4.5-mm screwdrivers, but they were also not compatible with the cap screw head. Hence, we used jumbo cutter as a final modality to

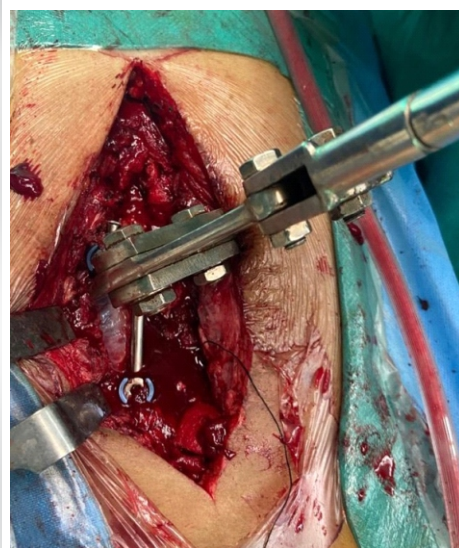
Figure 3: Image showing jumbo cutter being used to cut the rod.

cut the rods close to the head of the screws (Fig. 3) due to which polyaxial screw along with small piece of rods on their head behaved like a single unit. These rods acted as levers with which pedicle screws were removed (Fig. 4). Following implant removal, 6.5-mm screws 2 each were inserted in D10, D11, L1, and L2 vertebra while a single pedicle screw was inserted in fractured D12 vertebra (Fig. 5). On post-operative day 3, the patient was allowed to walk with the support of walker. Patient's general condition was fine and was pain free except for the operative site pain. The patient was started on antiosteoporotic treatment at the time of discharge. At present, i.e., 2 years after the revision surgery, the patient is pain free, is able to

the cap screw could not be removed due to screwdriver mismatch. Hence, we modified the technique in which we cut the rods near the pedicle screw head and then removed the screws. The same method has been mentioned by Ulus et al. using speed drill or circular saw [10]. However, in our case, we used a jumbo cutter to cut the rods which is easily available. Our screw remover design reduces the time and effort of surgery and also takes away the need to remove the fibrous tissue covering the cap screw heads and pedicle screw heads to engage the screwdriver.

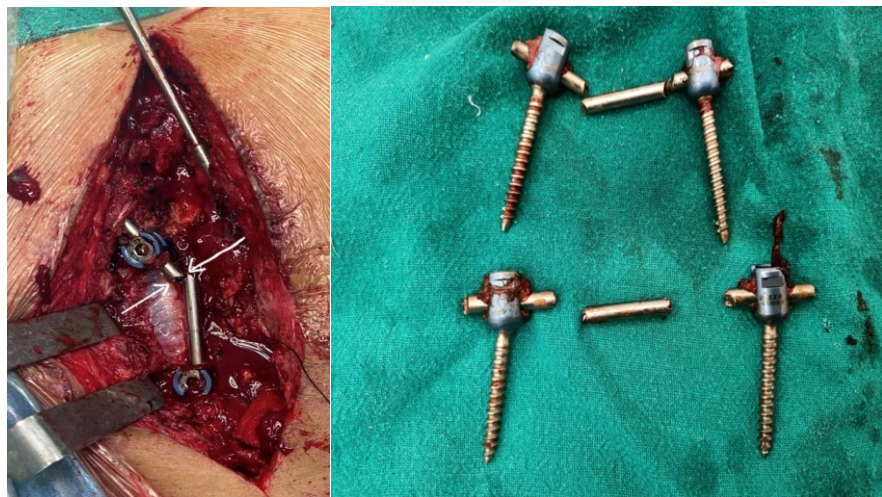
Figure 4: Pedicle screws with small piece of rods on their heads acting as a single unit.

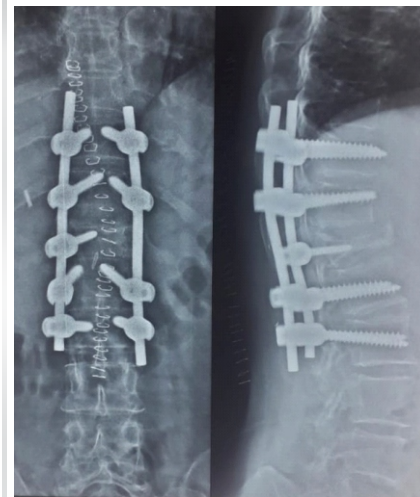
Figure 5: Post-operative image after revision surgery.
