## Acetabular liner dissociation: A case report and review of the literature

**Abstract** – Dissociation of the polyethylene liner from the acetabular shell is a rare but catastrophic complication of total hip arthroplasty (THA). There have been reports of polyethylene liner dissociation (PLD) as well as ceramic liner dissociation (CLD) in the literature. Amongst the commonly used implants, liner dissociation has been reported with the Pinnacle (DePuy), Harris–Galante (Zimmer) and Trident (Stryker) acetabular components. To the best of our knowledge, this is the first case report of PLD in an R3 (Smith & Nephew) acetabular component. This case report highlights the implant choice for treatment of the liner dissociation and the role of constrained implants in such cases.

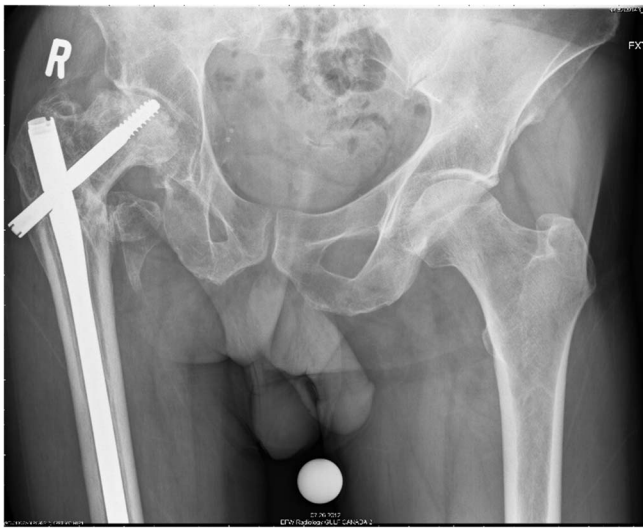
**Figure 1.** Painful right hip with collapse of the femoral head due to avascular necrosis.

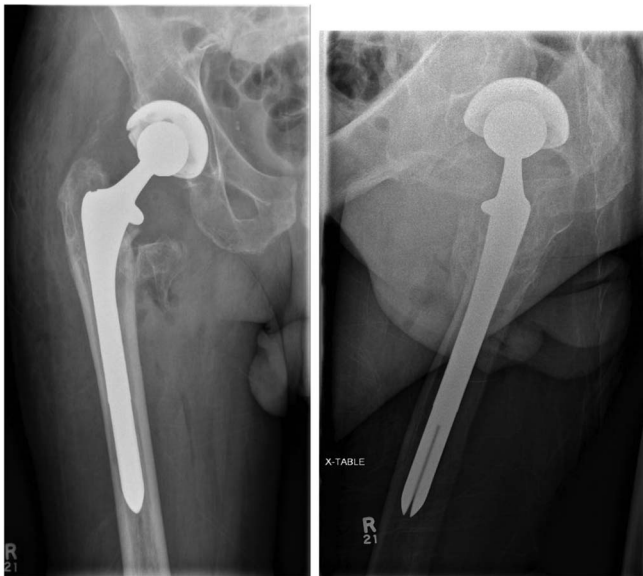
**Figure 2.** A and B: Complex primary THA.

The patient required release of the gluteus maximus, iliopsoas and anterior capsule to address the flexion contractures. An uncemented THA was performed using the Smith & Nephew R3 size 60 acetabular shell with 60/36 highly cross-linked polyethylene liner in the templated position. As the old fracture was extending up to the subtrochanteric region, a size 15 Echelon uncemented stem was used to bypass the subtrochanteric region. A CoCr 36 + 10 femoral head was used and was found to be stable (Figure 2A and B). Clinical and radiographical follow up of his THA was unremarkable for 5 years postoperatively. However, 5 years after the primary operation, the patient had a fall and presented with a new onset of hip pain, and radiographs showed radiolucency medial to the femoral neck in association with an eccentrically placed femoral head lying in contact with the acetabular metal shell. Careful evaluation of the radiographs showed that this radiolucency was consistent with a PLD (Figure 3A and B).

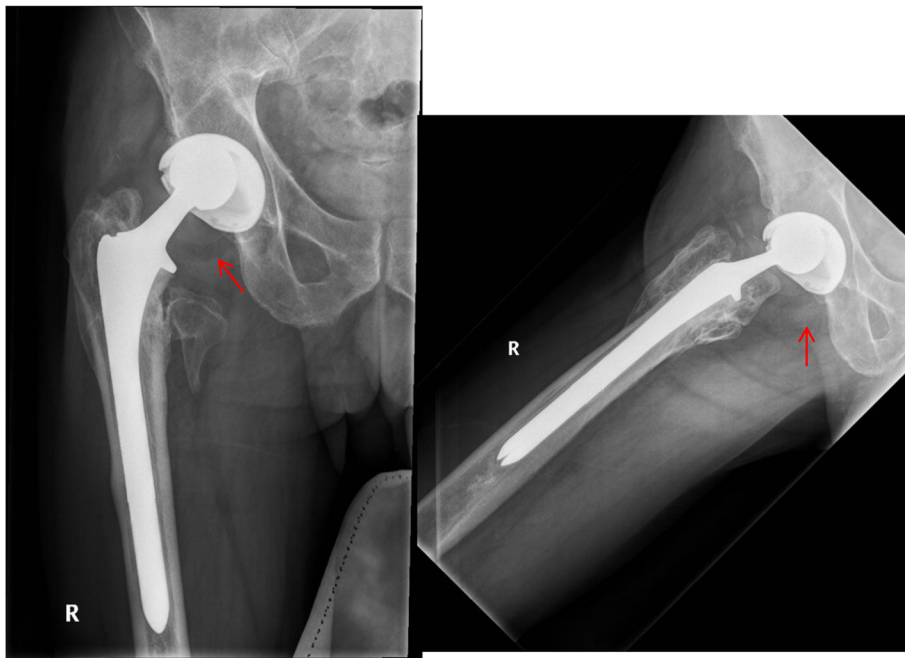
**Figure 3.** A and B: Proximal migration of the femoral head and radiolucent ring suggestive of polyethylene liner dissociation.

The radiolucency of the dissociated liner seen on plain radiographs has been described as the “crescent” sign while using ultrasound this has been described as the “tram track” sign [8–10]. PLD has been reported with some of the most commonly used implants [1, 2, 4, 6, 11]. However, to date there have been no reports of this complication with the Smith & Nephew R3 system.

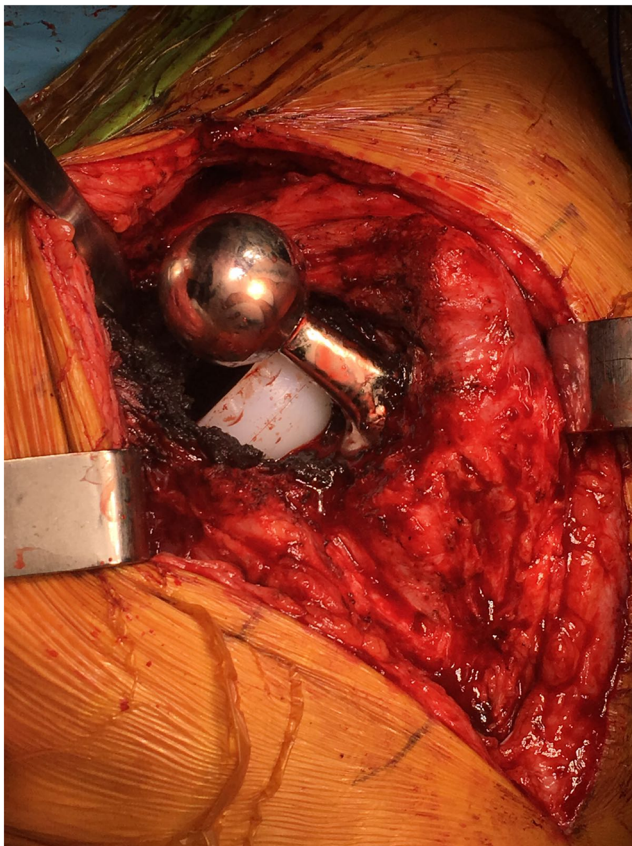
**Figure 4.** Intra operative picture showing the dissociated liner.

Infection work up including inflammatory markers and a joint aspiration were clear; hence a single-stage revision was proposed. Patient declined surgery and opted to carry on for further 3 months at which point his pain worsened and hence revision arthroplasty was performed. Intraoperatively, the acetabular liner was found to be dissociated (Figure 4). The femoral component was stable and therefore retained. Surgery involved replacement of the acetabular shell and liner and the femoral head along with excision of a pseudo tumour resulting from metallosis. Trial reduction and range of movement testing

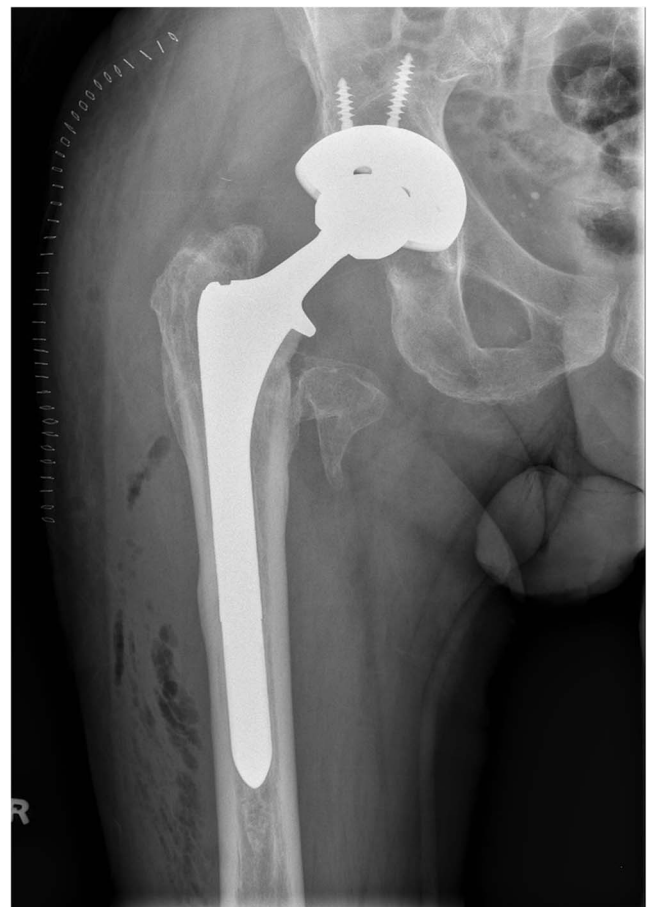
**Figure 5.** Radiographs after revision of the acetabular components.

were satisfactory, and hence the definitive components implanted included a Zimmer Continuum shell of size 64 mm with an offset liner and 36 mm + 12 Oxinium femoral head (Figure 5).

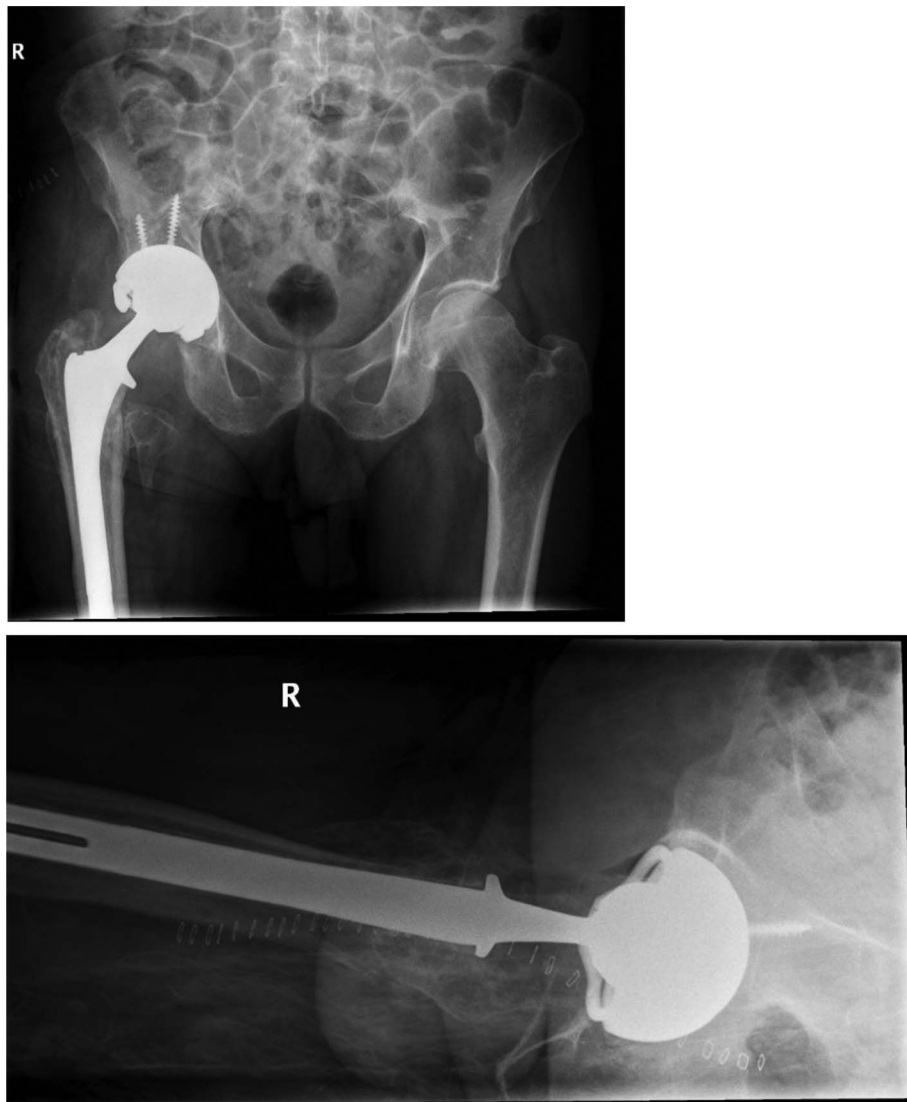
**Figure 6.** A and B: Constrained liner following the 2nd revision THA.

polyethylene was revised and a constrained liner was used instead with a new size of 36 mm + 12 Oxinium femoral head (Figure 6A and B).
