# Chemical, Physical, and Mechanical Properties of 95-Year-Old Concrete Built-In Arch Bridge

**Abstract:** This research aimed to determine the durability and strength of an old concrete built-in arch bridge based on selected mechanical, physical, and chemical properties of the concrete. The bridge was erected in 1925 and is located in Jagodnik (northern Poland). Cylindrical specimens were taken from the side ribs connected to the top plate using a concrete core borehole diamond drill machine. The properties of the old concrete were compared with the present and previous standard requirements and guidelines. The laboratory testing program consisted of the following set of tests: measurements of the depth of carbonated zone and dry density, water absorption tests, determination of concrete compressive strength and frost resistance, determination of modulus of elasticity, measurement of the pH value, determination of water-soluble chloride salt and sulfate ion content, and X-ray diffraction analyses. Large variations in the cylindrical compressive strength (14.9 to 22.0 MPa), modulus of elasticity (17,900 to 26,483 MPa), density (2064 to 2231 kg/m<sup>3</sup>), and water absorption

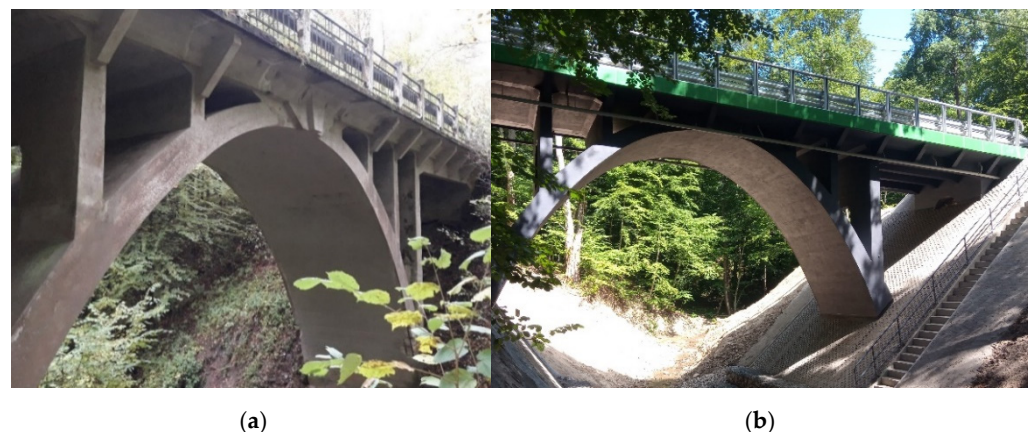
**Figure 1.** Jagodnik arch bridge before (a) and after (b) reconstruction.

The arch bridge investigated in this study is located above a forest canyon and the Kumieli river (watercourse) (see Figure 1). The structure of the center span bridge (about 12.95 m) is a reinforced concrete slab, monolithically connected to reinforced concrete shields supported on a plate arch. The arch bridge was built in 1925 in Jagodnik (Poland) by Karl Metzger & Co. building company (see p. 181 in [24], where a photo of the investigated arch bridge is inserted). In 1925, Jagodnik (Berendshagen) was part of the district of Elbing in Germany (present-day Elbląg in Poland). The arch bridge was erected under the guidelines of the German Committee for Structural Concrete issued in January 1916 [25] for structural use of concrete, design, and construction. This guideline was in force until September 1925, when the German standard DIN 1045 [26] was introduced.

The design team of the Jagodnik arch bridge made a decision on the possibility of reconstructing the 95-year-old arch bridge and designing it for car traffic to a limited tonnage. On top of the existing old structure, a new deck slab with pavement covers was made. The entire surface of the old concrete was protected with repair mortars.

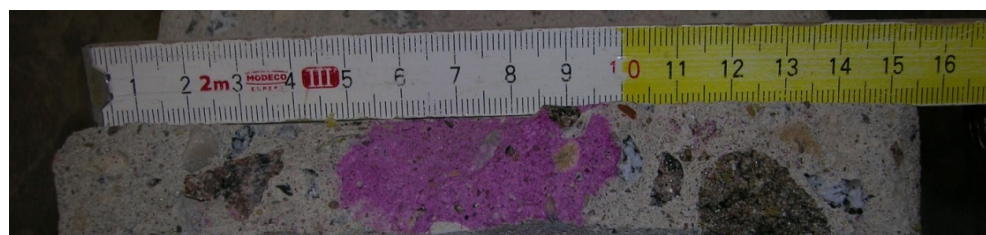
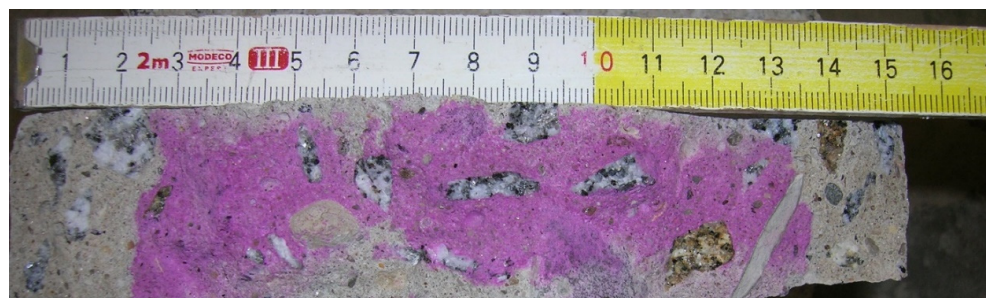
**Figure 2.** Depth of carbonated zone: (a) about 5 cm; (b) about 2.5 cm.

The chemical reaction of calcium hydroxide dissolved in pore water with atmospheric carbon dioxide (conversion into calcium carbonate, which is then mainly calcite [36]) is called carbonation of concrete. Carbon dioxide in the air penetrates into concrete and diminishes the pH value and also causes shrinkage in the concrete [37]. The depth of the carbonated zone measured with the phenolphthalein solution is illustrated in Figure 2. Freshly fractured surfaces of all specimens reacted with the alcoholic solution of phenolphthalein, immediately turning to pink/purple color, indicating the presence of calcium hydroxide, except at the thin, already carbonated external layers. Large variations in depth of the carbonated zone was observed in the investigated specimens of old concrete, ranging approximately 20 to 55 mm (see Table 1). The average depth of carbonation of the old concrete was  $36 \pm 2$  mm. The result of the mean value is presented as the sum of mean values and standard error of the mean of the specified range.

Specimen No.	1_1	1_2	2_1	2_2	3_1	3_2	4_1	4_2	5_1	5_2	Mean (mm)
Cover 1 (mm)	45	35	40	44	30	40	50	30	25	24	$36 \pm 2$
Cover 2 (mm)	45	35	40	45	25	40	55	32	25	20

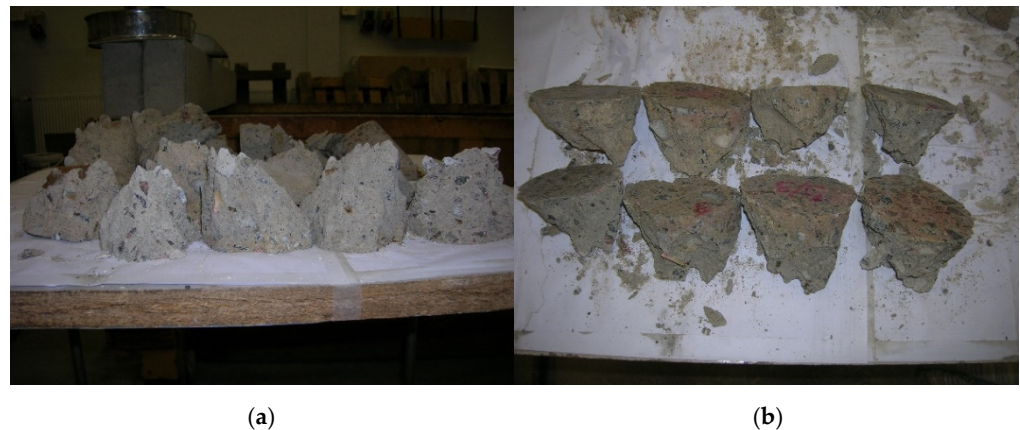
Figure 3. Concrete specimens after uniaxial compressive tests: (a,b) views of the form of failure.

Uniaxial compressive experimental tests were carried out using the Advantest 9 C300KN mechanical testing machine. Experiments were performed on the failure of the concrete cylinder specimens (see Figure 3). The uniaxial tensile test results of compressive strength for cylindrical samples  $f_{c,cycl 100}$  is presented in Table 3. The mean value of compressive strength of cylindrical samples  $f_{c,cycl 100}$  was 18.8 ± 0.7 MPa. The strength results of the cylindrical samples  $f_{c,cycl 100}$  with length/diameter ratio of 1.0 were comparable to the cube strength  $f_{c,cube}$  of 15 × 15 × 15 cm concrete specimens according to the EN 12504-1 standard [27], i.e.,  $f_{c,cycl 100} = f_{c,cube} = 18.8 ± 0.7$  MPa. The variation in compressive strength

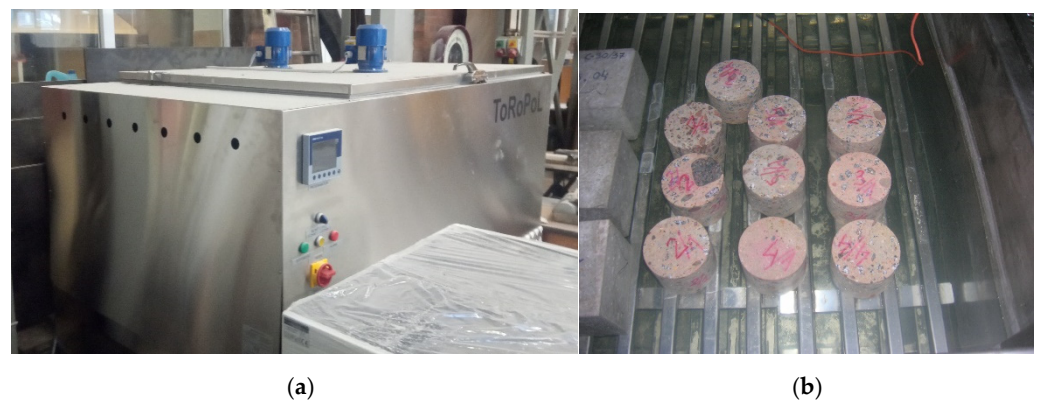
**Figure 4.** Frost resistance tests: (a) view of freezing chamber; (b) view of concrete specimens inside the freezing chamber.

Uniaxial compressive tests were undertaken using a computer-controlled mechanical testing machine with a constant rate of loading and a range of 0.6 MPa/s according to the EN 12390-3 standard [32]. The frost resistance of the old concrete was determined according to guidelines given by the PN-B-06250 standard [33]. A freezing chamber with a temperature- and time-controlled refrigerating and heating system was used. The freezer cycle consisted of freezing at  $-18 \pm 2$  °C for 4 h and thawing by total immersion in water at  $18 \pm 2$  °C for 4 h.

With regard to evaluation of freezing resistance, according to the PN-B-06250 standard [33], the compressive strength should not decrease by more than 20% in comparison to the base samples and the specimens should not show cracks [47]. In this study, we started the test by saturating the concrete samples with water. Then, 10 concrete samples were placed in a freezing chamber with a temperature- and time-controlled refrigerating and heating system (see Figure 4). The concrete samples were placed in the freezer compartment with a minimum 20 mm gap. A total of 50 freezer cycles were carried out consisting of freezing at  $-18 \pm 2$  °C for 4 h and thawing by total immersion in water at  $18 \pm 2$  °C for 4 h. After the last defrosting, a strength test was carried out. The frost resistance assessment was based on measuring the change in compressive strength. The mean value of compressive strength of the cylindrical samples after 50 freezer cycles  $f_{c,cycl\ 100}^{50\ \text{freezer cycles}}$  was  $17.9 \pm 1.0$  MPa, which was about 5% lower than the compressive strength of cylindrical samples  $f_{c,cycl\ 100}$  without freezing (base samples). The difference between compressive strength  $f_{c,cycl\ 100}$  and  $f_{c,cycl\ 100}^{50\ \text{freezer cycles}}$  was small (<20% according to PN-B-06250 [33]); therefore, it could be stated that the 95-year-old concrete possessed freezing resistance.

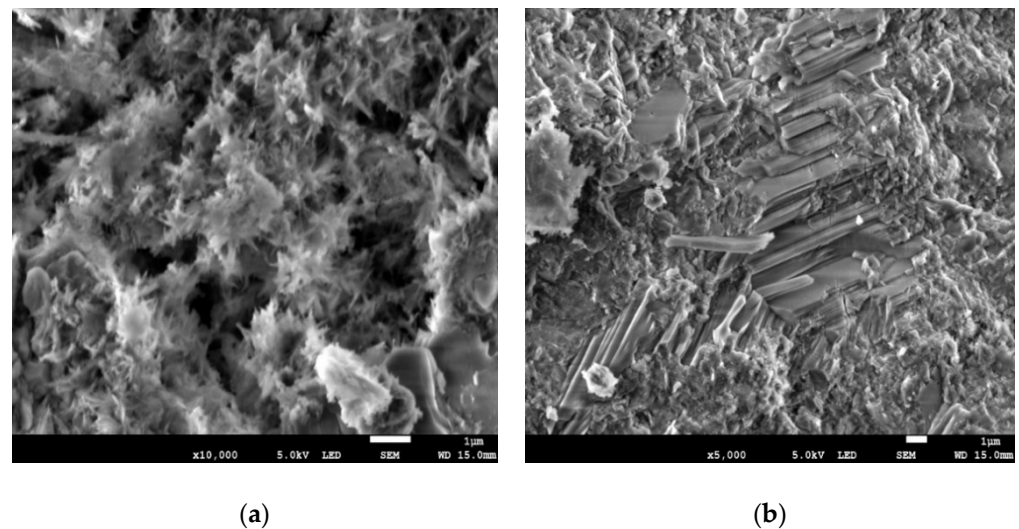
**Figure 5.** Scanning electron microscope (SEM) images of the samples taken from the cover layer of the concrete structure: (a)  $\times 10,000$ ; (b)  $\times 5000$ .

Based on the specified chemical properties, samples from 1s and 1c concrete specimens were chosen for XRD analyses to assess the presence of crystalline compounds and identify them. For the tests, specimens measuring  $10 \times 10 \times 10$  mm were taken from the cover layer and the center layer (about 7.5 cm below the surface of the concrete) of the tested concrete element. Microstructure tests were carried out for four samples (two samples from the cover and two samples from the center layer of old concrete specimens). Element composition tests (EDS) were carried out for four samples (three samples from the cover and three samples from a depth of about 7.5 cm below the surface). The results of the microstructure (SEM images) and element composition of the tested samples are shown in Figures 5 and 6.

- Portlandite crystals were found in the tested samples, shaped most often as hexagonal platelets. Both isolated and clustered occurrence was noted. The visible portlandite occurred in the form of large pseudo-hexagonal crystals, forming columnar conglomerates arranged in parallel. In both cases, the resulting products (phases CSH and CH) were due to cement hydration reactions with water. The microstructure of the concrete has a significant influence on its properties, such as its strength and durability.

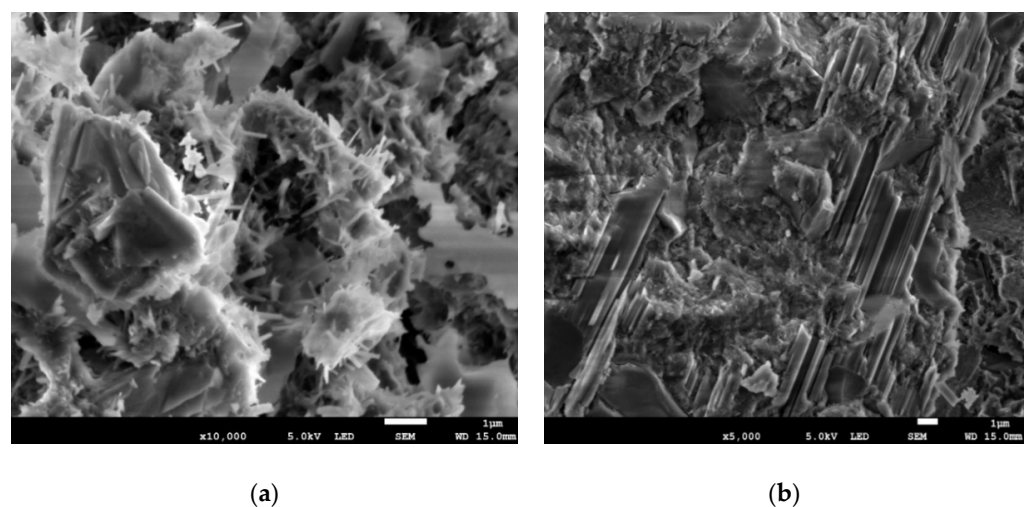
**Figure 6.** SEM images of the samples taken from center layer of the concrete structure: (a)  $\times 10,000$ ; (b)  $\times 5000$ .

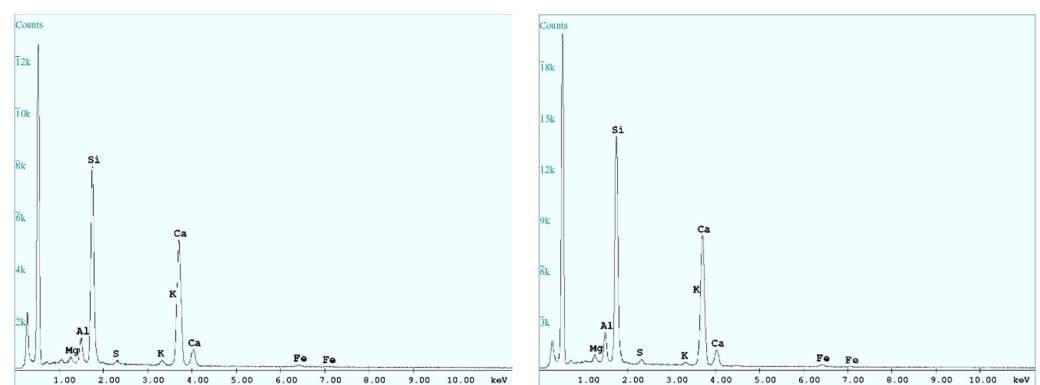
**Figure 7.** Energy-dispersion X-ray spectrometer (EDS) spectra of samples taken from the (a) cover layer; (b) center layer.

The results of element composition tests are presented in Tables 8 and 9. They indicated the dominance of two main elements in the microstructure of the tested samples: Si (silica)

and Ca (calcium) (see Figure 7). The content of these elements for samples taken from the cover layer was 29.4 to 34.7% for silica and 54.1 to 57.5% for calcium. For the specimen samples taken from center layer, the content was 25.6 to 36.8% for silica and 51.6 to 60% for calcium. The content of other elements, such as Al, Fe, Mg, K, and Na, was definitely lower compared to the Si and Ca content in all samples.
